TO: Jim Stewart, Director of Public Works, Borough of Naugatuck
FROM: Pamela Westgate, P.E., Kleinfelder
DATE: July 28, 2016

This Technical Memorandum describes the condition assessment and needs identified in evaluations of the Hop Brook, Horton Hill, Inwood, Maple & May, and the Platts Mill Pump Stations (PSs) in the Borough of Naugatuck, CT. This assessment of the five pump stations was done as part of developing a Facilities Plan for the Borough owned wastewater collection and treatment facilities in Naugatuck. The purpose of the condition assessment was to:

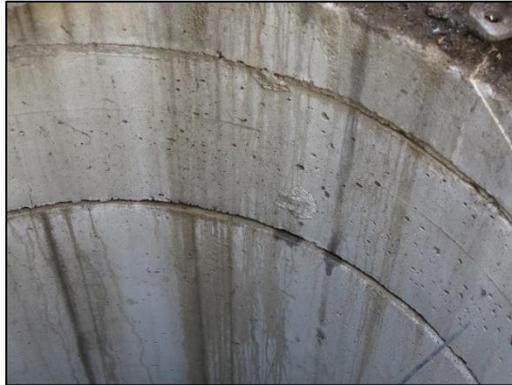
Figure 4. Horton Hill Misaligned Concrete Ring

- The wet well is made from concrete ring sections with one of the upper rings slightly displaced, as presented in the following figure, and may benefit from realignment or sealing to prevent leakage.

- HH1 – Seal the interior of concrete rings, with particular focus on the top cover area to prevent leaks. A more costly alternative to sealing would be to realign the ring through excavation and replacement.
- HH2 – Remove rust and paint exterior gas piping, or replace the gas line with corrosion resistant piping.
- HH3 – Roof damage visible. Appears to be from a single impact event.
- HH4 – One of the pumps at this location was overhauled in 2014 and one pump is new, although they appear to be in good operating condition, they may require replacement in the next 20 to 25 years.

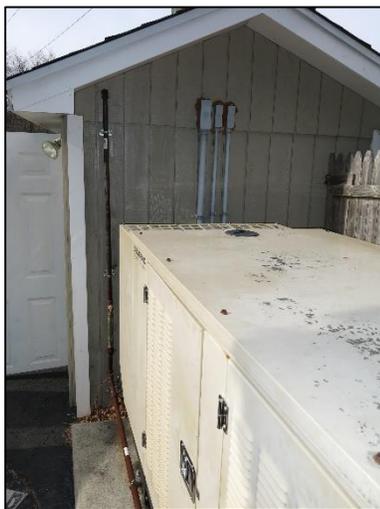
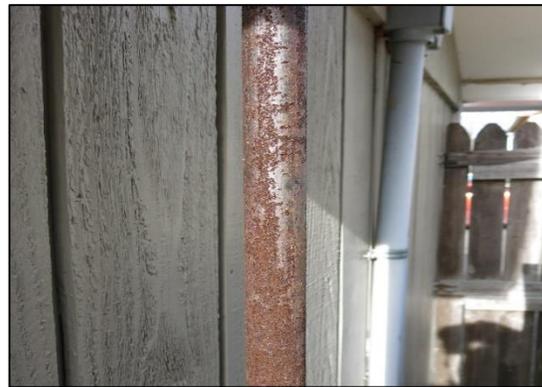
Figure 5. Horton Hill Generator Gas Line

- The natural gas line to the generator from the gas meter has surface corrosion as seen in the following figures. Replacing the natural gas line with corrosion resistant material may be considered.
- The pumping and piping systems appear to be in good condition.

- HH-B-1: The natural gas line to the generator from the gas meter has surface corrosion; recommendations include removing rust and paint exterior gas piping, or replacing the gas line with corrosion resistant piping.

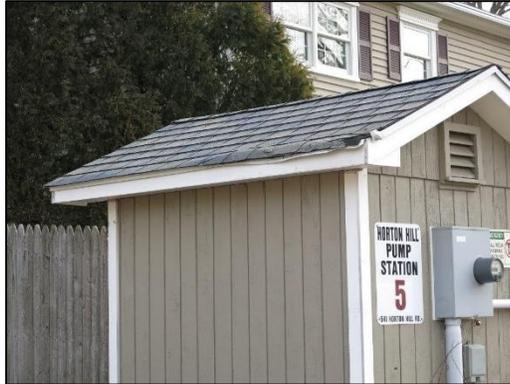
Figure 6. Horton Hill Exterior Damage

- The edge of the roof has minor damage, as can be seen in the following figure.

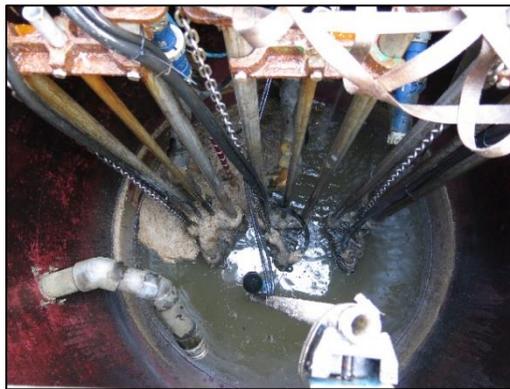
Figure 7. Inwood Wetwell

concrete materials in the Inwood wetwell. In addition, Maple & May pumps station, which are up stream of Inwood, are showing evidence of corrosion. Hydrogen sulfide may be forming at Maple & May pump station and increasing in concentration as it continues to Inwood pump station. The conditions favorable to hydrogen sulfide formation are not currently being addressed. This may lead to increased corrosion and degradation over time. The Borough could consider collection system odor control and corrosion control to prevent further deterioration at Inwood pump station and Maple & May pump station.

- IW1 – The hydrogen sulfide formation at this station has the potential to cause further corrosion damage. This issue should be further investigated to determine the most economical method to reduce the odor causing gases.

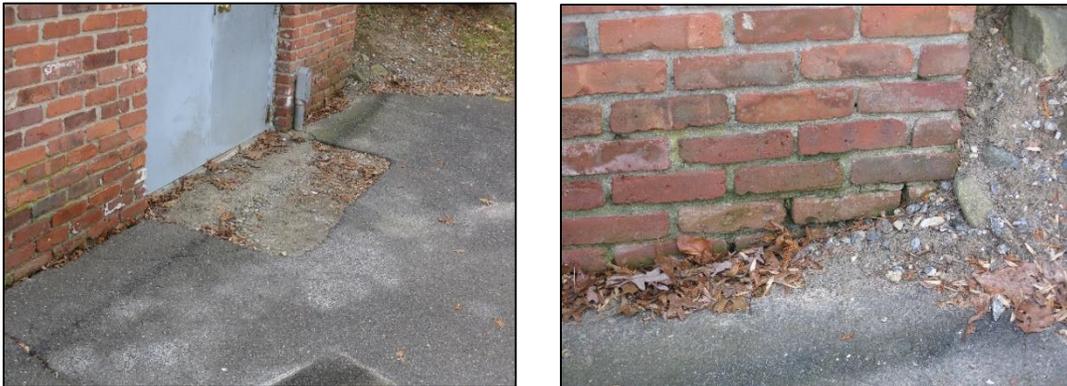
Figure 8. Inwood Asphalt & Brick Damage

- The roof appears to be in good condition on the exterior, but evidence of leaks were noticed on the roof plywood interior.
- The brick exterior mortar has degraded and repointing is recommended, as presented in the following figure. The deterioration of mortar may be due to corrosion from hydrogen sulfide since this edge of the building is closest to the wetwell hatch.
- The asphalt pad surrounding the building is in fair condition, however, a section is cut out in front of the building doors and should be replaced, as seen in the following figure.

- IW6 – Repair asphalt at door entry.
- IW7 – Control system and wiring is in fair condition, may require replacement in the future.
- IW8 – Interior and exterior roof shows signs of leakage. The roof is currently in good condition, will need replacement at some point.

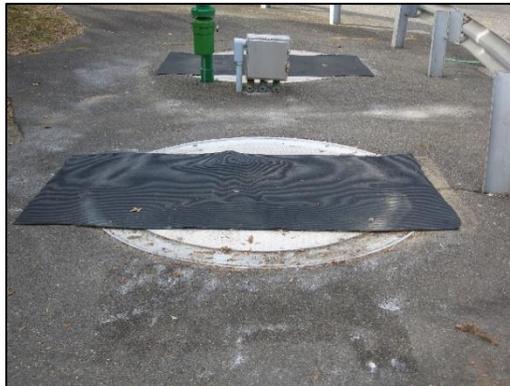
Figure 9. Inwood Pads over Access Hatches

- The hatch covers have mats covering them as seen in the following figure. This station is located in a residential neighborhood, odor issues are of high importance and it is recommended to replace the hatches with tighter seals through replacement or provide a better seal on the existing hatches to prevent odor emissions.

- IW2 – Replace emergency generator.
- IW3 – Seal wetwell and drywell covers to prevent odor issues in surrounding neighborhood. A more costly alternative to increasing the seal on the existing covers would be to replace the covers. It should be noted that the hatch sizes seem to be custom and may require custom fabrication.

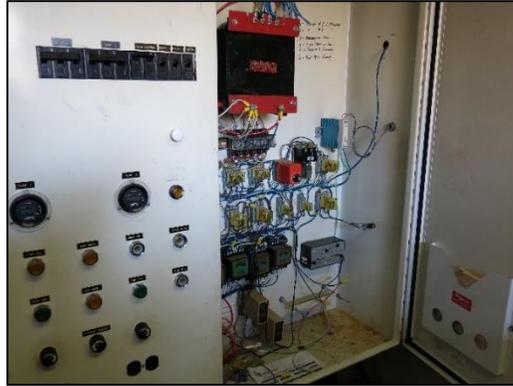
Figure 12. Platts Mill Control System

- The piping system, wetwell, and pumping system appears to be in good condition.
- The station control system is original to construction with outdated relay logic technology, and should be considered for replacement. It should be noted that the controls are still functioning, however, replacement parts may be difficult to obtain.

- PM-A-1: The generator and automatic transfer switch (ATS) are beyond their design life and in need of replacement
- PM-A-2: Replace grounding electrode conductor connection.
- PM-B-1: Upgrade control system.

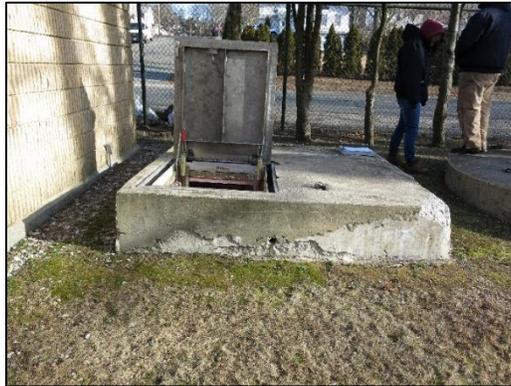
Figure 13. Platts Mill Drywell hatch and Concrete

- The drywell concrete pad shows evidence of spalling, as presented in the following figure, and should be repaired.

- PM-C-1: Repair dry well concrete casing at entry hatch.
- PM-C-2: Replace panelboard, feeder, and branch circuitry.

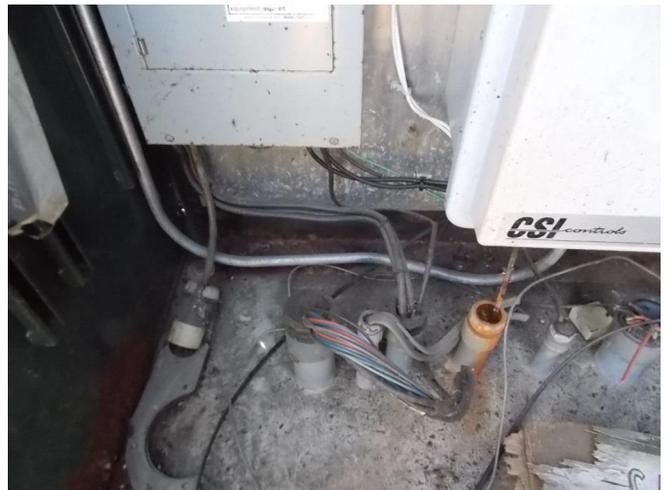
E-PS1-4 EXPOSED WIRING

- The power conductors are exposed within the equipment enclosure and the seal fittings are lacking on the conduits exiting the ground into the enclosure as required by code and NEC Article 500 classification. It is recommended that these be addressed as soon as possible.

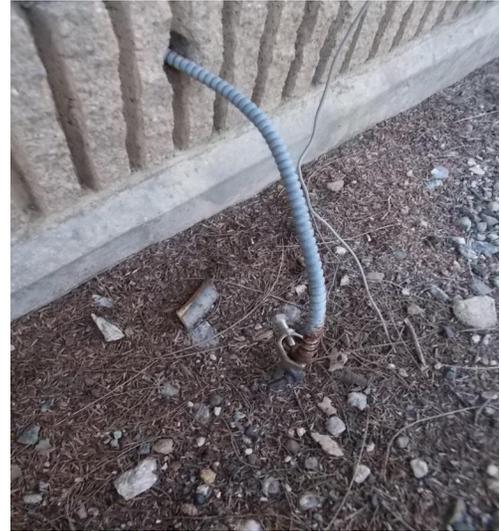
E-PS2-4 GROUNDING ELECTRODE

- Exterior grounding electrode connection does not appear to meet code requirements at the Platts Mill PS ().
- The generator at the Maple & May PS has had failures and been rebuilt within the past year ().
- The working space between the generator and the main pump control panels at the Inwood and Platts Mill PSs is not adequate per code requirements.
- Electrical equipment does not have proper Arc Flash labeling at any of the pump stations.
