**Re: Condition Assessment
Hop Brook Pool, 75 Crown Street, Naugatuck, CT 06770
CHA Project No. 23304.1000.28000**

CHA is pleased to present this Phase 1 report that documents the condition evaluation of the swimming pool located at 75 Crown Street in the Borough of Naugatuck, Connecticut (Borough). The structural portions of this report are based on a site visit conducted on September 20, 2011 by Brian Bidonde, P.E. of CHA. The reported condition of the plumbing system is based on pressure testing of the pool's water lines, which was completed on November 9, 2011 by Phil Brennan of Savol.

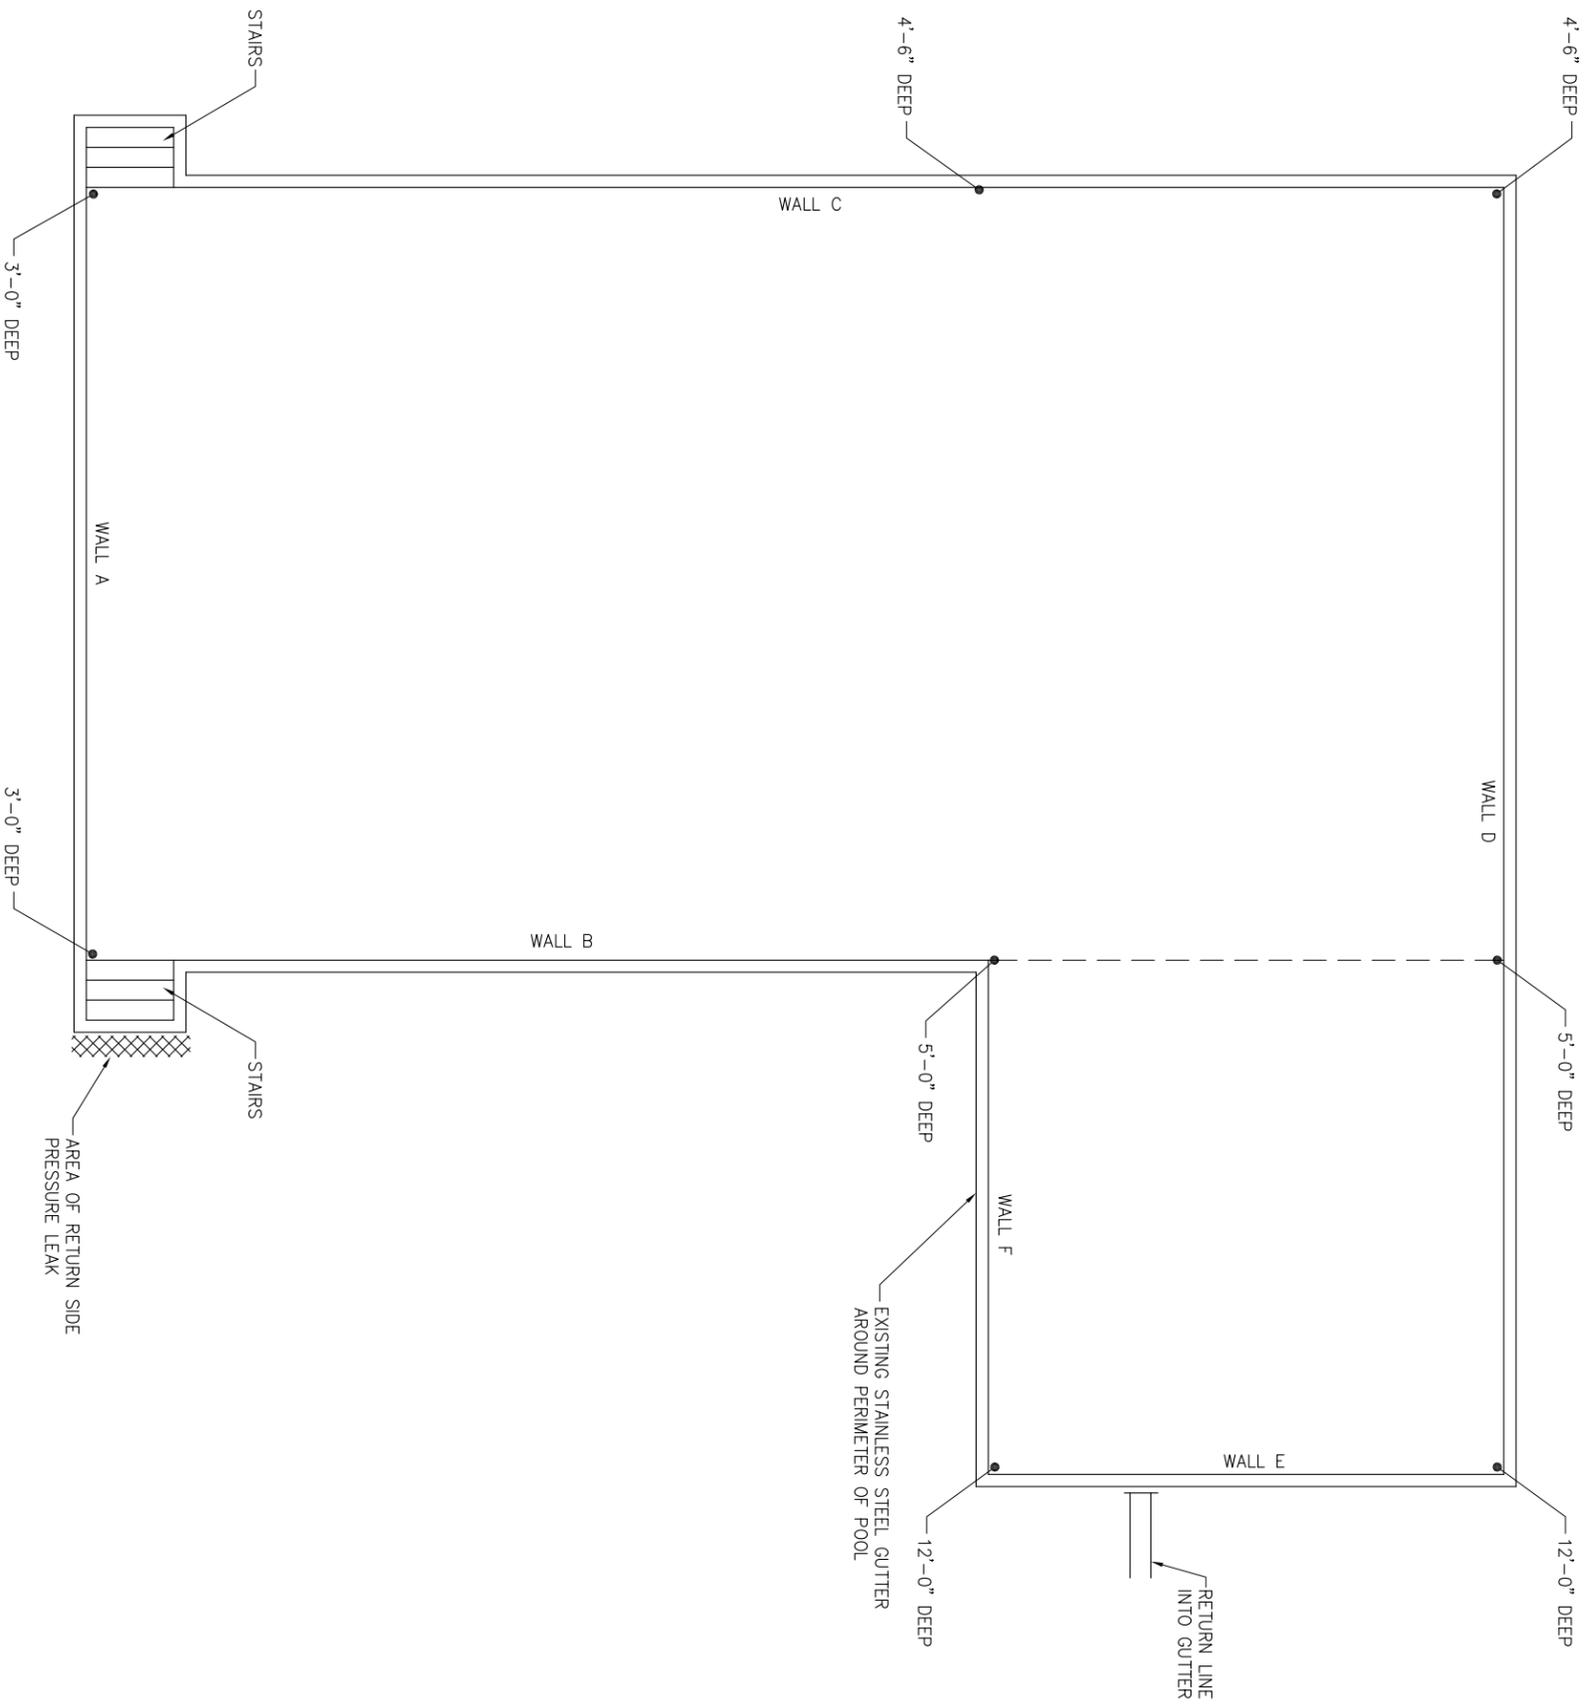
PROJECT NO.
22304
DATE: 11/18/11
FIGURE 1

4. The pool floor is covered with layers of patches and cementitious material similar to the walls.
 5. Most of the pool floor between Walls B and C from Wall A to the corner of Walls B and F is unsound (see Figure 1). The unsound concrete consists of cracks, spalls, delaminated layers of cementitious material, and failing patches that are not bonded to the substrate. No spalls were observed to be deep enough to expose a structural layer of concrete that is assumed to exist under the surface layers (Photograph 7).

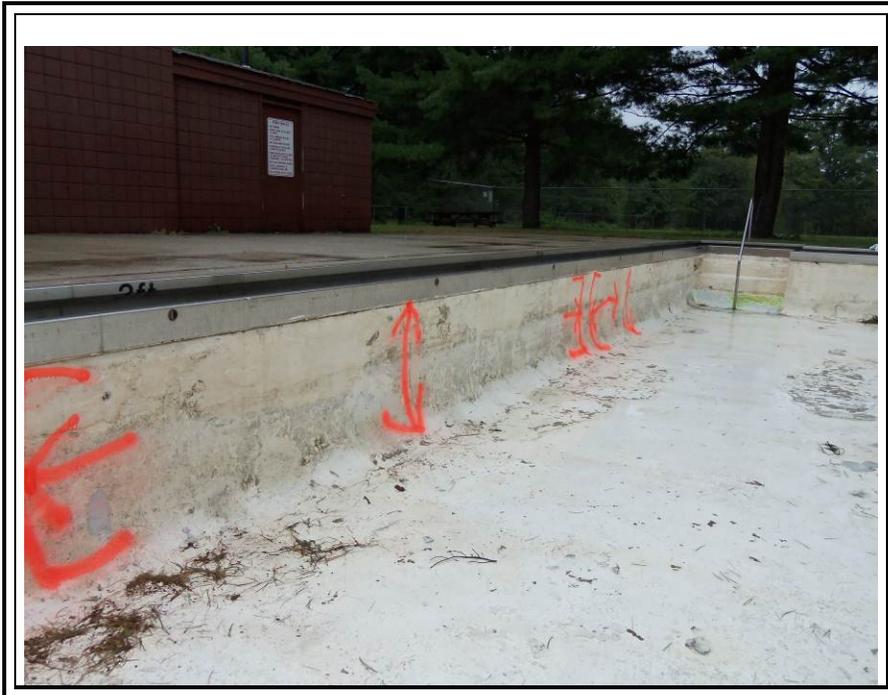
Photograph 1

- a. Nearly the full length of Wall A is unsound (Photograph 1). Wall A is at the shallow end of the pool.
 - b. Wall B is located at the shallow end of the pool, and is mostly unsound. Large cracks are located at the west end of the wall and a large spall is located at the east corner. The spall has revealed what appears to be a layer of shotcrete and corroding welded wire fabric against what is believed to be the original concrete wall. Several layers of cementitious materials were placed over the shotcrete layer. According to a Borough maintenance employee who has done previous repair work on the pool, a

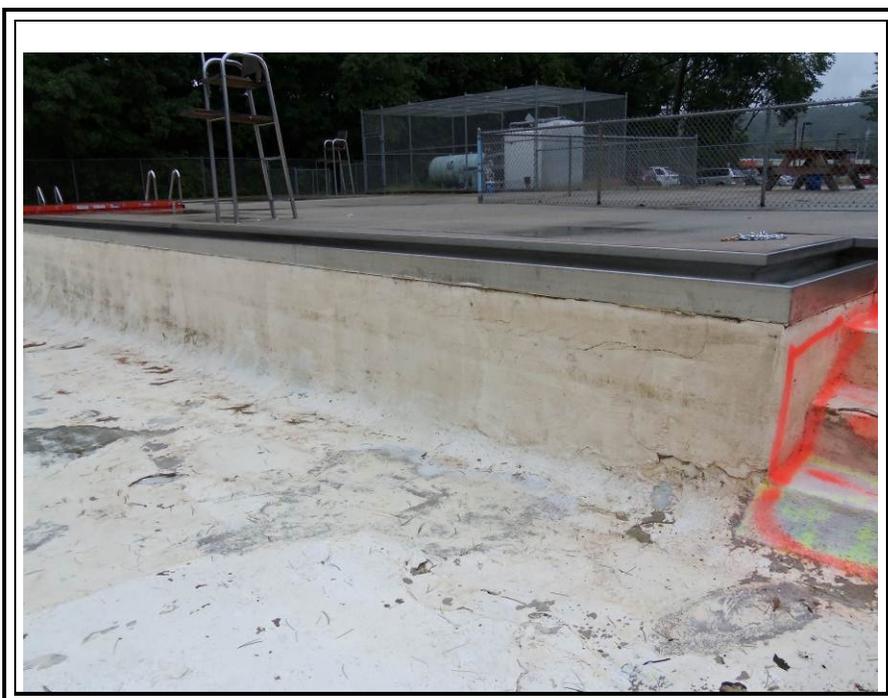
Photograph 2

large portion of this wall was previously patched. The employee believes that the structural integrity of this wall is questionable (Photograph 2).

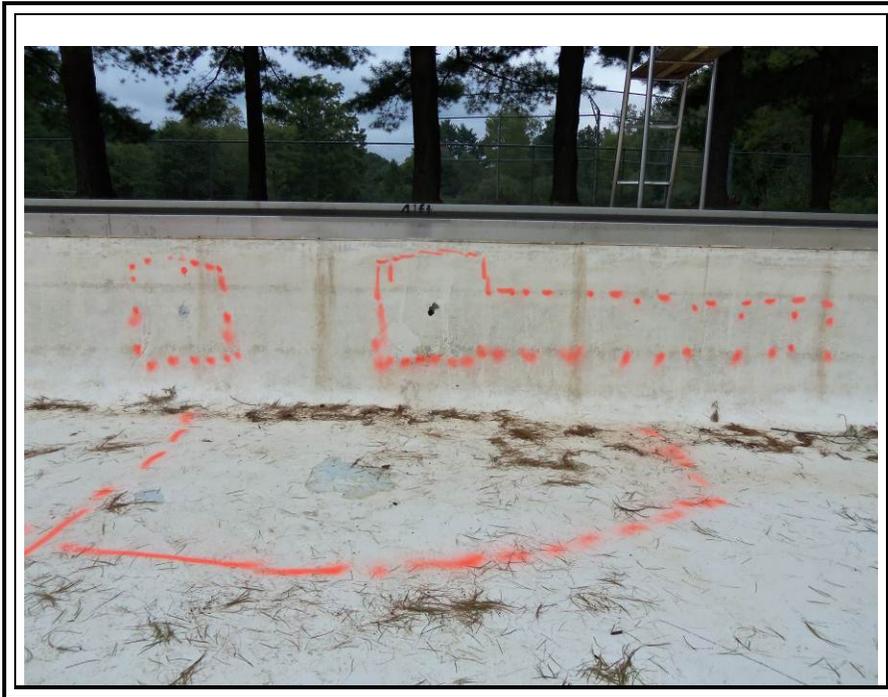
Photograph 3

- c. The western portion of Wall C is at the shallow end of the pool, and is mostly unsound. Two large voids were detected in this wall, and are believed to consist of abandoned light fixtures that were covered with concrete. In one of the voids, what appears to be an electrical cable was observed. According to a Borough maintenance employee who has performed previous repair work on the pool, a large area at the western end of this wall was previously patched. This employee stated to CHA that the patch went through the entire thickness of the wall, and he believes that the integrity of this wall is questionable (Photograph 3).

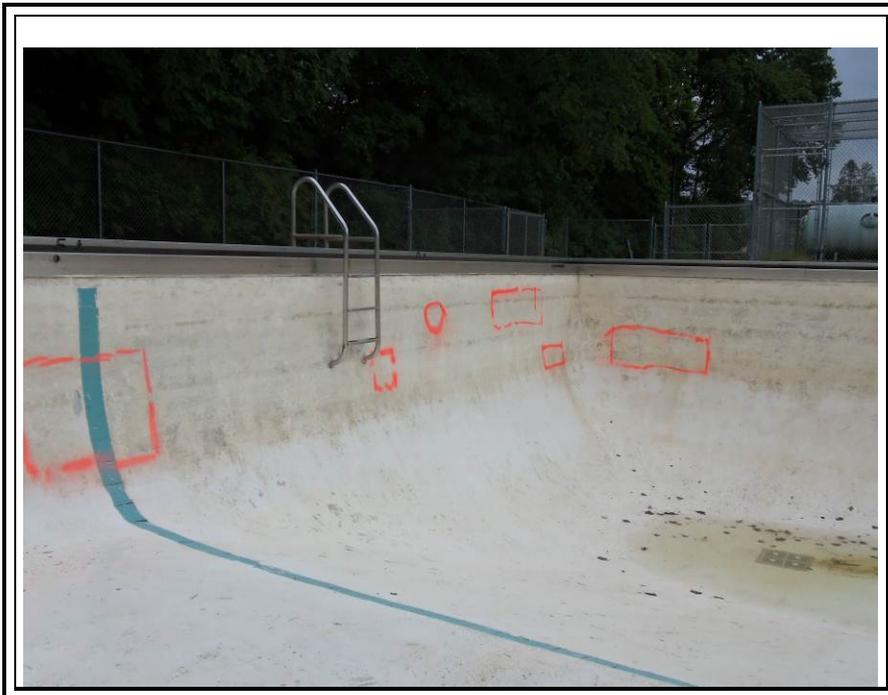
Photograph 4

- d. The deterioration of Wall D is less severe than Walls A, B, and C, but is still significant. Unsound concrete was detected above the level that the pool is drained to at the end of the season (Photograph 4).

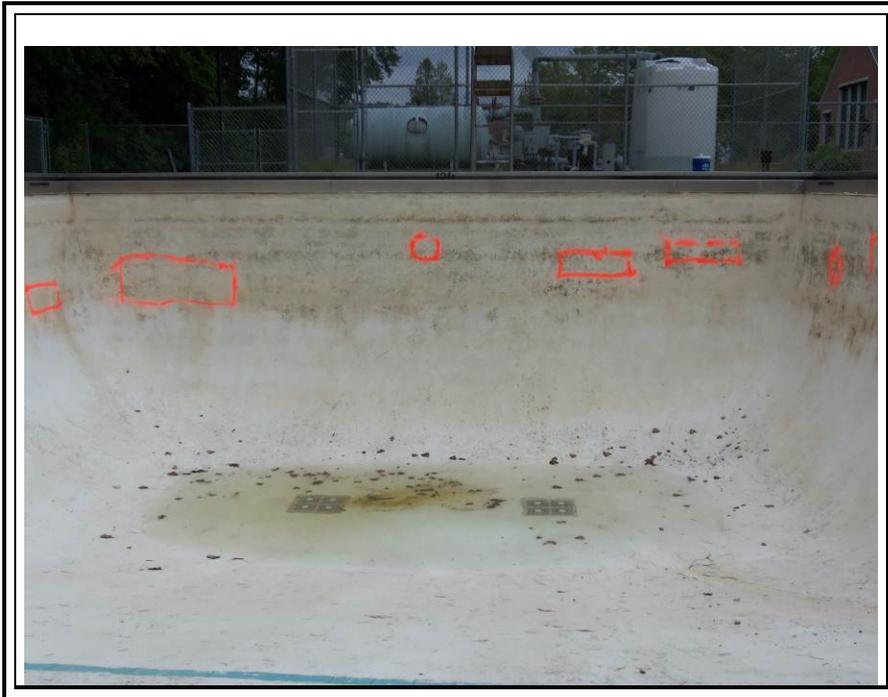
Photograph 5

- e. The unsound concrete at Wall E is located above the level that the pool is drained to at the end of the season. In addition, a circular area approximately 18 inches in diameter of unsound concrete was found at the center of the wall, and is believed to consist of an abandoned light that was covered with concrete (Photograph 5).

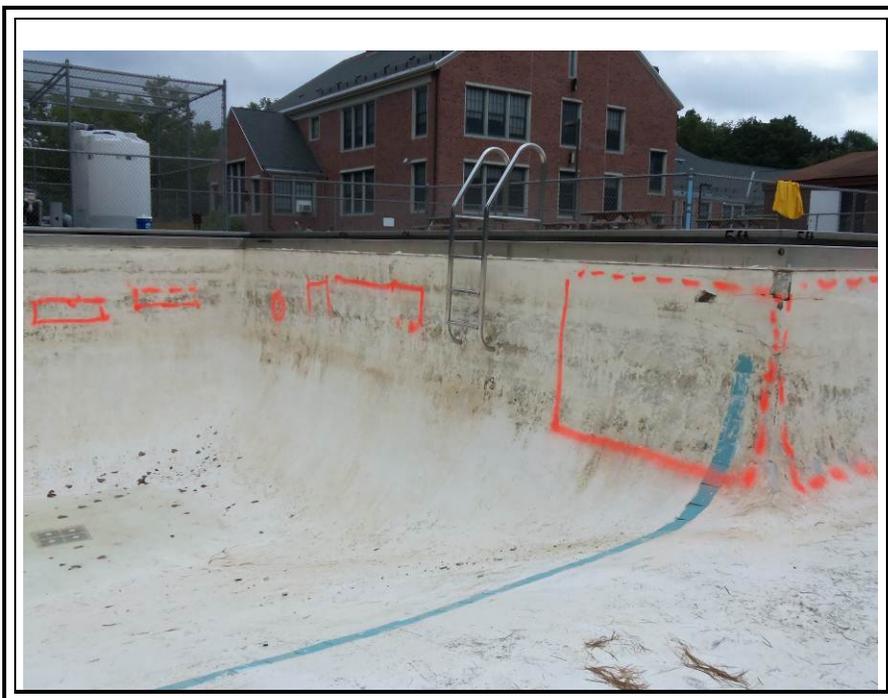
Photograph 6

- f. The unsound concrete at Wall F is located above the level that the pool is drained to at the end of the season. This wall also has a circular area of unsound concrete that is believed to consist of an abandoned light fixture that was covered with concrete. The most severe deterioration occurs at the north end of this wall at the corner with Wall B (Photograph 6).

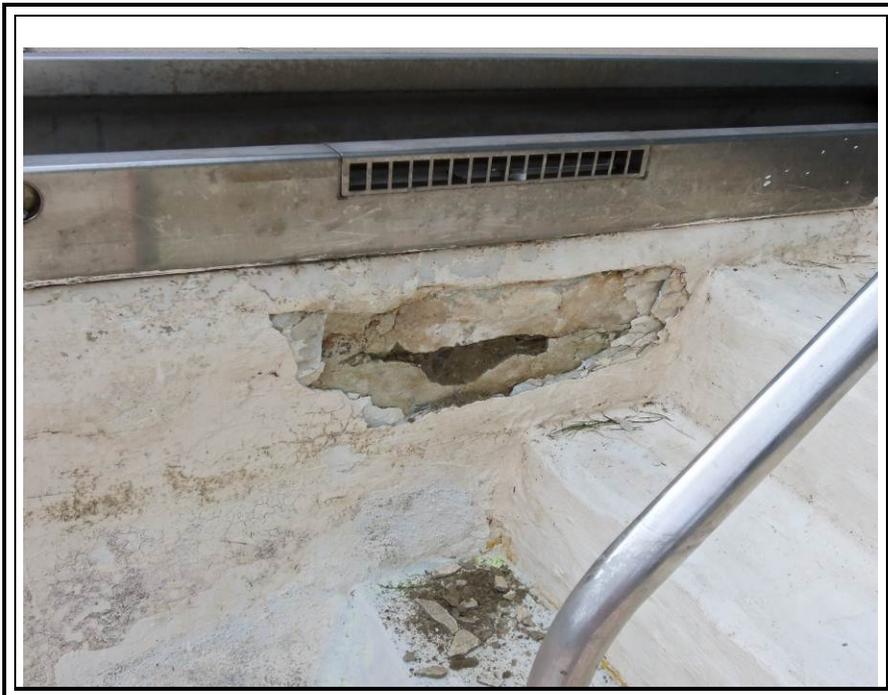
Photograph 8

7. The concrete stairs at the north and south ends of Wall A are in very poor condition. The concrete is cracking, spalling, and delaminating. A very deep spall was observed in the stair wall at the north end of Wall A (Photograph 8).
