**REQUEST FOR QUALIFICATIONS
ARCHITECTURAL/ENGINEERING DESIGN SERVICES
For the RENOVATION OF THE TUTTLE BUILDING**

EXISTING CONDITIONS REPORT

TUTTLE HOUSE NAUGATUCK, CONNECTICUT

**Re: Investigation of building envelope at the
Naugatuck Board of Education
Naugatuck, CT**

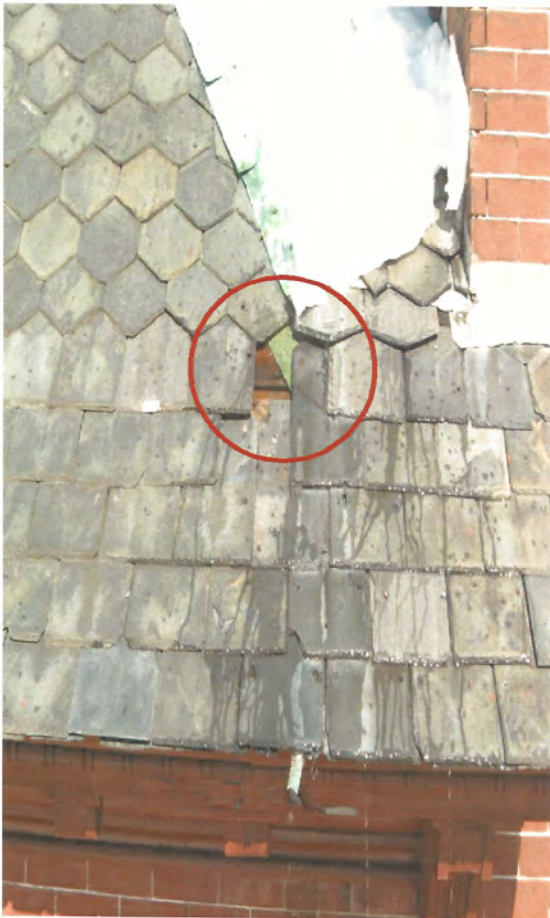
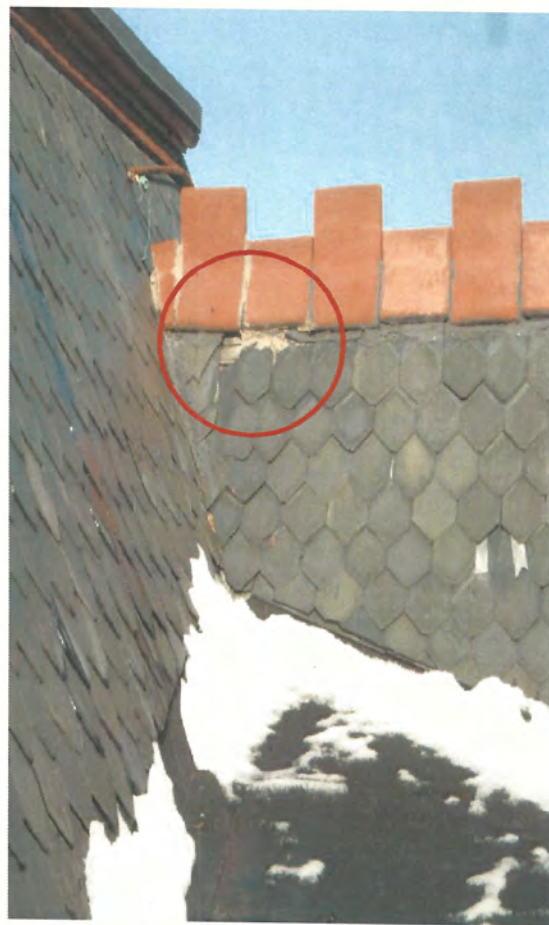
- Sections of slate shingles are missing exposing the wood plank deck to water infiltration. No building felts were observed under the slate which typically would provide a secondary level of water protection.

Exposed Wood Plank Deck

The roofs are in poor condition, evidence of leaks are too numerous to mention and visible on multiple surfaces on the 3rd floor walls and ceilings, as well as the wood plank decks and structural elements in the attic. KBA recommends that the roofs be removed in their entirety down to the wood decks. This will provide an opportunity to inspect the existing exposed wood plank deck in order to replace any water saturated, rotted and damaged decking.

A new slate roof should be installed over a continuous layer of ice and water shield to provide a secondary layer of protection that will guarantee the borough of Naugatuck a maintenance free water tight roof for the next 50 years. New copper hip and valley flashings must be integrated into this new roofing assembly to properly flash and terminate the numerous transitions. The ridges must also be sealed, flashed and made water tight before re-installing the original ornamental clay ridge caps.

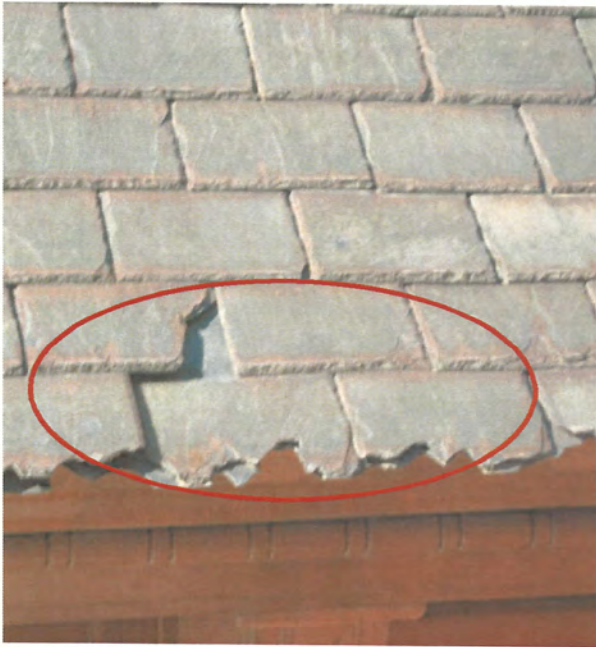
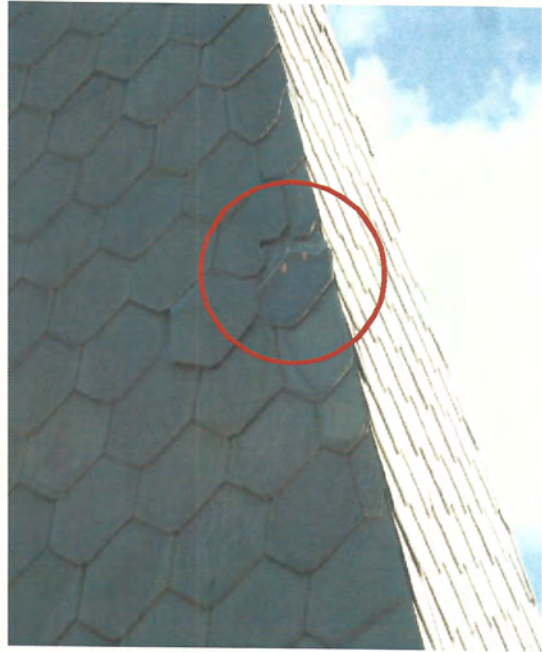
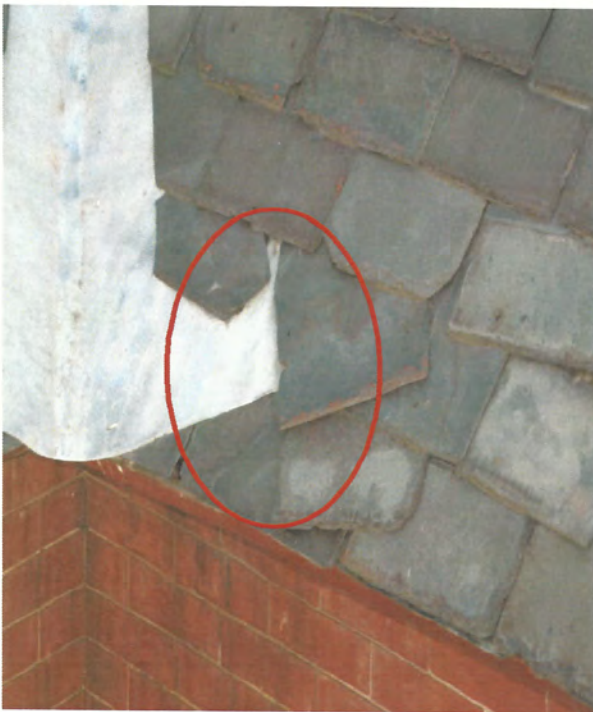
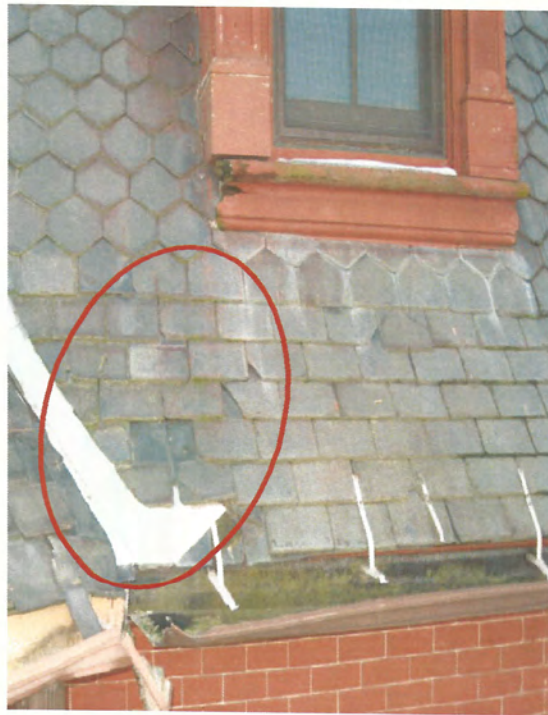
- Numerous individual pieces of slate shingles are cracked or have become dislodged and have fallen off the roof or are in danger of falling, creating potential liability issues.

Loose or Missing Slate

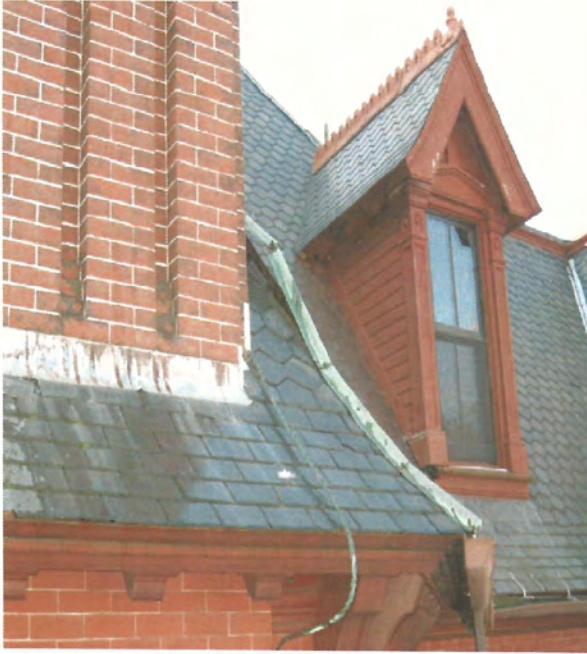
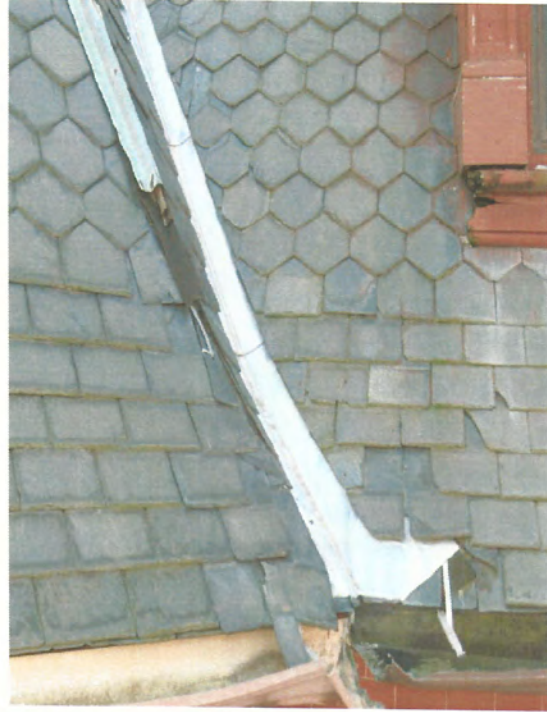
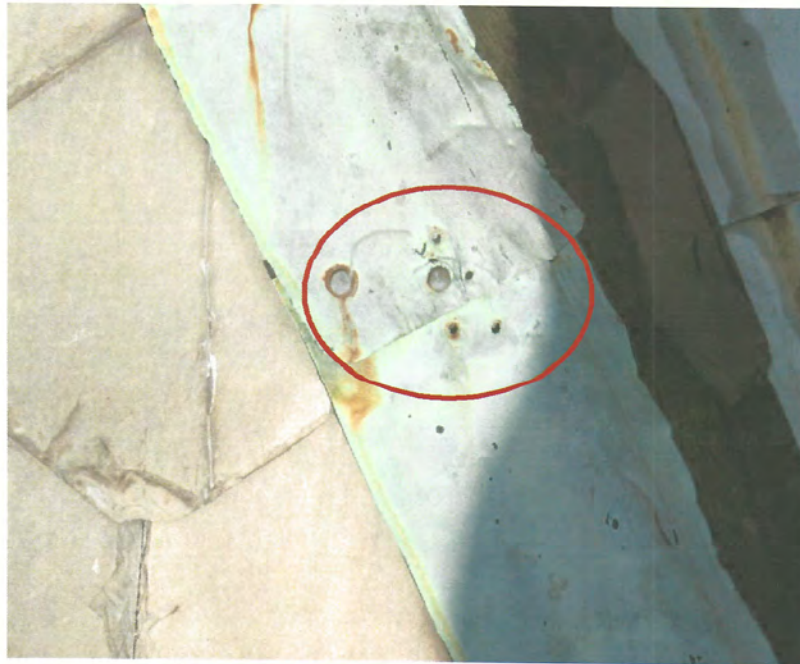
- The copper sheet metal flashings protecting the transitions at the hips are in poor condition. Sections on the east elevation have become detached from the roof surface. Other sections show evidence of repeated repairs which do not appear to be weather tight.

Existing Repairs Made at Hip Flashings

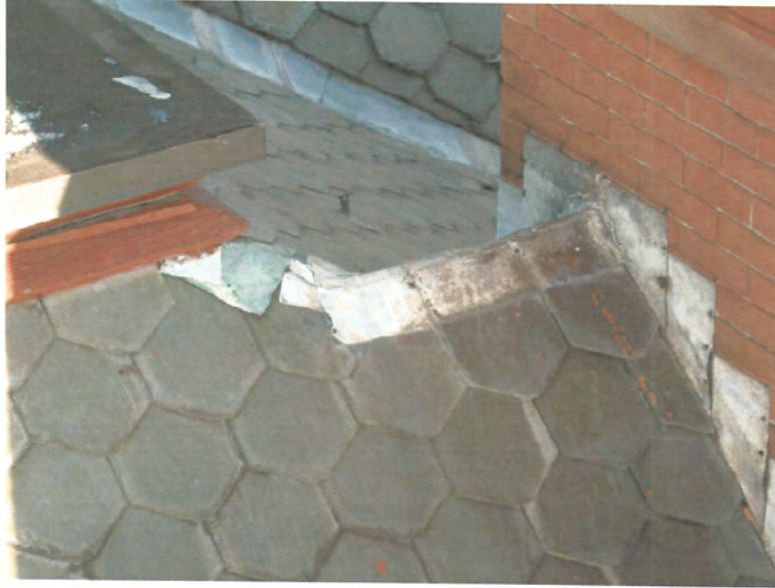
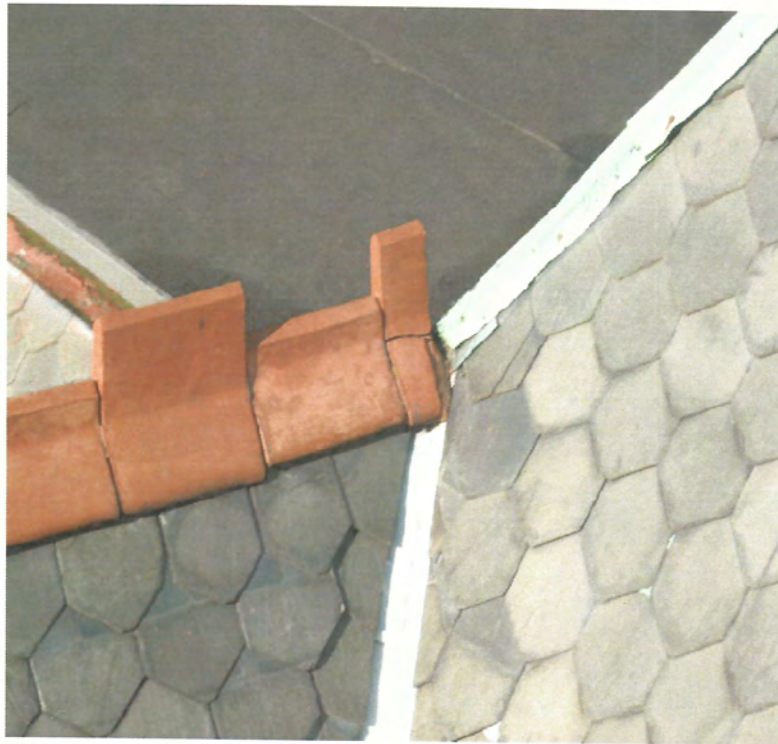
- Past efforts to repair the roof, demonstrate a poor quality of the workmanship indicating a lack of sophistication or understanding of the importance of making the facility water tight. Sheet metal details appear to be cobbled together using small sections secured with exposed fasteners. They are installed in a very crude fashion allowing water to enter the facility at numerous locations.

Repairs

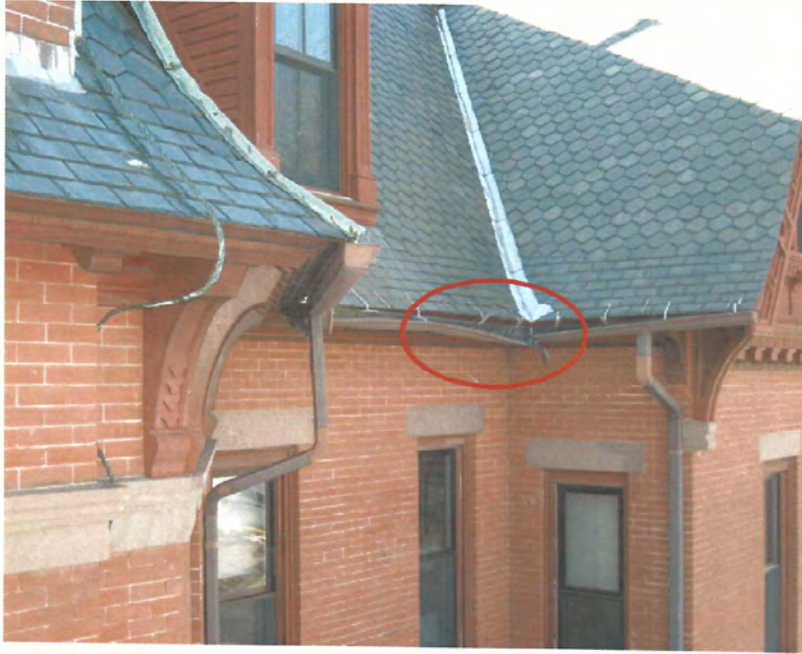
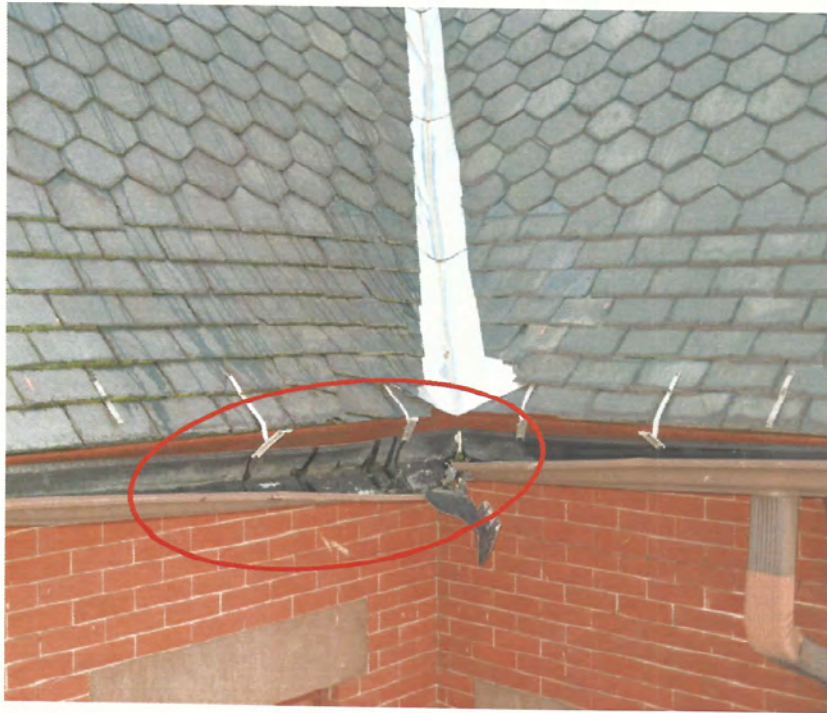
- The gutters are for the most part useless. Numerous sections of gutter are bent and hanging off the building. The gutter hangers do not appear to be adequate for the weight of snow and ice. Snow guards which help retain the ice and snow from accumulating and overloading the gutters with additional weight were not observed at these locations.

Damaged Gutters

KBA recommends that gutters and downspouts be installed at all the eave conditions to enhance water management and direct water away from the building's foundation and pedestrian walking areas. The project must also include snow guards to limit the amount of ice and snow build-up in the gutters and to avoid the sudden release of snow and ice onto the pedestrian traffic below

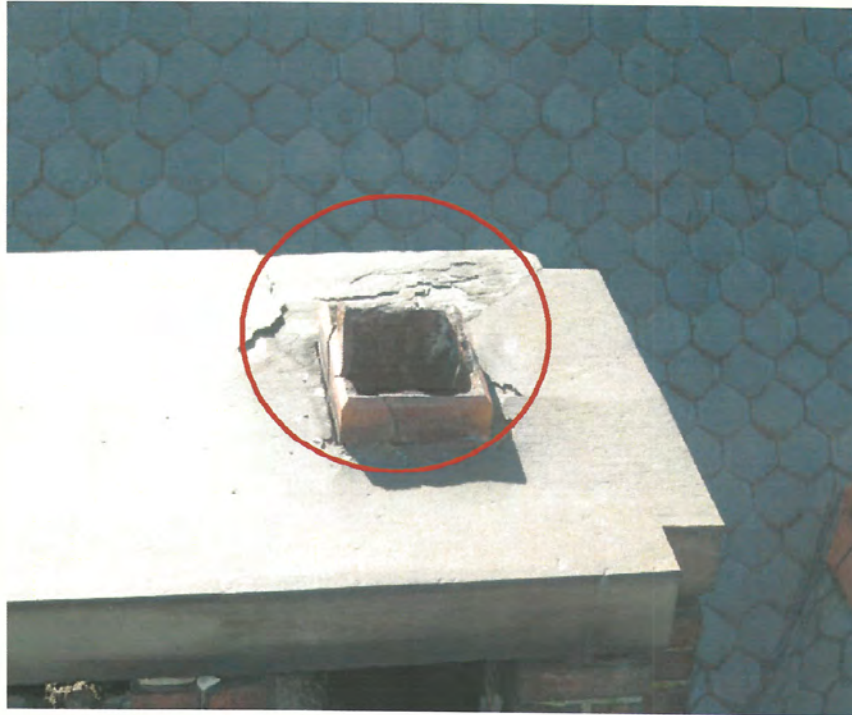
- Several slate chimney caps and clay flues are damaged and in need of replacement. The chimney cap and clay flue on the west side of the facility is missing completely.

Damaged Chimney Cap

To eliminate potential water infiltration, the chimneys must be repaired and re-pointed, the project scope should include new precast concrete caps, new copper flashing all around the transition with the roof and the incorporation of crickets to divert water, ice and snow away from the masonry. The rotted wood on the dormers must be removed, replaced, painted and flashed into the new slate roof to provide protection from water infiltration.

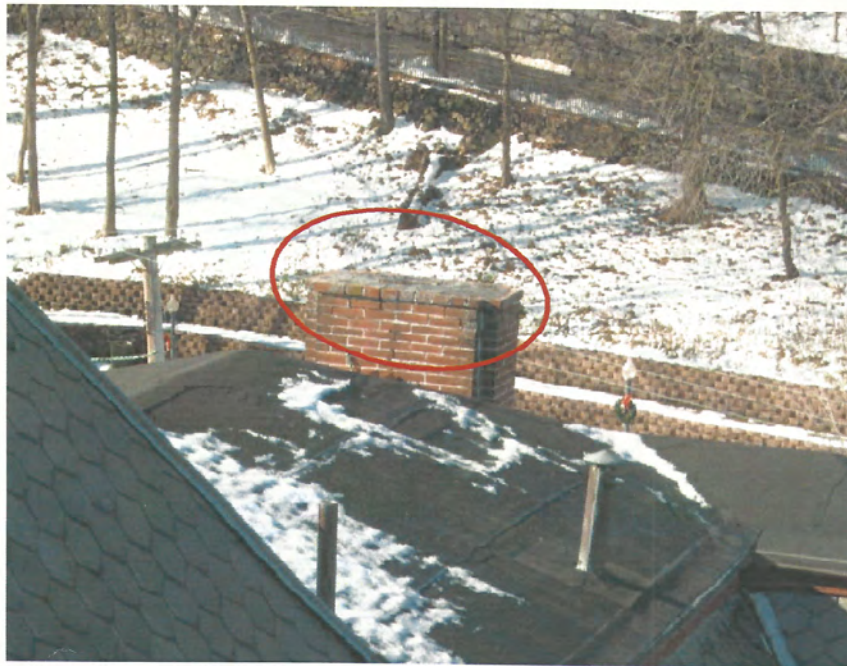
Missing Chimney Cap

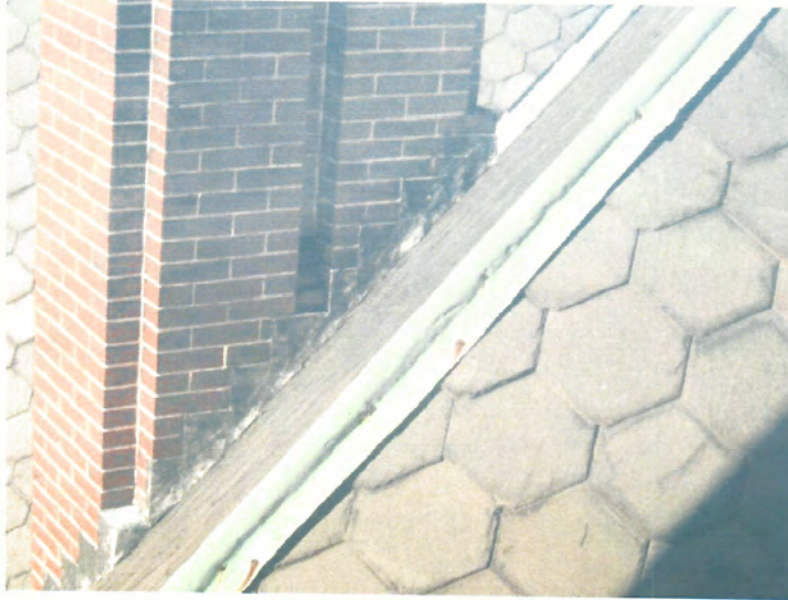
- Crickets which divert water, ice and snow around and away from roof top penetrations such as chimneys and exhaust fan curbs were not observed. The lack of crickets can contribute to a build-up of snow and ice behind the penetrations that can eventually turn into water and enter the facility.

No Crickets

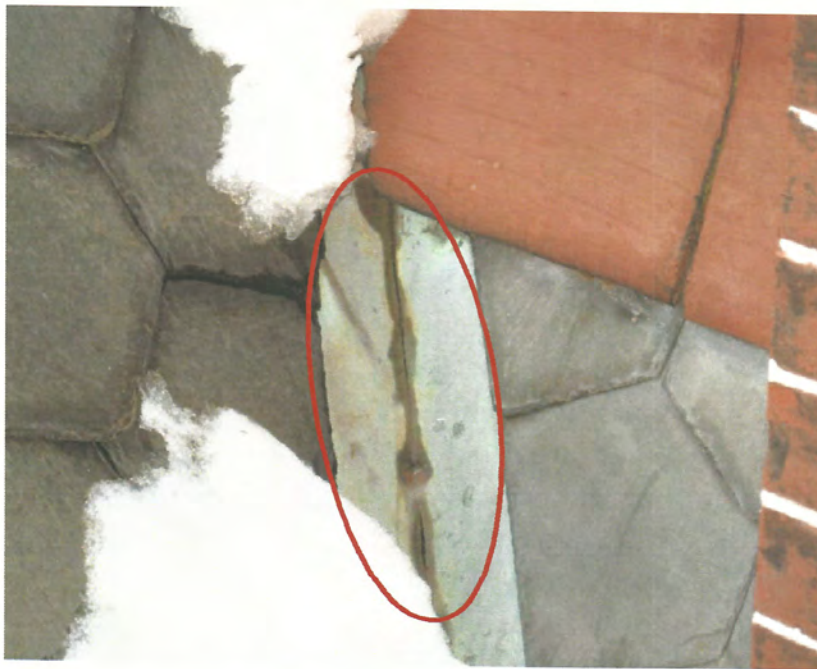
- It was noted that some of the copper valley flashings are split open and others had been repaired by applying a thick layer of roofing cement which will eventually dry out and continue to leak.

Copper Valley Flashing Spilt Open

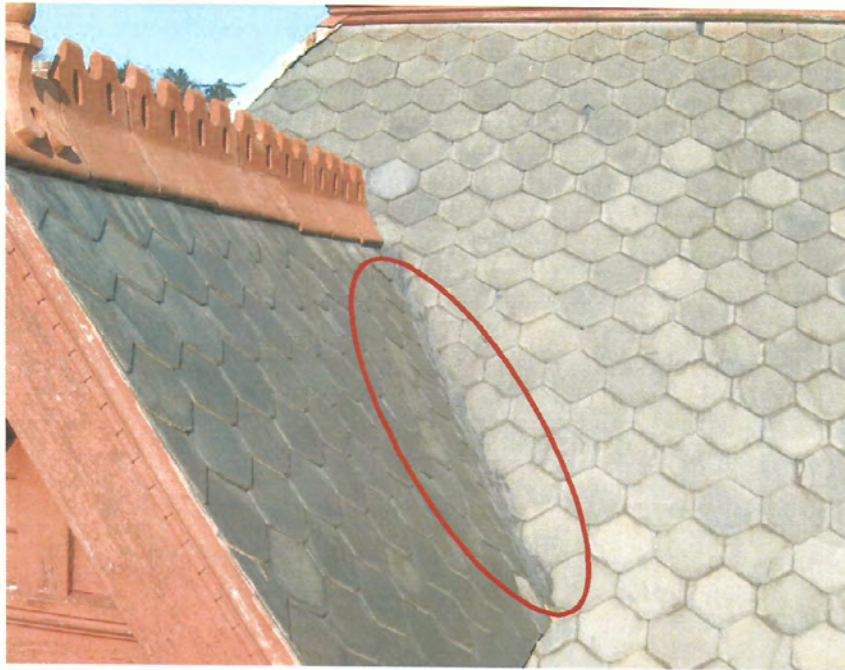
Copper Valley Flashing Covered with Roofing Cement

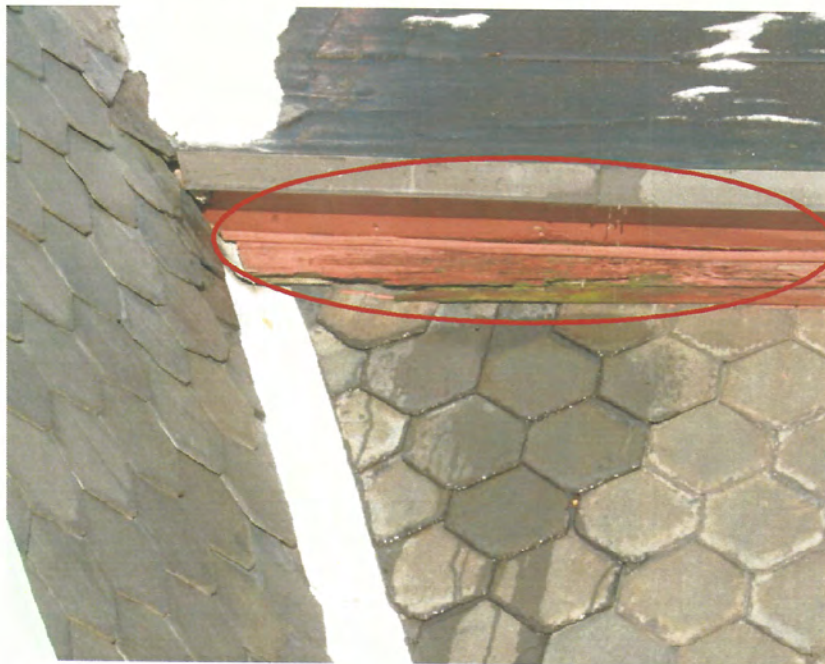
- Wood trim installed at several roof flashing details is rotted and in extremely poor condition.

Wood Trim

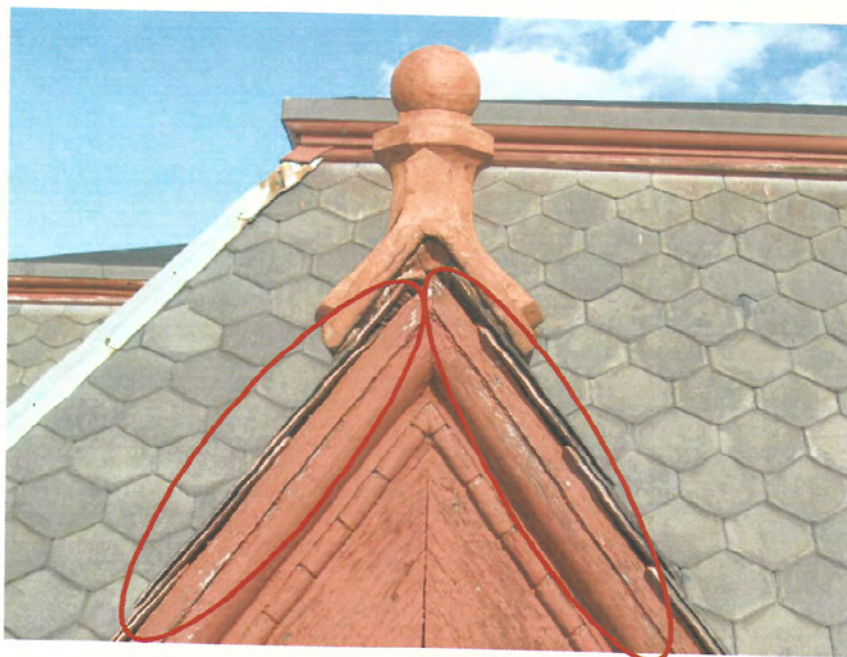
- The rake edges have no drip edges which typically are installed to help deflect the water away from the wood trim.

No Drip Edge

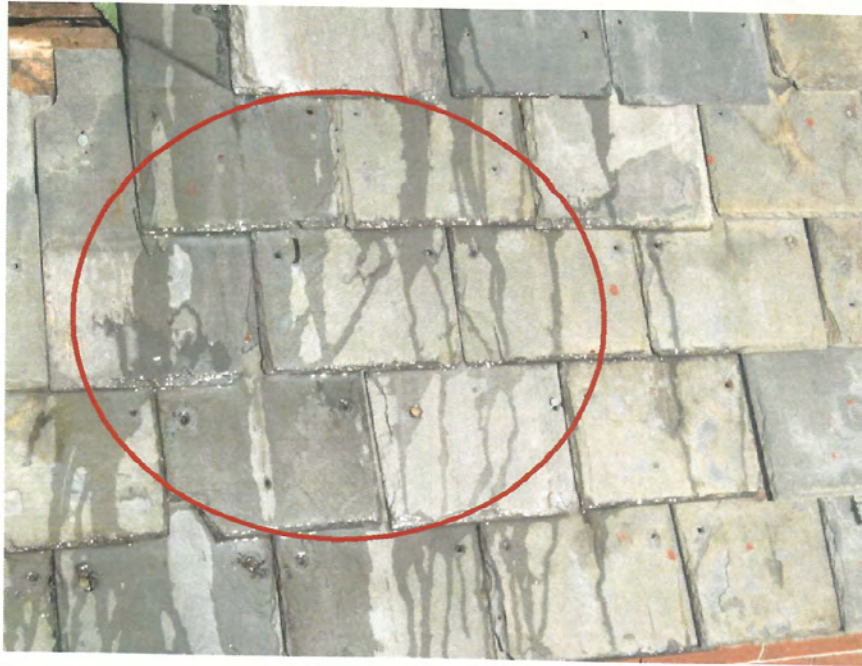
- Sections of roof on the south elevation were repaired with used slates as evidenced by the exposed holes, indicating that the pieces of old slate were rotated to hide defects or broken edges.

Repairs with used Slates

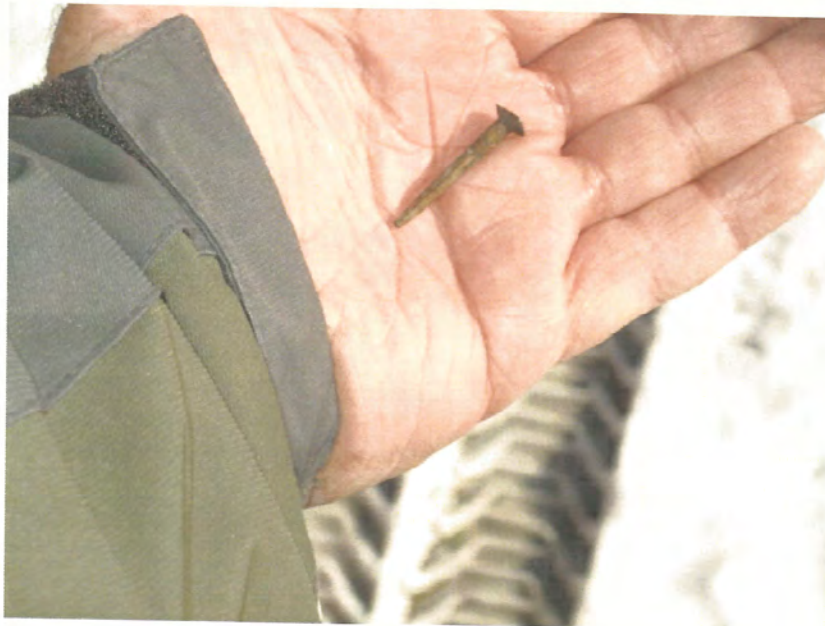
- The nails used to fasten the slate shingles to the wood deck are very small and do not meet current industry standards.

Nails do not meet Industry Standards

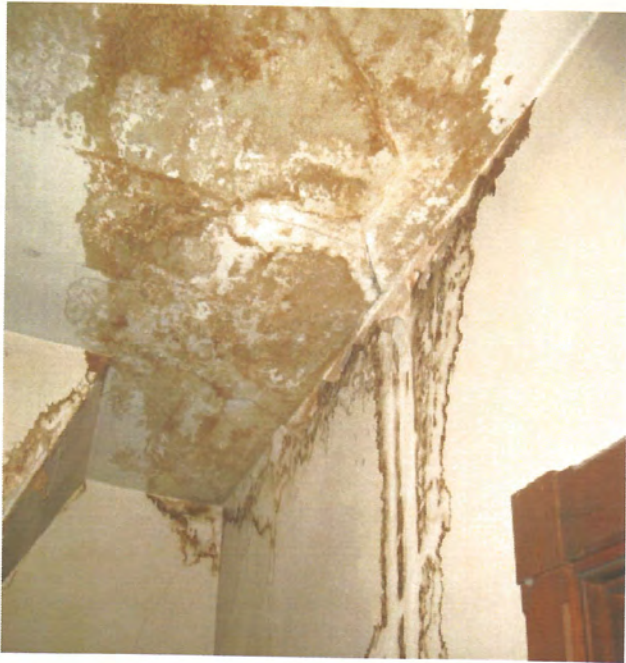
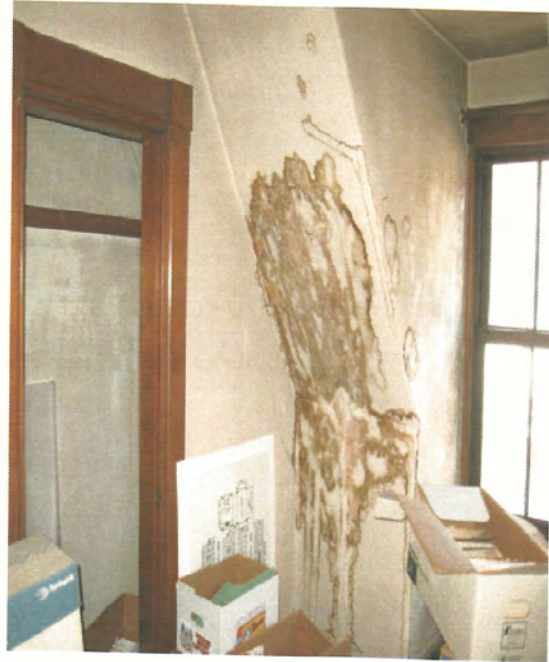
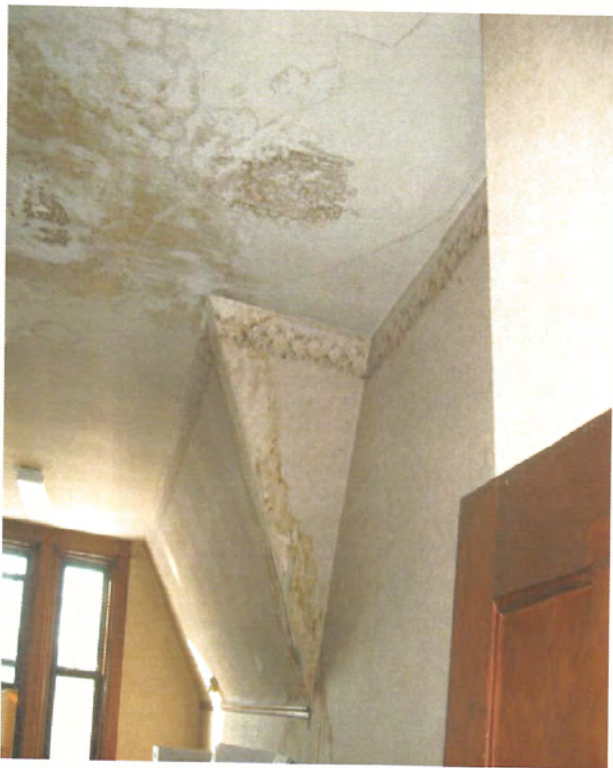
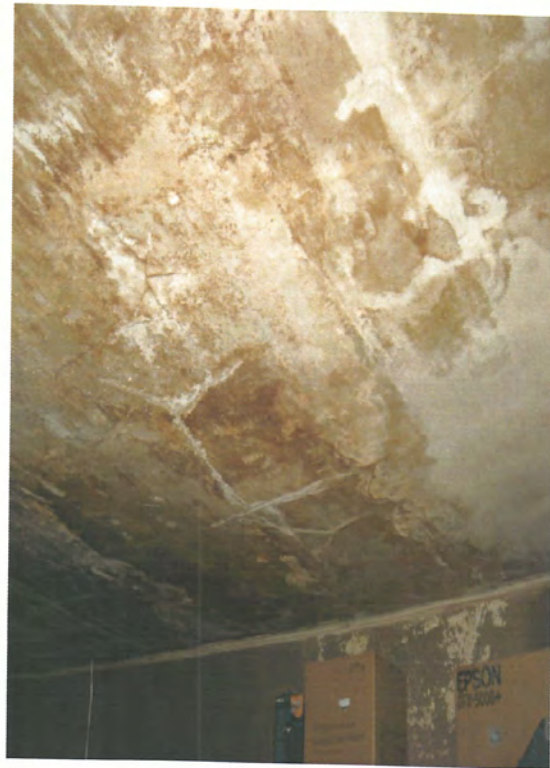
- The poor condition of the roof is dramatically displayed by the water stained wall and ceiling finishes on the 3rd floor which are self explanatory.

Water Stained Finishes

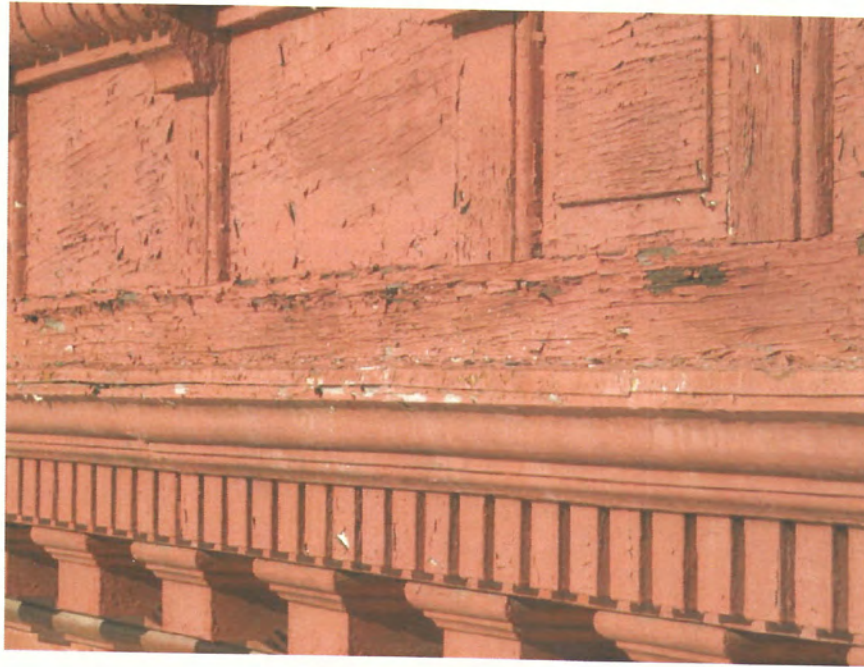
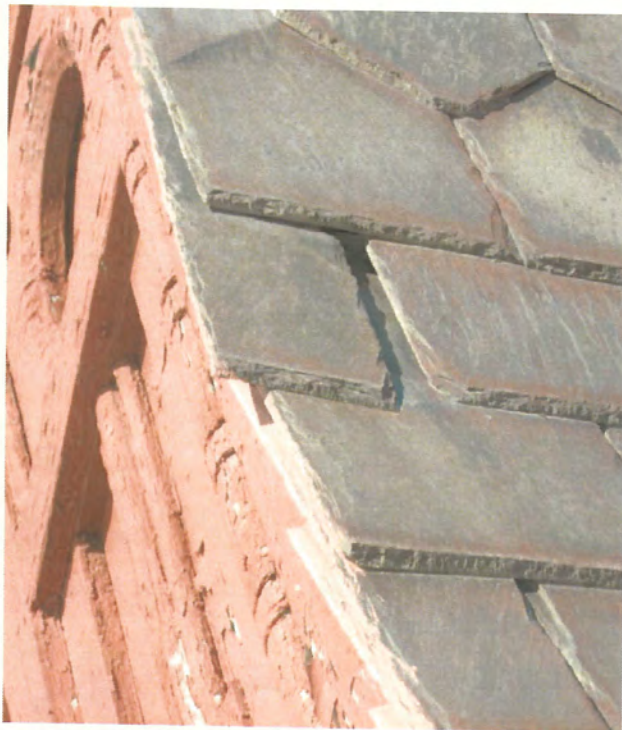
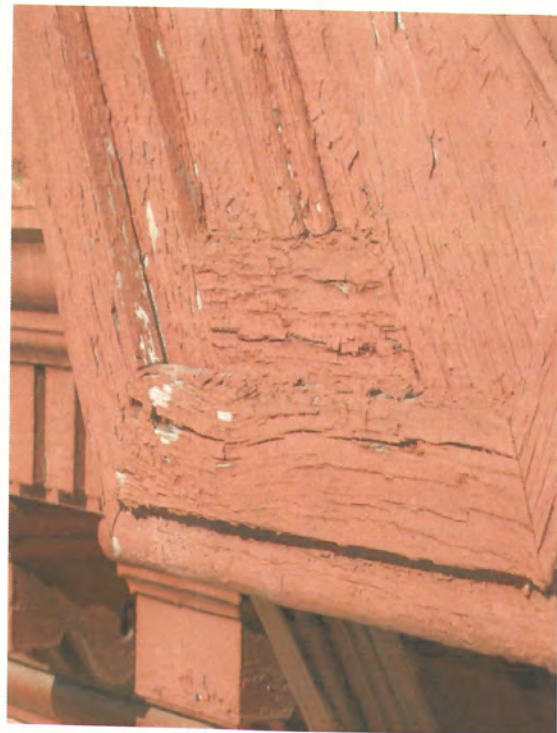
- The ornate carpentry wood work on the exterior of the building exhibits evidence of severe neglect. The wood is dried; the paint is peeling and flaking, exposing the wood to the damaging effects of the wind, rain, snow and ice. This example of woodwork is irreplaceable and should be preserved and protected immediately.

Dried Wood and Peeling Paint

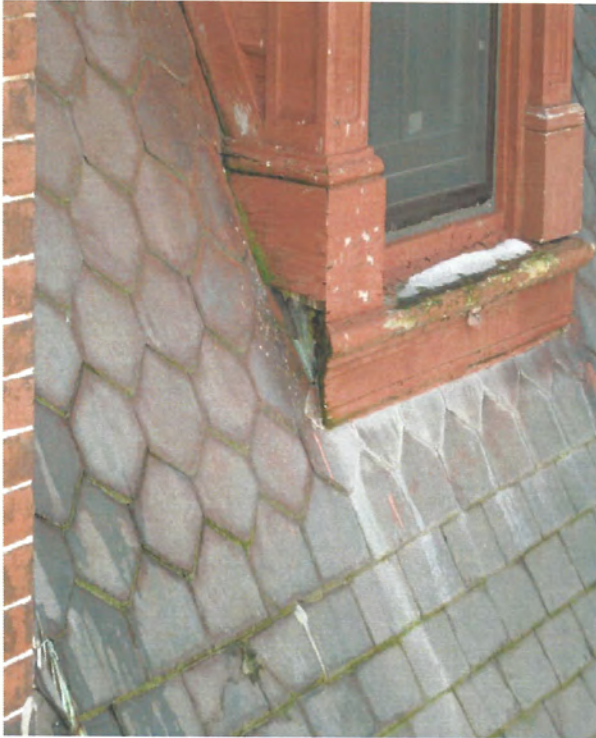
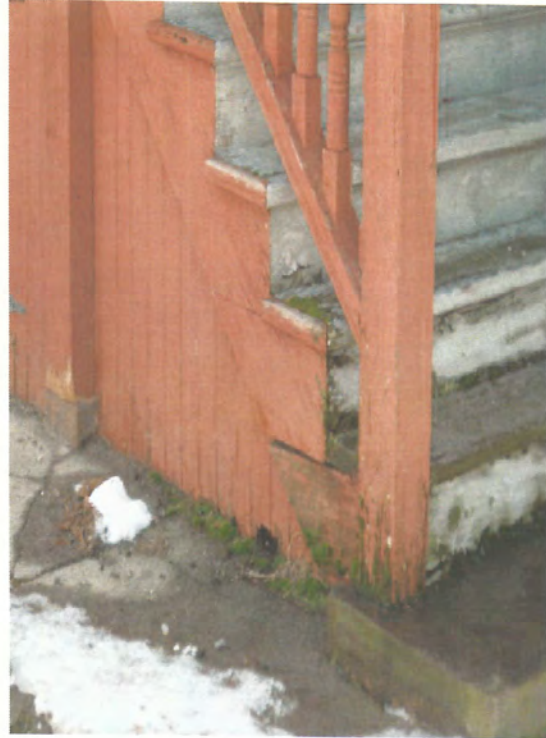
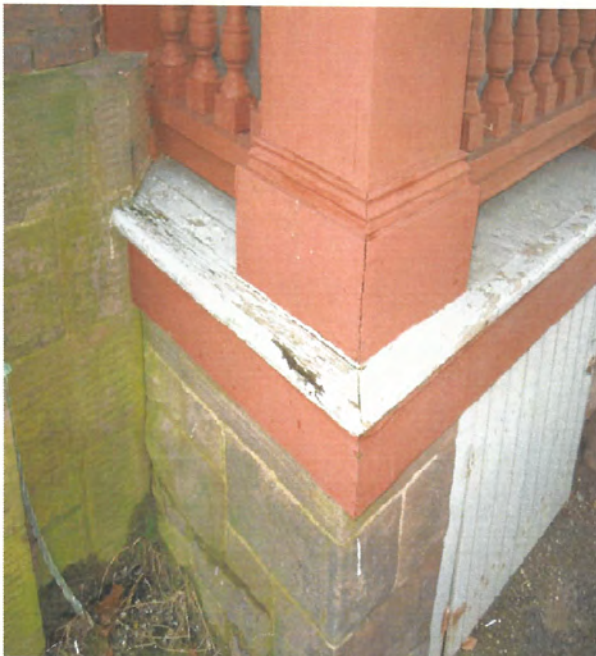
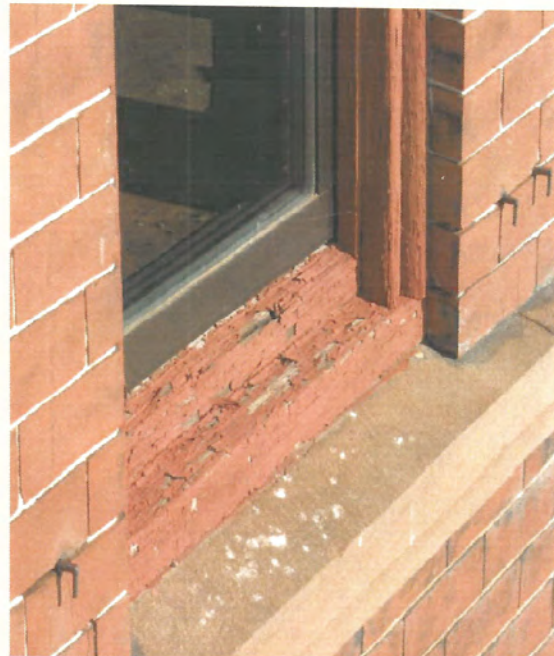
- The wood construction at windows, exterior stairs and dormers is in poor condition and must be repaired and protected before it is lost completely.

Poor Condition of Wood Conditions

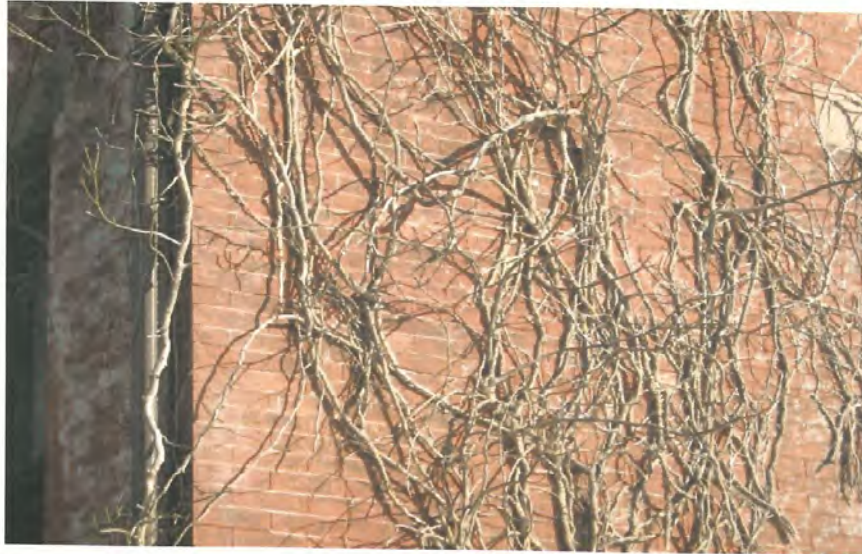
Vegetation growing on the exterior walls typically opens up the mortar joints allowing water to enter the facility, accelerating the deterioration to the masonry due to repeated freeze thaw cycles.

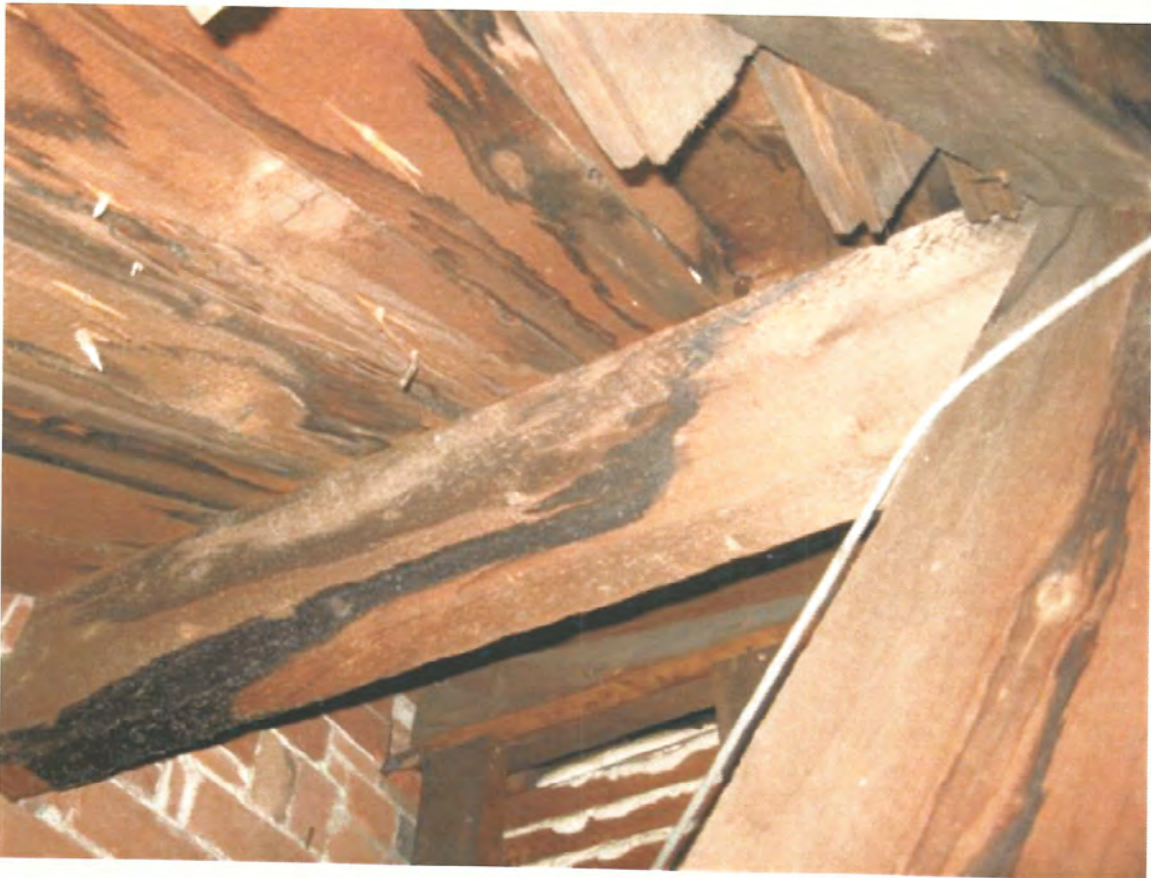
- There are a number of locations in the attic where water staining is visible on the timber beams, joists and underside of roof deck. Water stains are also noticeable in plaster walls and ceilings on the 3rd floor which indicates that possible deterioration to the wood framing and exterior masonry walls may be occurring due to the water infiltration.

Water stained timber beams viewed from the Attic

All areas where water damage has occurred should be examined for the extent of deterioration to the members. This would include removing the plaster on the walls and ceilings on the 3rd floor. All members with staining should be probed to determine if there is rot and the depth of the rot. At locations where the water staining is visible in the plaster at the masonry walls, a portion of the plaster should be removed to examine the condition of the masonry. After the extent is documented, repairs will be prescribed to restore the structural integrity of the members.

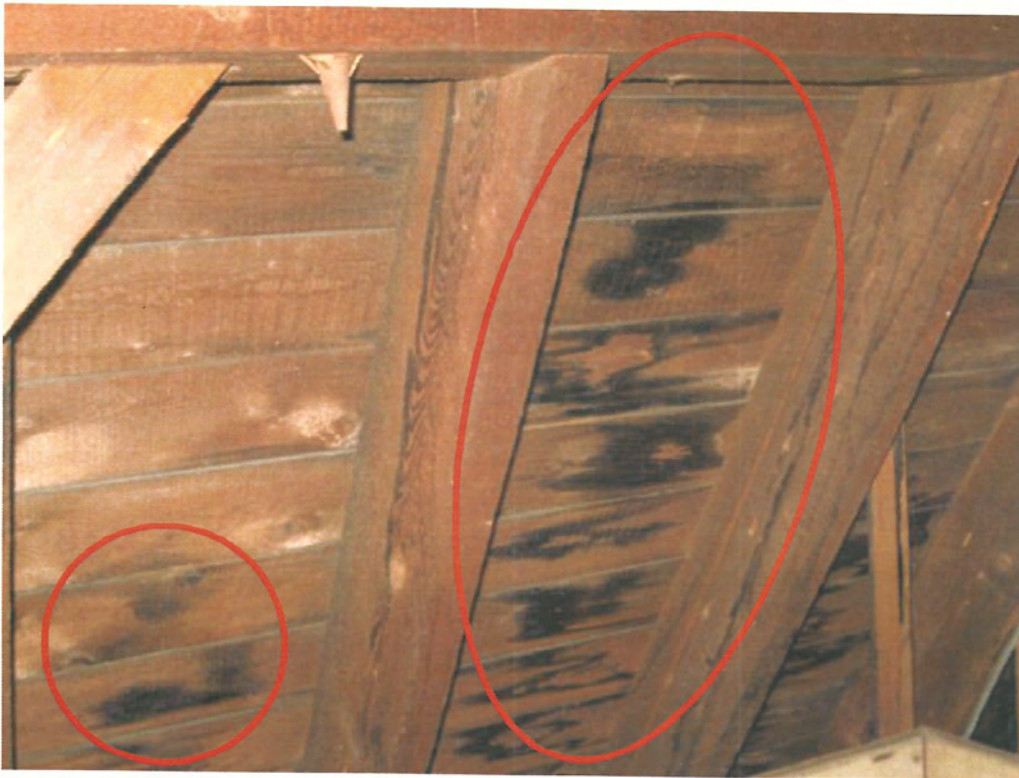
Water stained wood roof decking

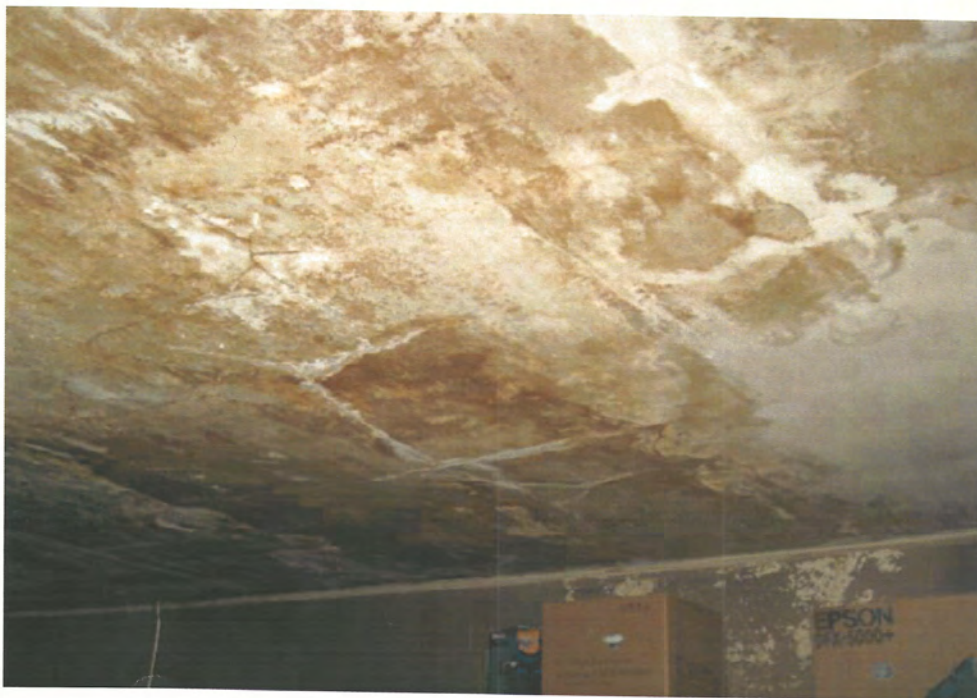
Water stained and sagging plaster ceiling viewed from the Third Floor

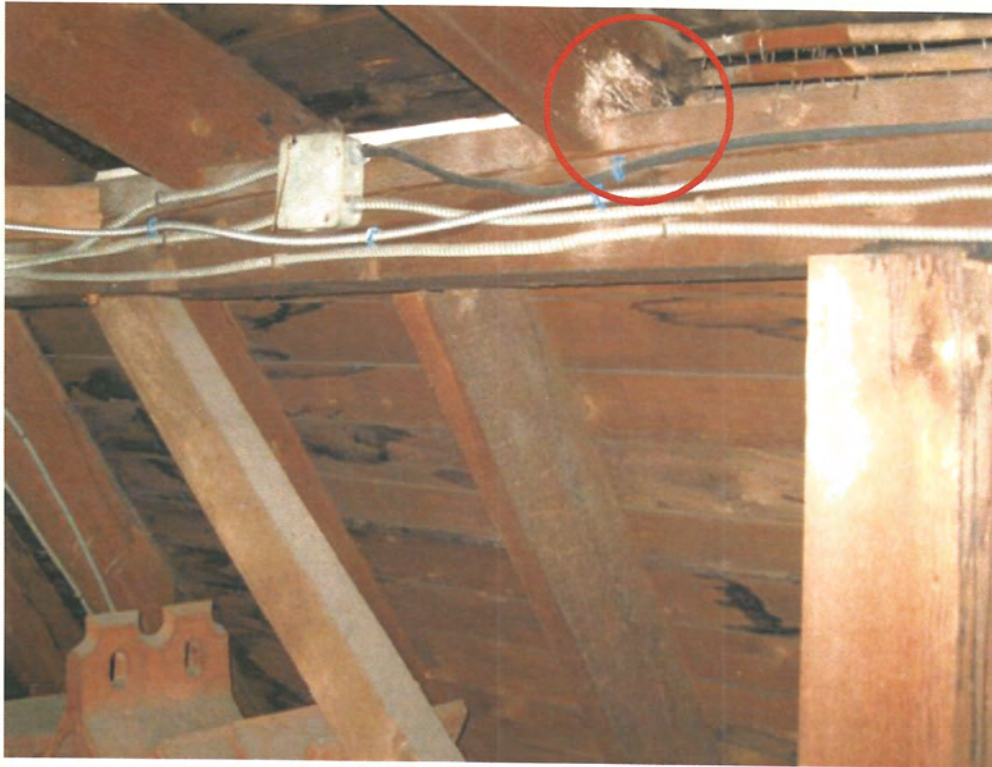
Water stained roof joist at bearing end

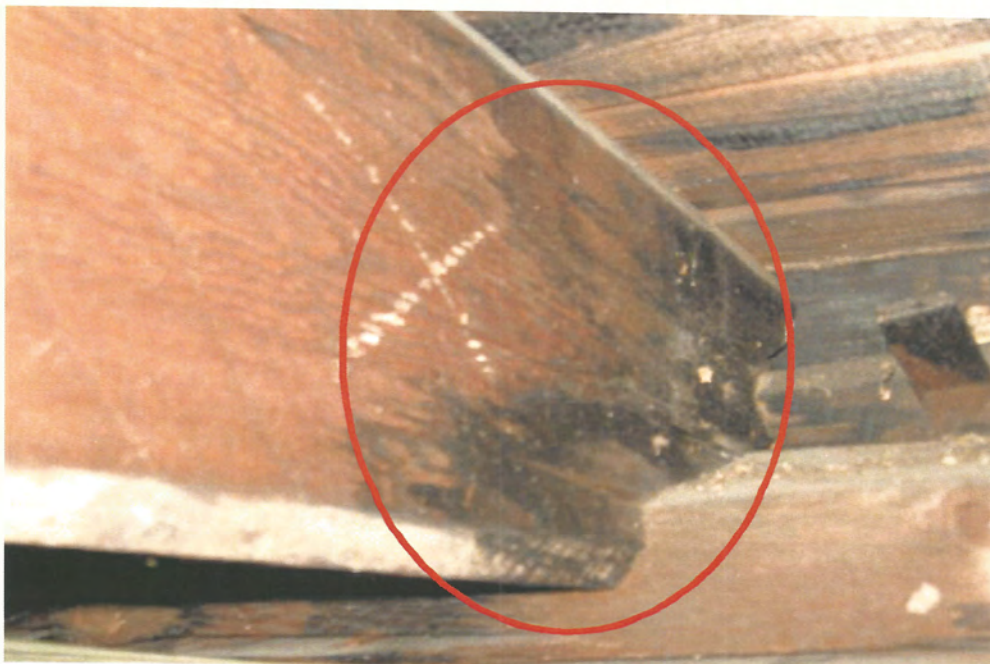
Water stained roof joist at bearing end

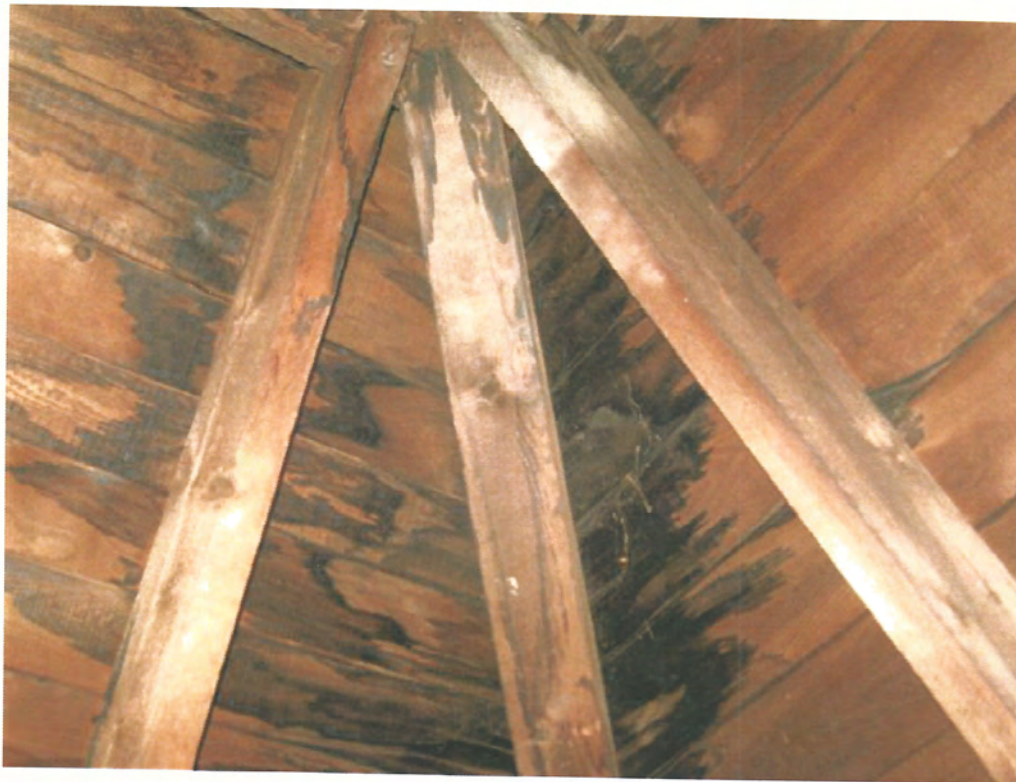
Water stained roof deck and timber beams at hip roof
