**REQUEST FOR QUALIFICATIONS
ARCHITECTURAL/ENGINEERING DESIGN SERVICES
For the RENOVATION OF THE TUTTLE BUILDING**

EXISTING CONDITIONS REPORT

TUTTLE HOUSE NAUGATUCK, CONNECTICUT

**Re: Investigation of building envelope at the
Naugatuck Board of Education
Naugatuck, CT**

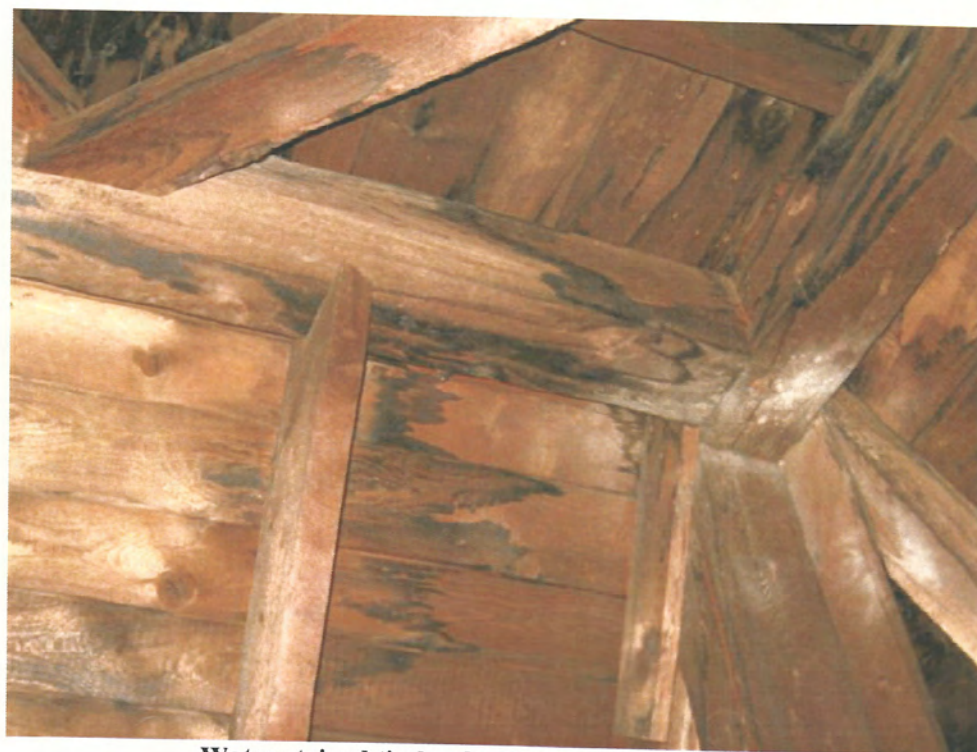
Water stained timber beams, roof joists and deck

All areas where water damage has occurred should be examined for the extent of deterioration to the members. This would include removing the plaster on the walls and ceilings on the 3rd floor. All members with staining should be probed to determine if there is rot and the depth of the rot. At locations where the water staining is visible in the plaster at the masonry walls, a portion of the plaster should be removed to examine the condition of the masonry. After the extent is documented, repairs will be prescribed to restore the structural integrity of the members.

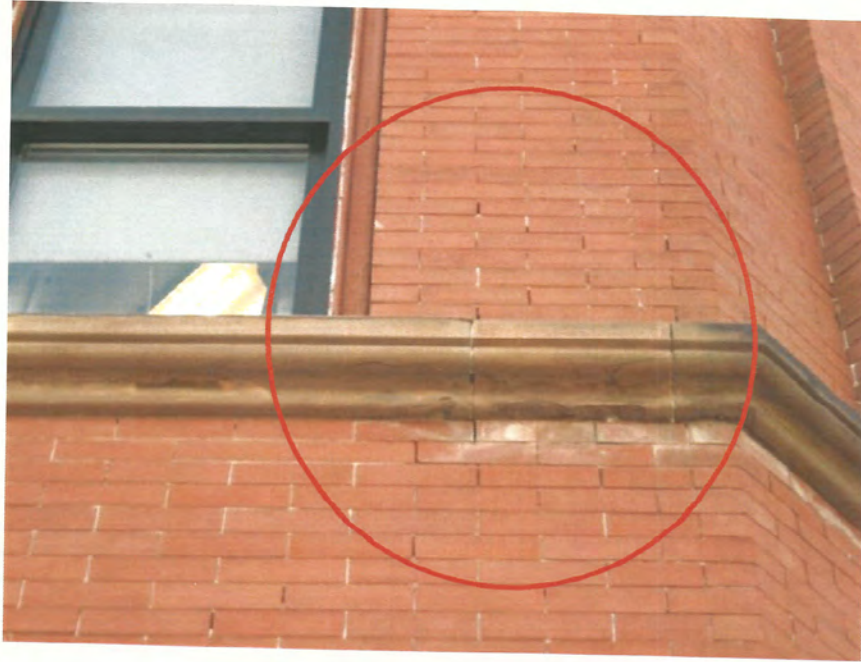
- The exterior masonry walls are constructed with brick with thin (1/16" to 1/8" wide) mortar joints. In many locations the mortar is in various stages of spalling or wearing away. This condition is causing voids in the mortar joints of different depths. These voids are allowing rainwater and freeze/thaw damage to occur. The voids may also allow water to enter the building and cause mold issues.

Voids in mortar joints

The mortar joints which are exhibiting spalling and voids must be cleaned of all debris and loose mortar and repointed. Any damaged bricks should be replaced. Limestone caps that are cracked should be removed and replaced if they cannot be repaired.

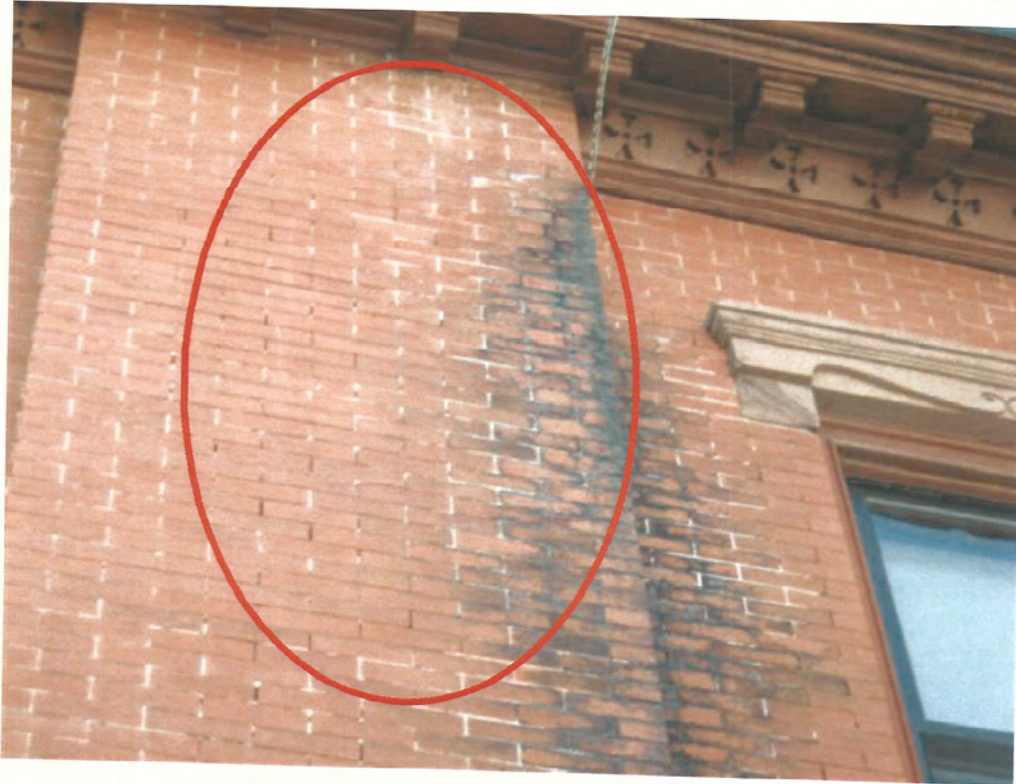
Voids in mortar joints and spalling mortar

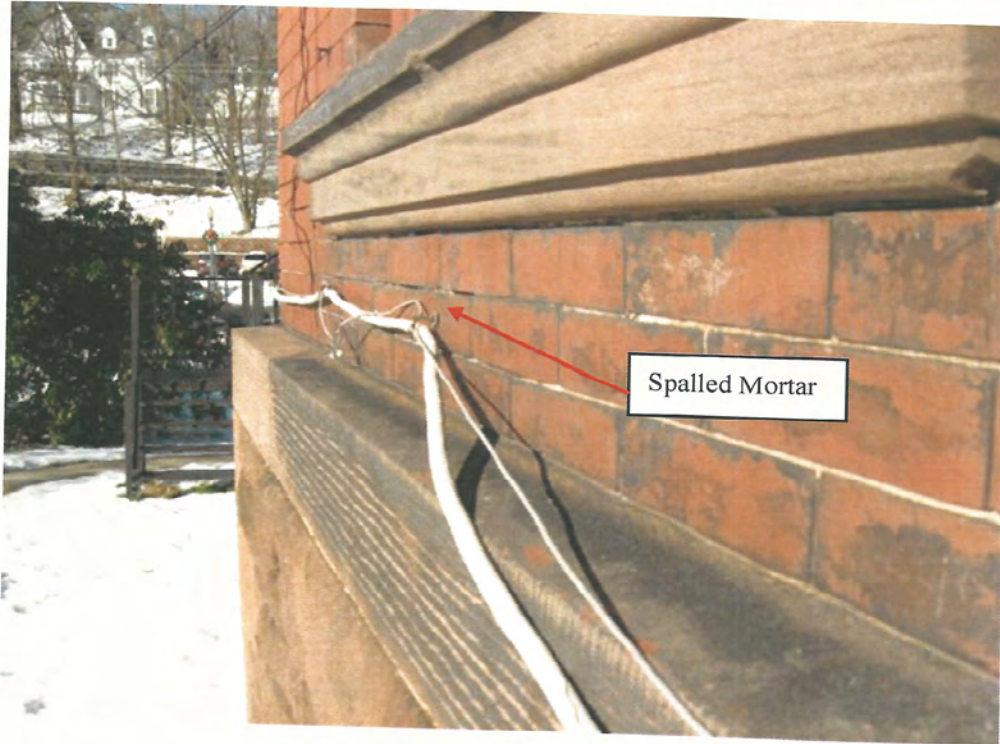
Spalling mortar joints in brick wall

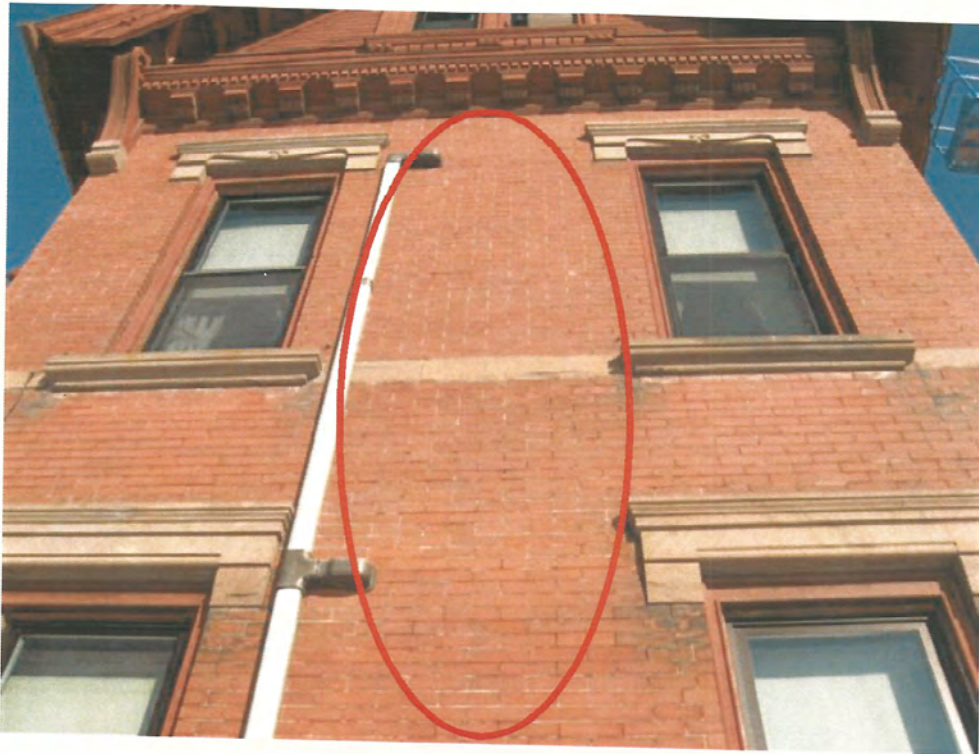
Voids and spalling in brick mortar joints

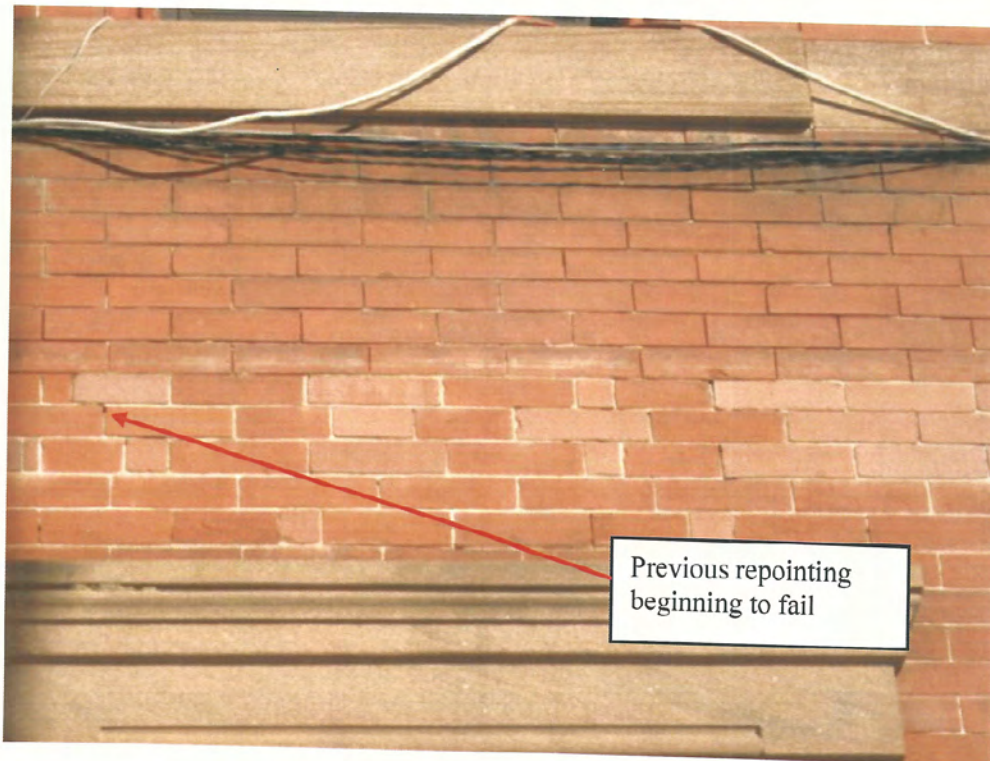
Close up of mortar joints

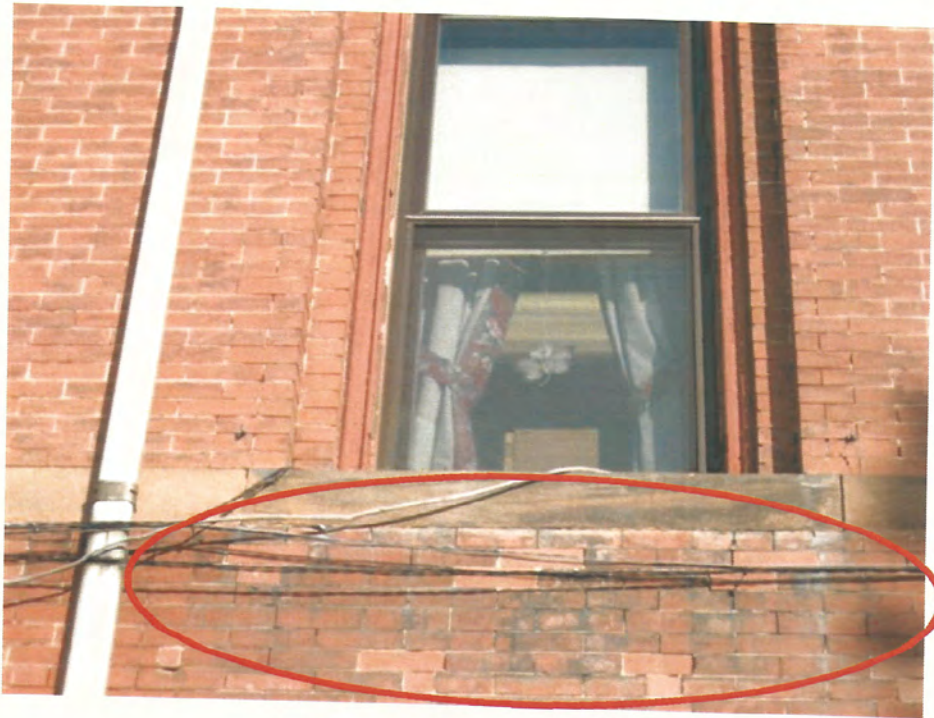
- Movement is visible in the brick below a few of the windows. The mortar has spalled at these locations and water infiltration in conjunction with freeze/thaw damage may have caused the condition.

Failing masonry below window

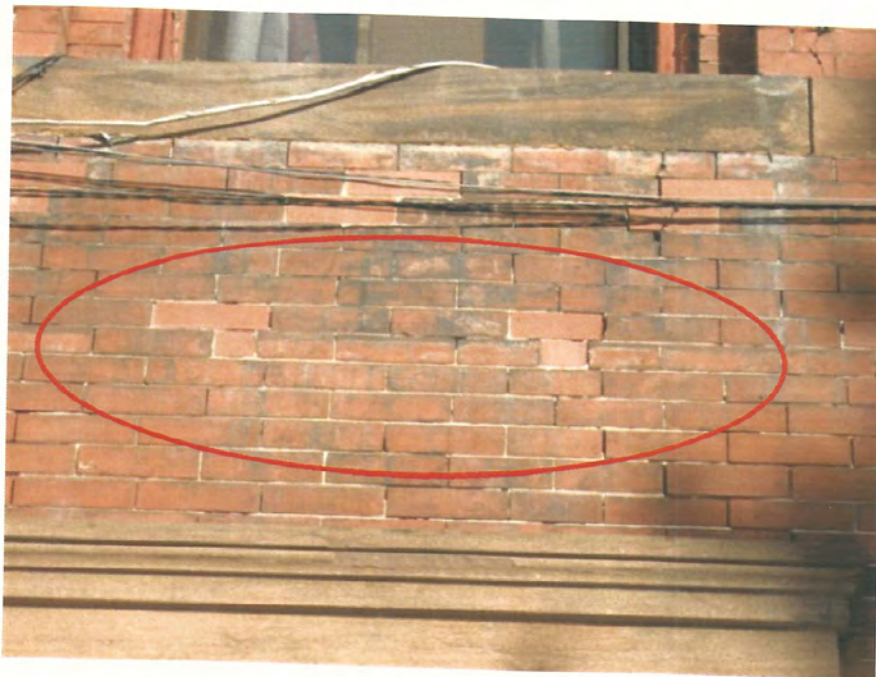
Close up of movement in masonry below window

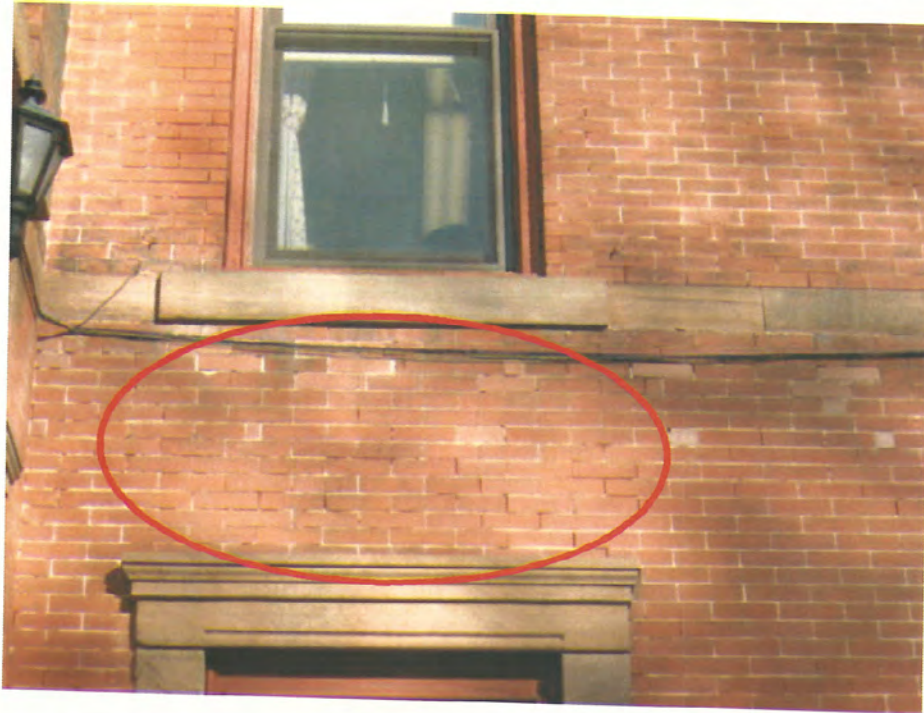
Movement above door opening with diagonal cracking

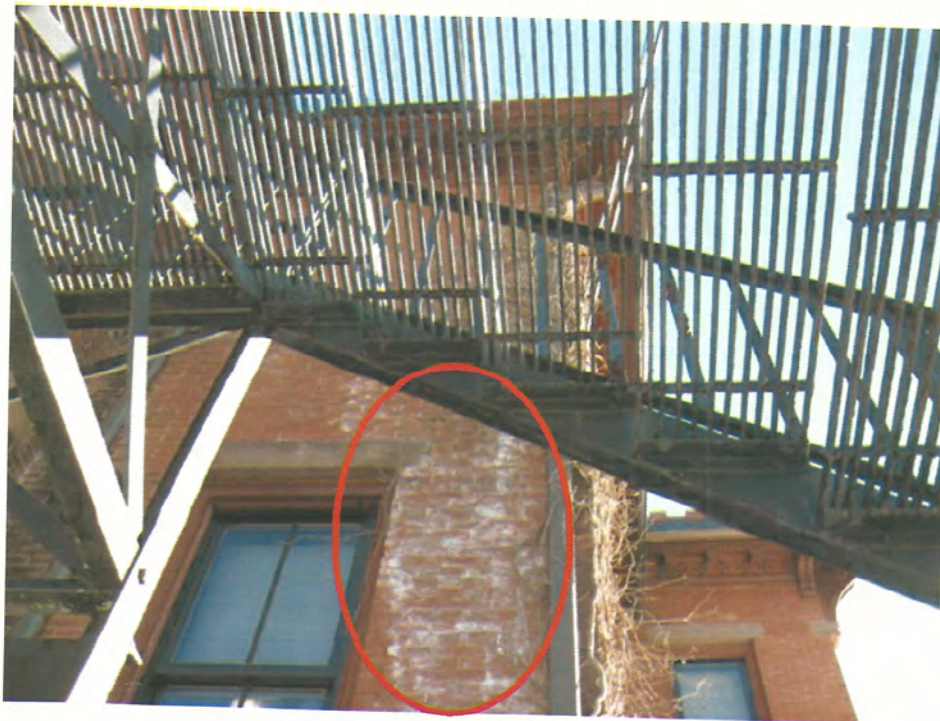
- Efflorescence is present on the brick surface at specific locations on the north and west sides of the building. Water infiltration behind the outer wythe of brick is the cause of the efflorescence.

Efflorescence in brick at southwest corner

The locations where water is infiltrating the outer wythe of brick must be determined to eliminate the efflorescence. All voids or openings in the brick where water is entering into the walls must be sealed with the appropriate materials.

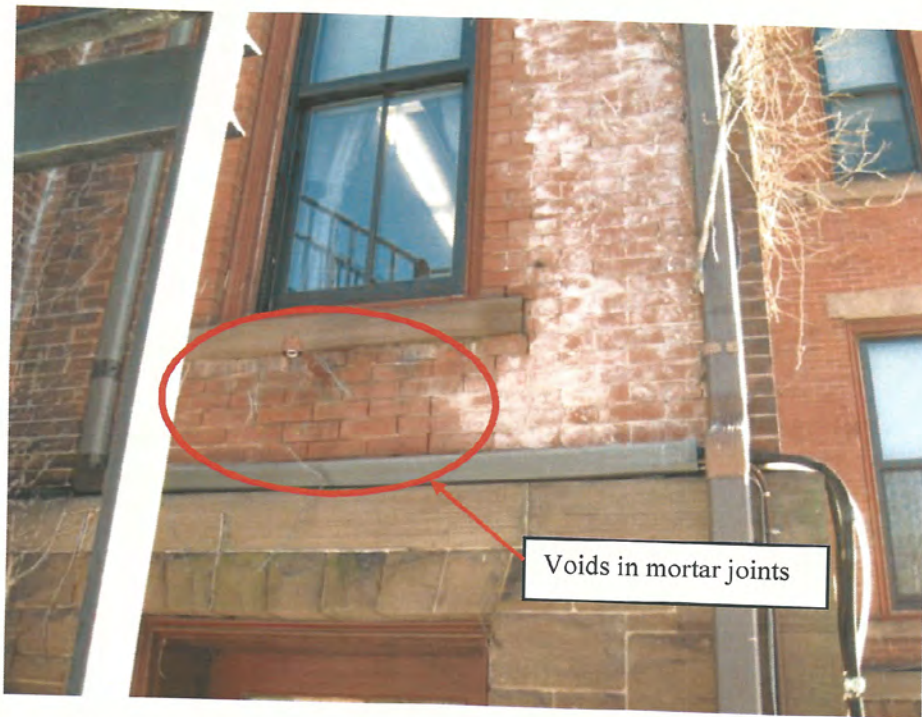
Close up of the efflorescence in the brick alongside the downspout

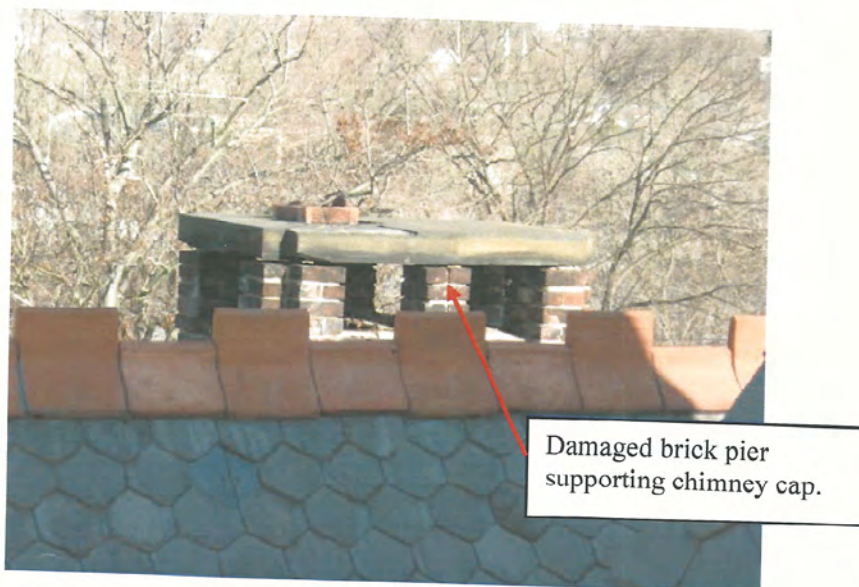
- The chimney repairs will include repointing and partial reconstruction of portions of the top of two of the chimneys. Repairs for the top of the west and north chimneys will include removal and replacement of the caps and rebuilding portions of the brick directly beneath the caps which has deteriorated. The north chimney was previously repaired but the repair is starting to crack and the mortar is spalling.

North chimney viewed looking north

Each of the chimneys will require re-pointing and in some cases rebuilding of portions of the chimney to properly repair them.

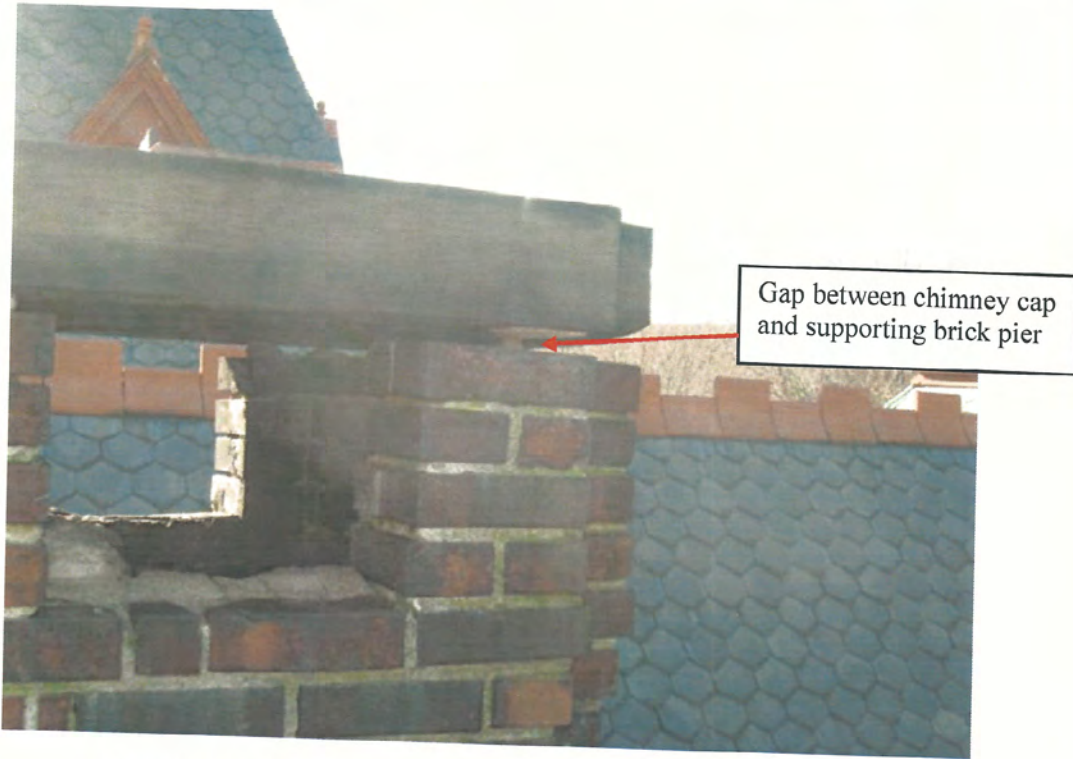
Close up of damage to the north chimney viewed looking south

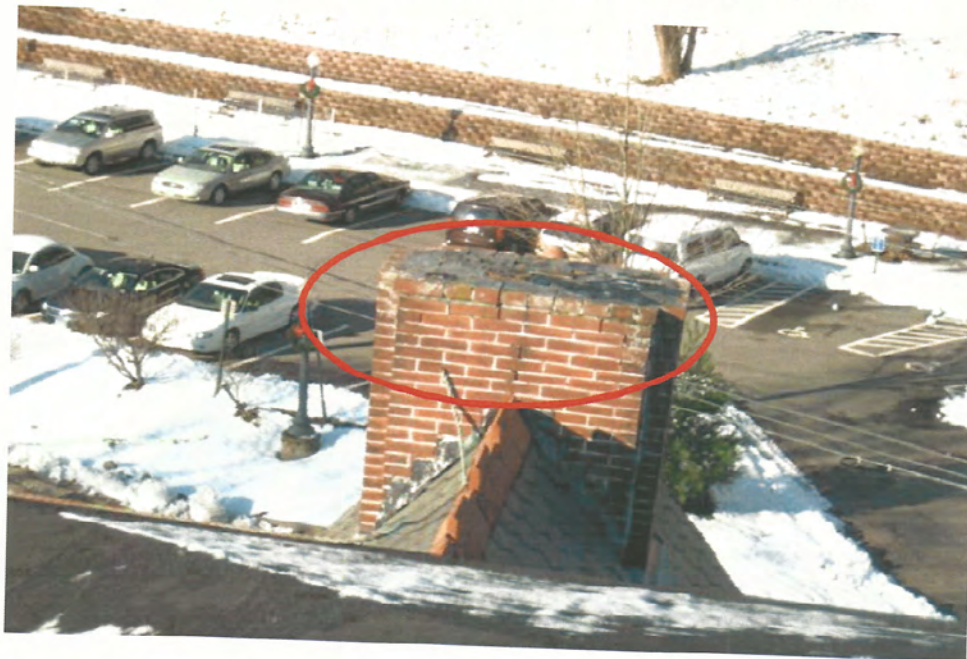
West chimney with spalling mortar and damaged brick

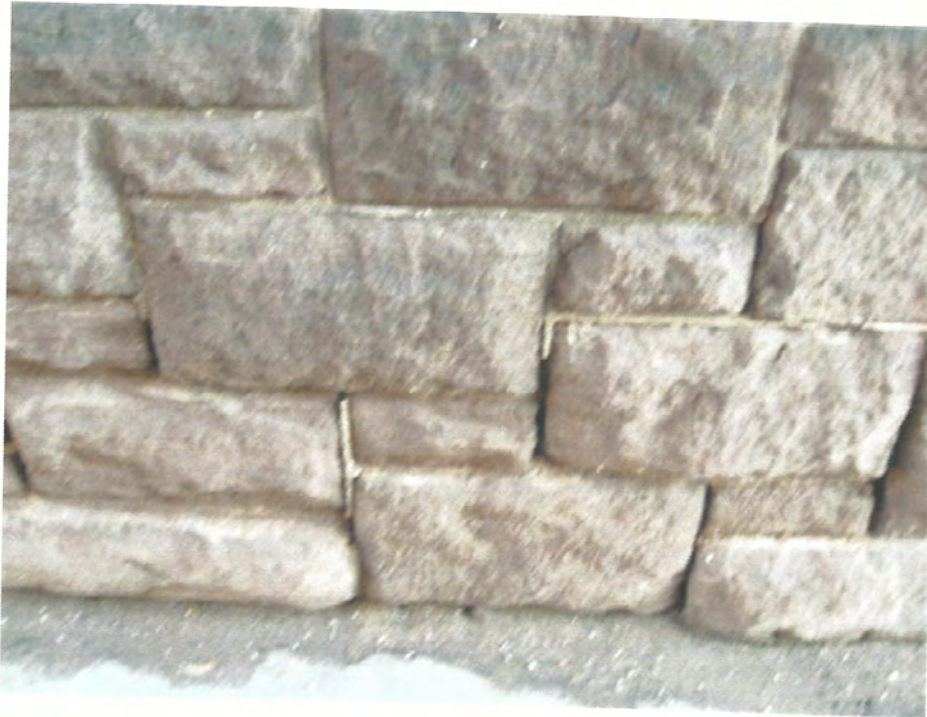
- Spalling of the mortar in the cut stone foundation walls was observed. Similar to the brick walls described above, the areas where spalling has occurred will permit water to enter into the joints and cause additional damage.

Spalling mortar in stone foundation wall mortar joints

All of the mortar joints in the cut stone foundation walls must be cleaned of all loose deteriorating mortar and other debris. After this procedure is complete the joints must be repointed to prevent water from entering into the building.

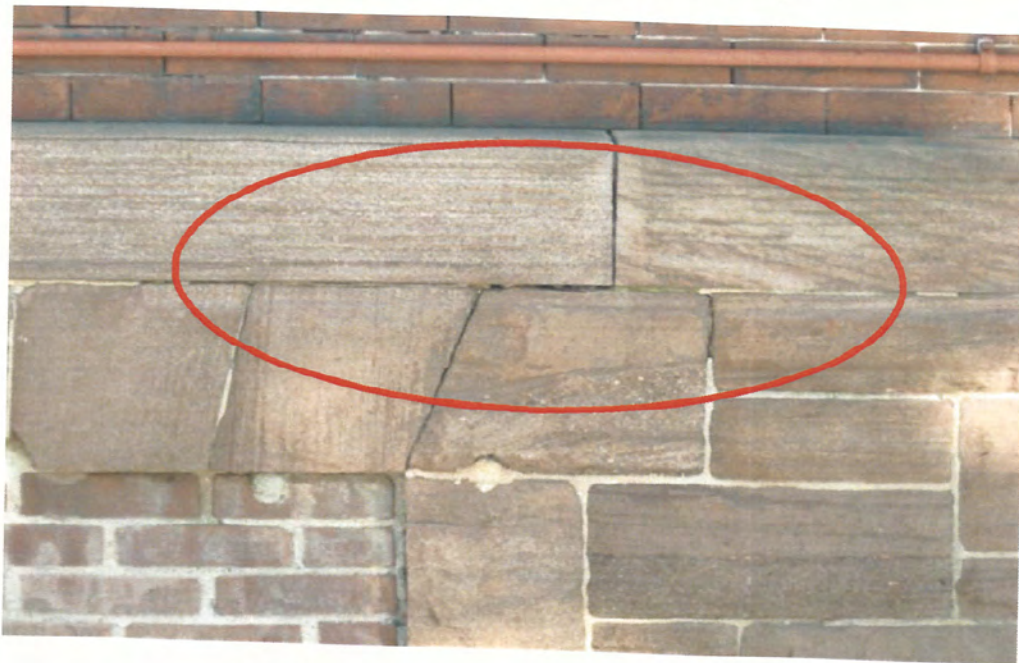
Voids in cut stone foundation wall mortar joints

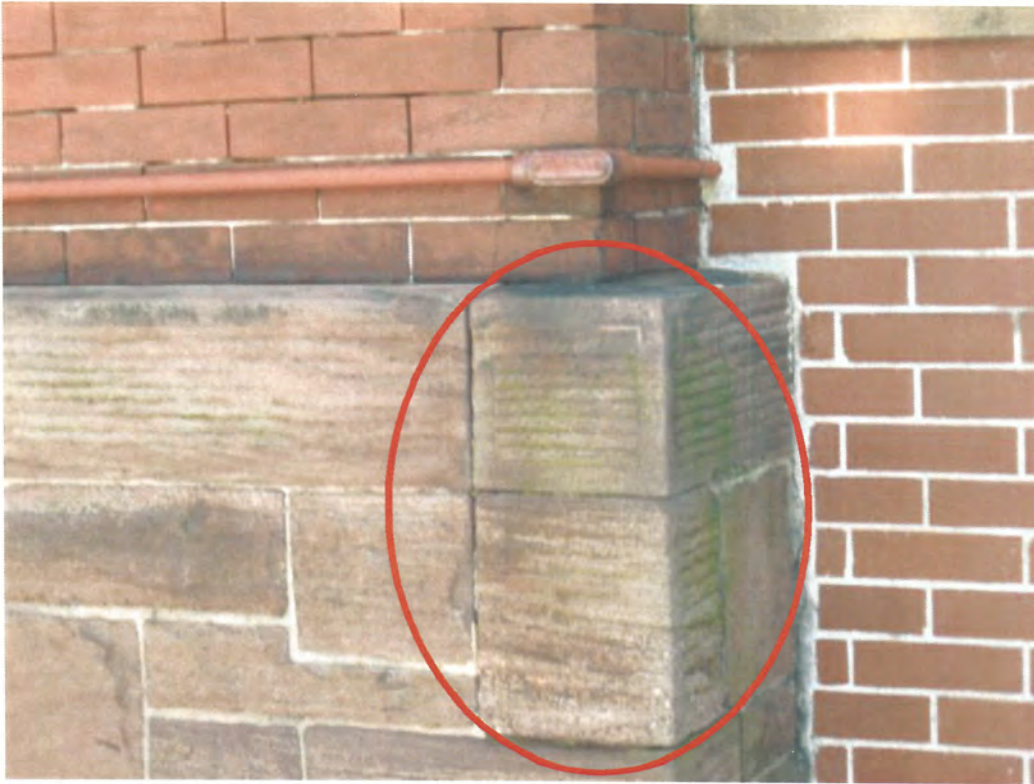
Spalled mortar in stone foundation wall and brick wall above
