Structural Report

1959 Original Building

Existing Conditions Assessment

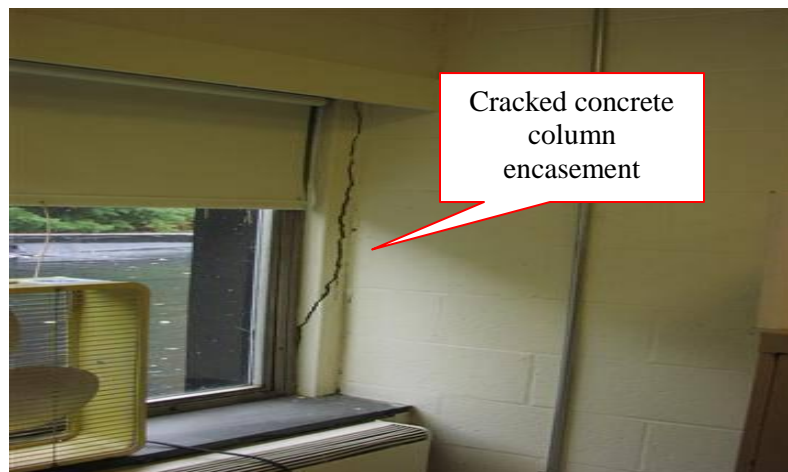
- The first item involves the exposed condition of the concrete incased steel columns at the two story classroom wing. The columns are exposed directly to the elements and are subjected to freeze / thaw cycles and water intrusion as well as heating from the interior. Typically, the concrete encasement has exhibited cracks and spalling with large vertical cracks occurring alongside the window frames on the inside. Typically the exterior cracks are hairline to 1/8" in width, traveling vertically.

Condition at Column Encasement

These cracks are allowing water to enter into the concrete encasement and the freeze / thaw cycle increases the amount of damage. The lack of any insulation and waterproofing to protect the concrete encasement from the cold and rain is aggravating the condition and it will continue to deteriorate.

- The concrete column encasement cracking must be addressed by insulating the exposed concrete and protecting the concrete from water intrusion. The installation of insulation and weatherproofing materials will require that the windows be removed and replaced to allow additional space for the insulation and wood blocking necessary for the installation.

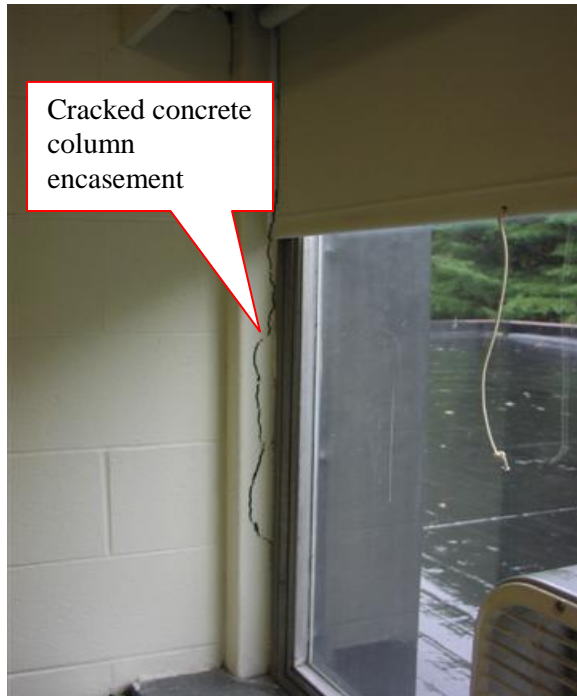
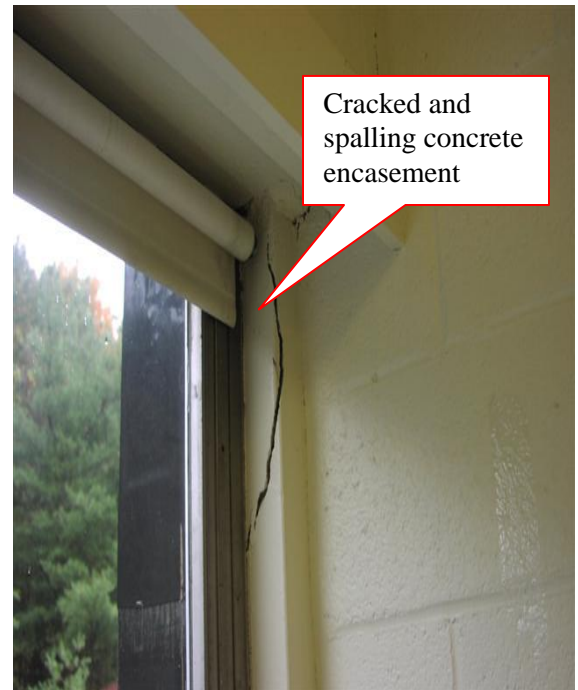
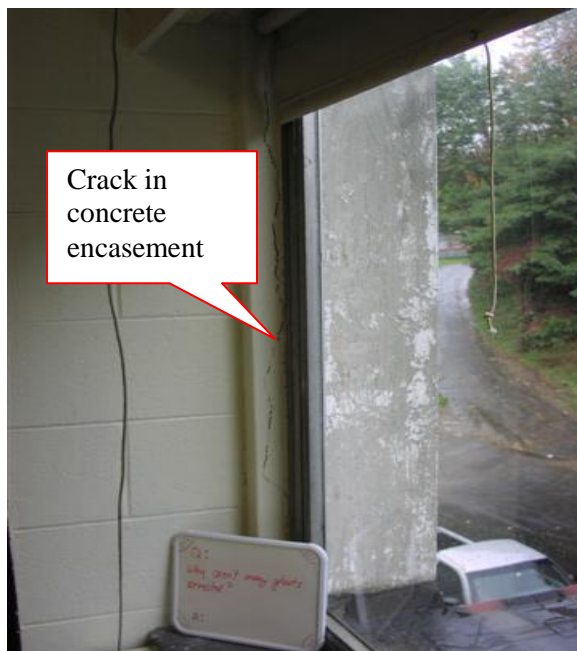
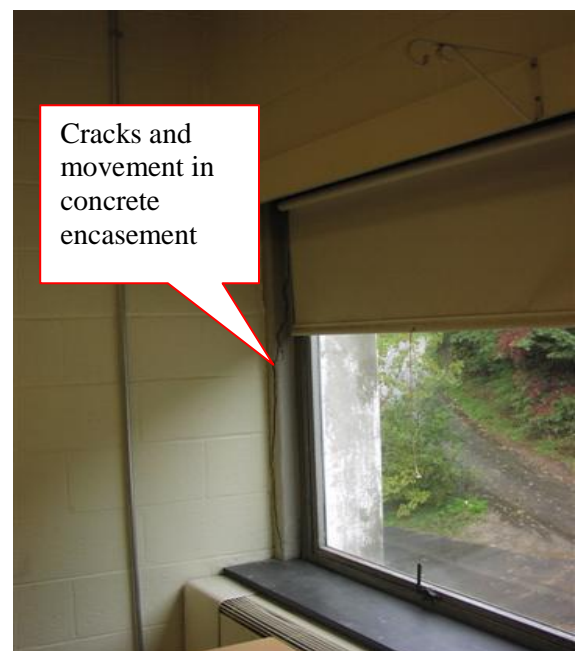
Interior Conditions at Column Encasement

- The exposed interior portions of the concrete encasement must be patched with materials that are compatible with the existing concrete. All loose concrete must be removed as part of the repair procedures.

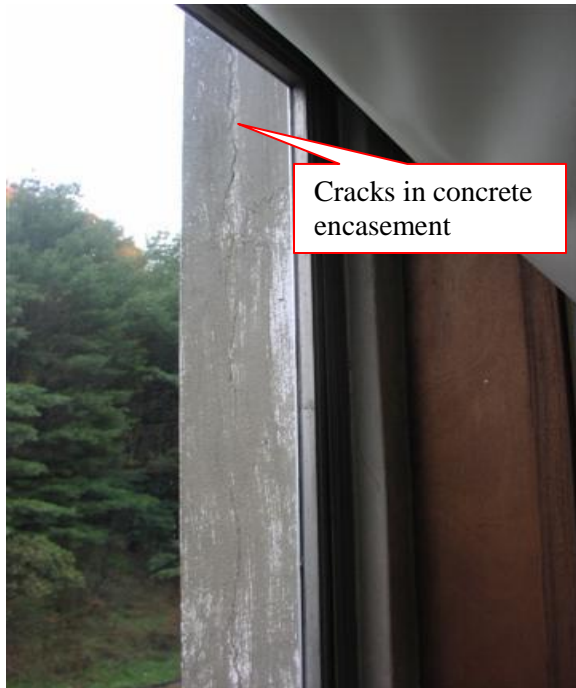
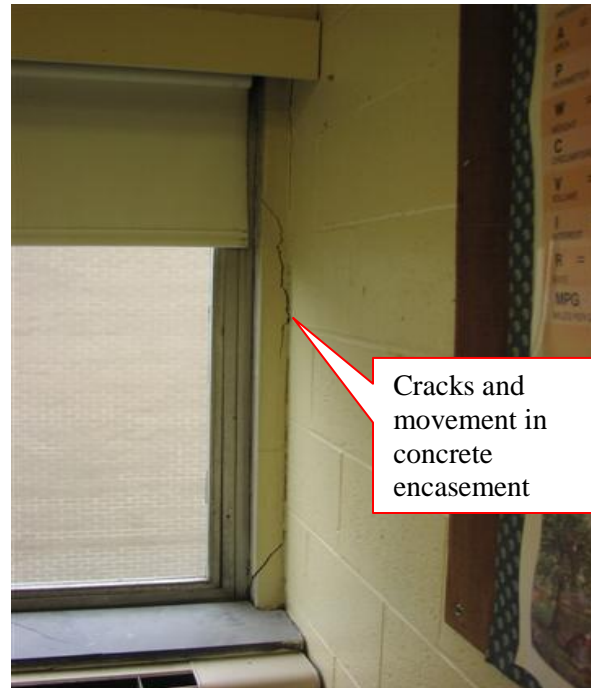
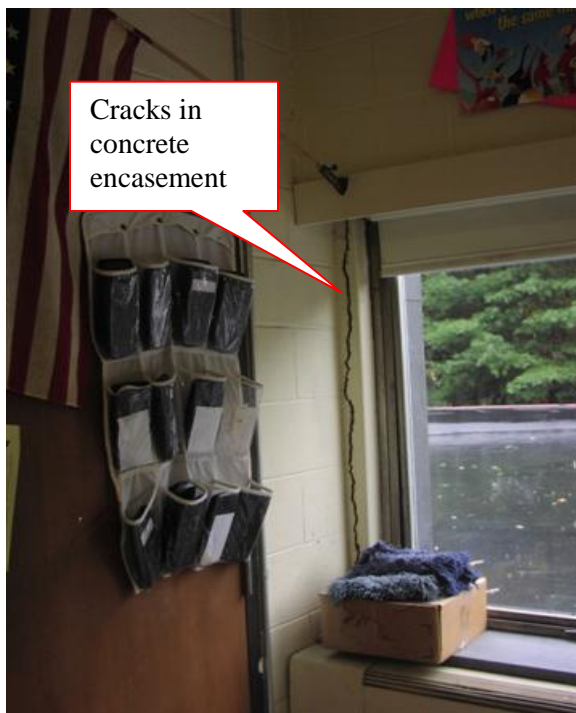
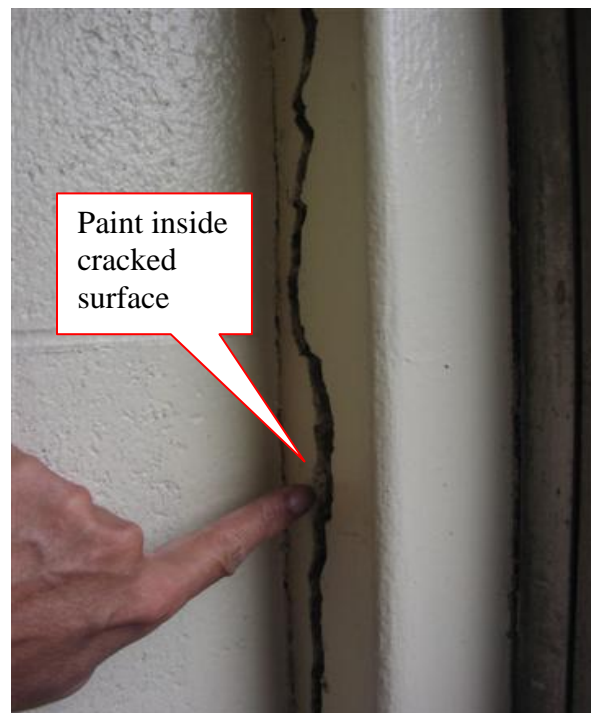
Interior Conditions at Column Encasement

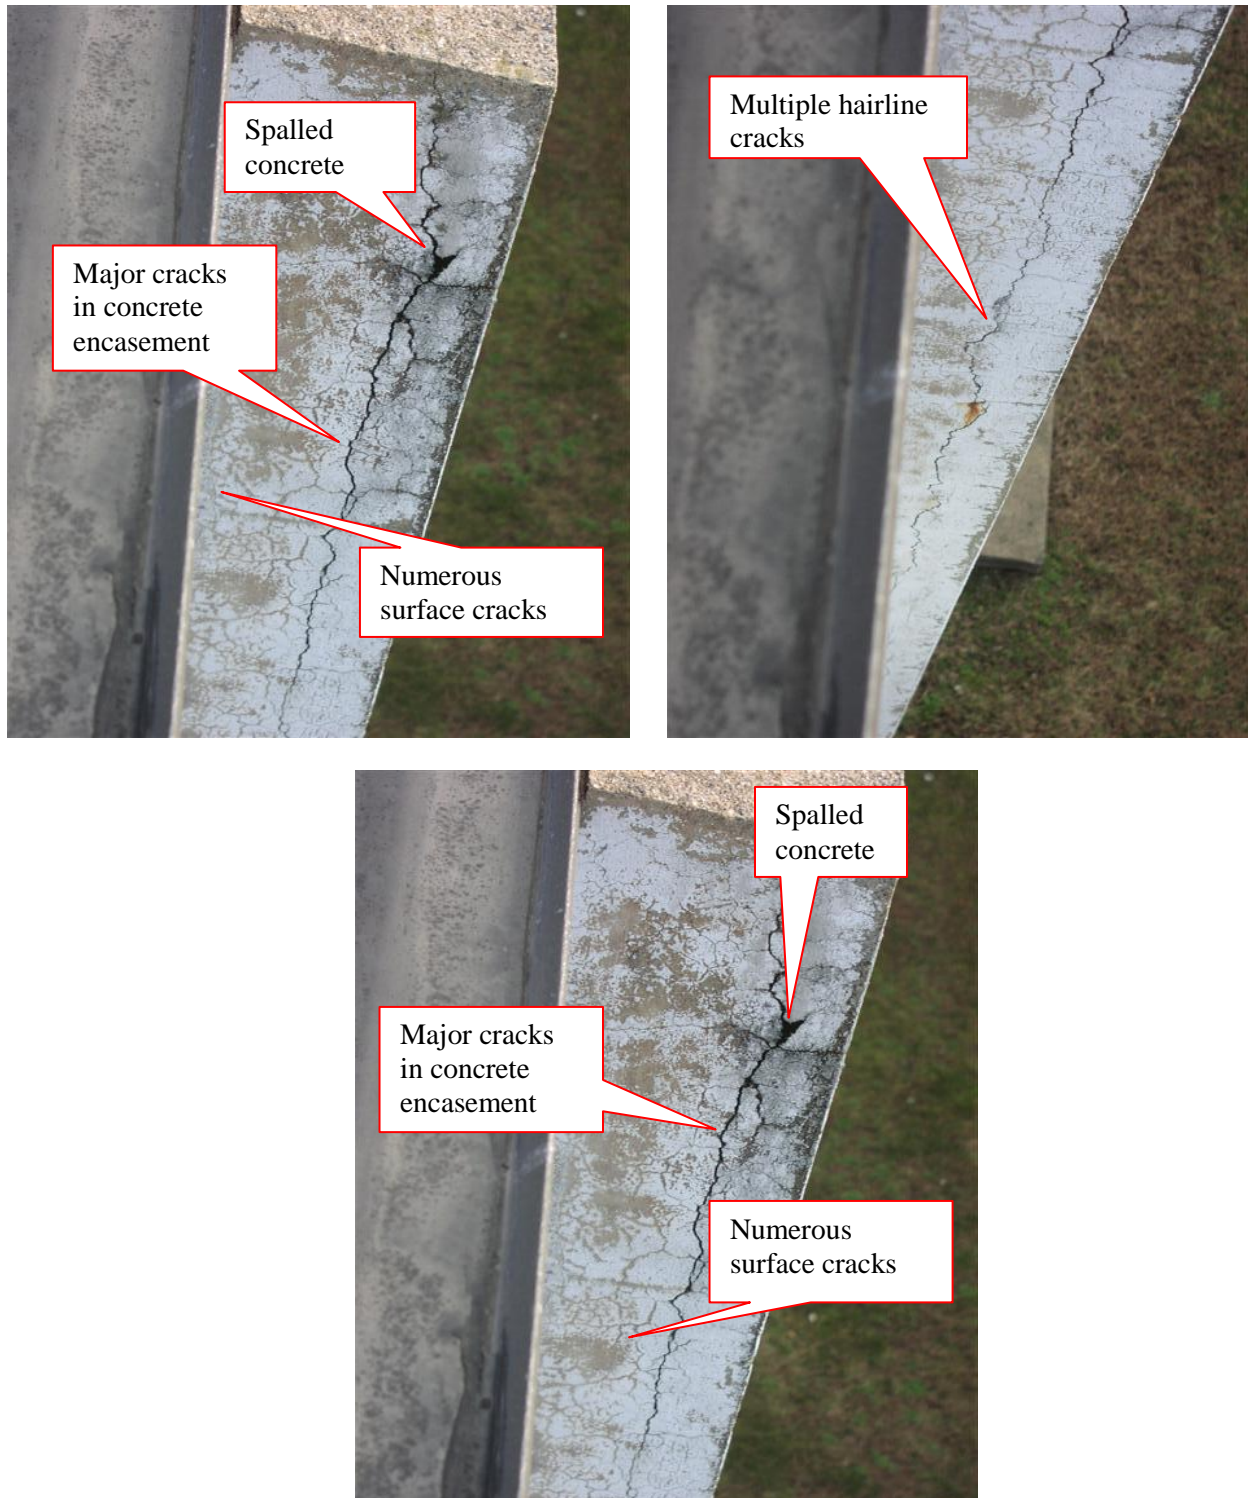
Numerous Cracks in Concrete Column Encasement – Exterior View

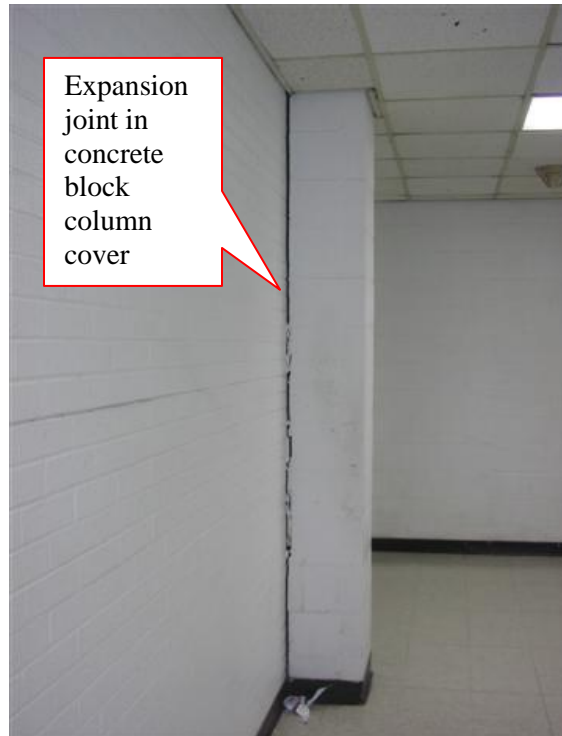
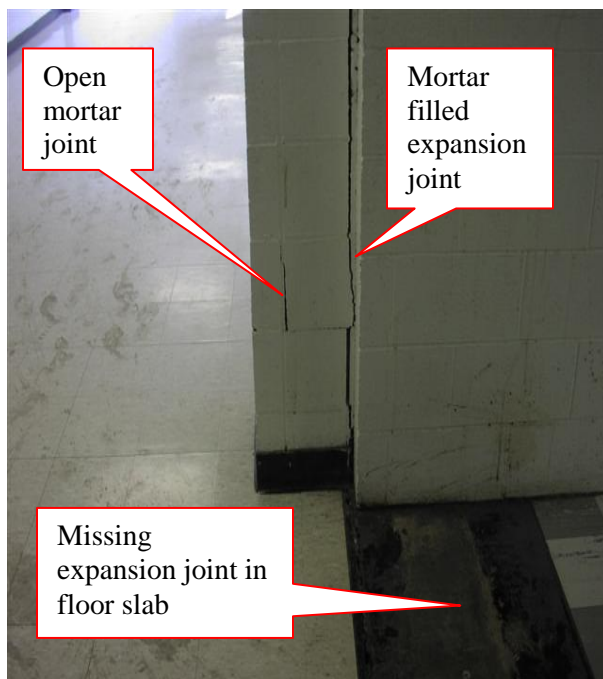
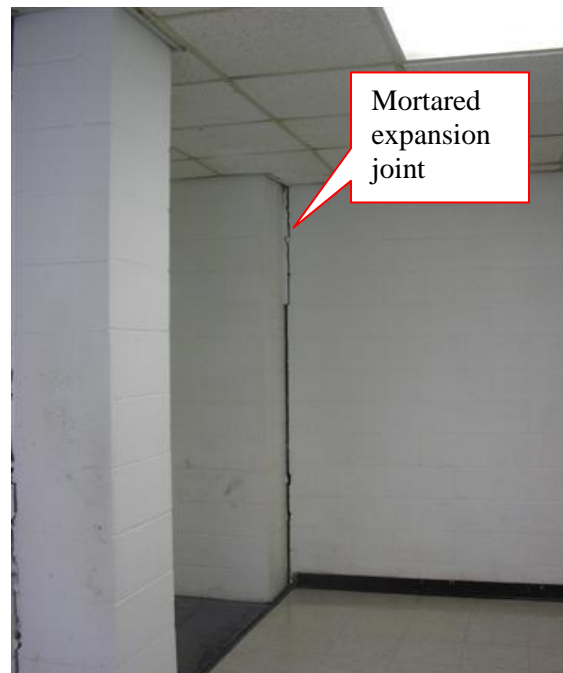
- Cracks and movement in the concrete block walls and pilasters at the corridor connecting the 1974 addition to the original school on the east side of the building. The joint that has opened varies in width from ½" to 1". The floor slab also has opened at the joint between the buildings. Expansion joints are not present between the buildings. A condition is similar on the west connection between the two buildings.

Mortared Expansion Joint in East Connector

- All interior joints at each of the Connectors must be cleaned of mortar and proper expansion joint closures installed. This would include creating joints in the connecting floor slabs. The joint must sawcut through the slab and expansion joint covers installed over the expansion joints to allow for common movement between buildings.

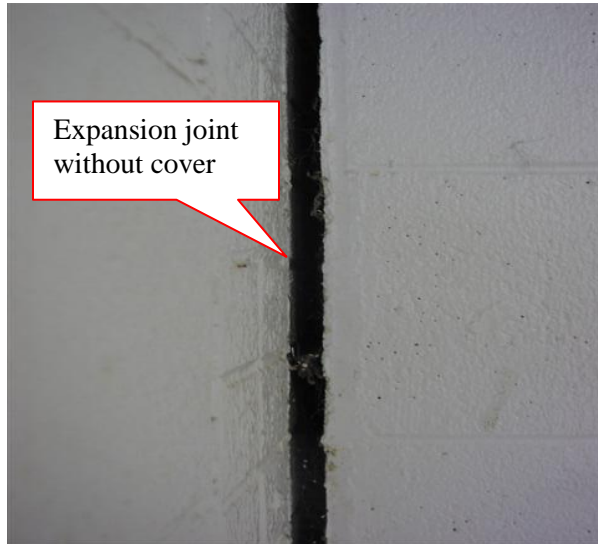
Close up of Joint at Column Enclosure in Upper Level of East Connector

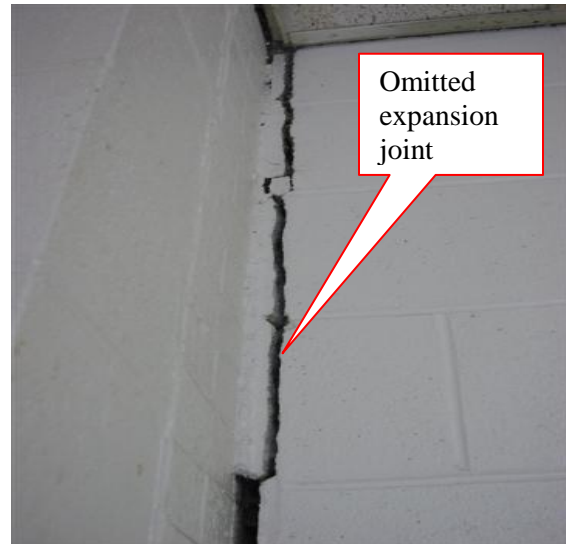
Close up of Mortared Joint at North Wall of East Connector

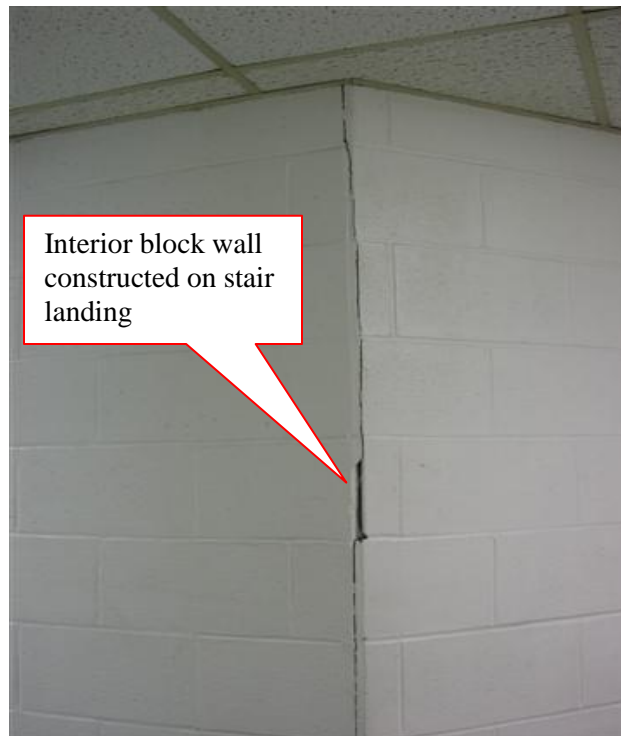
Cracks and Movement at West Stair in Original Building

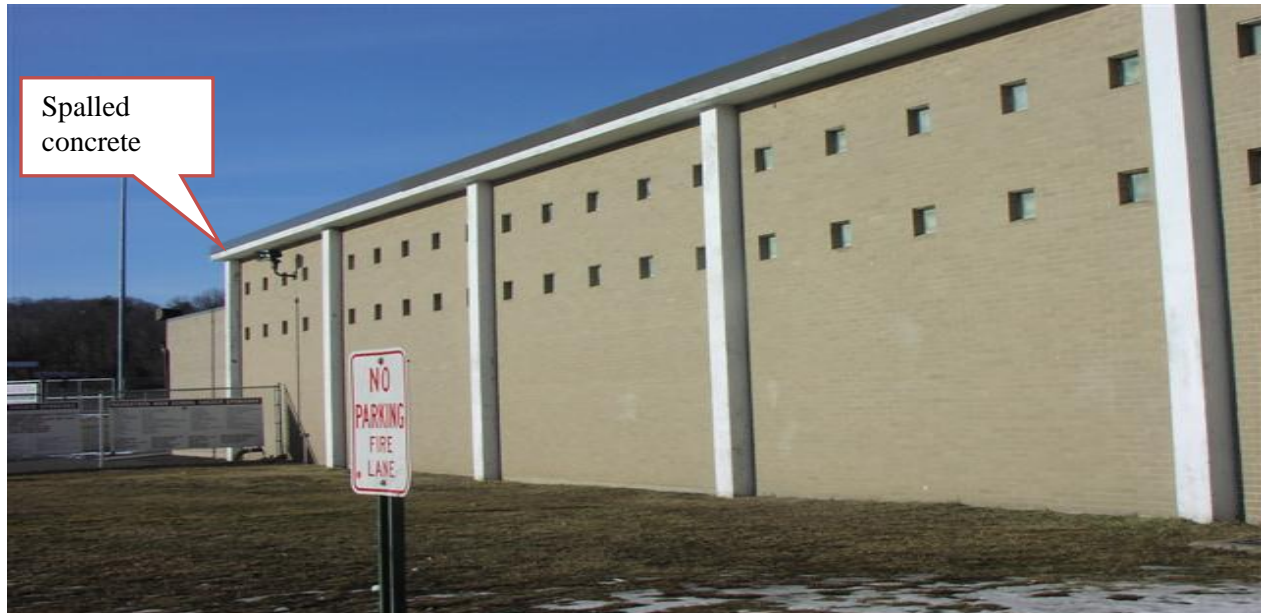
- Spalling of the concrete tees is visible from the exposed underside of the roof deck on the exterior of the south face of the Natatorium Building. The spalling has occurred around the precast concrete column located at the southwest corner of the building. The cause has not been determined.

South Face of Natatorium

- The spalled precast tee surface at the Natatorium must be cleaned of all loose concrete material and repaired with proper restoration materials to be determined.

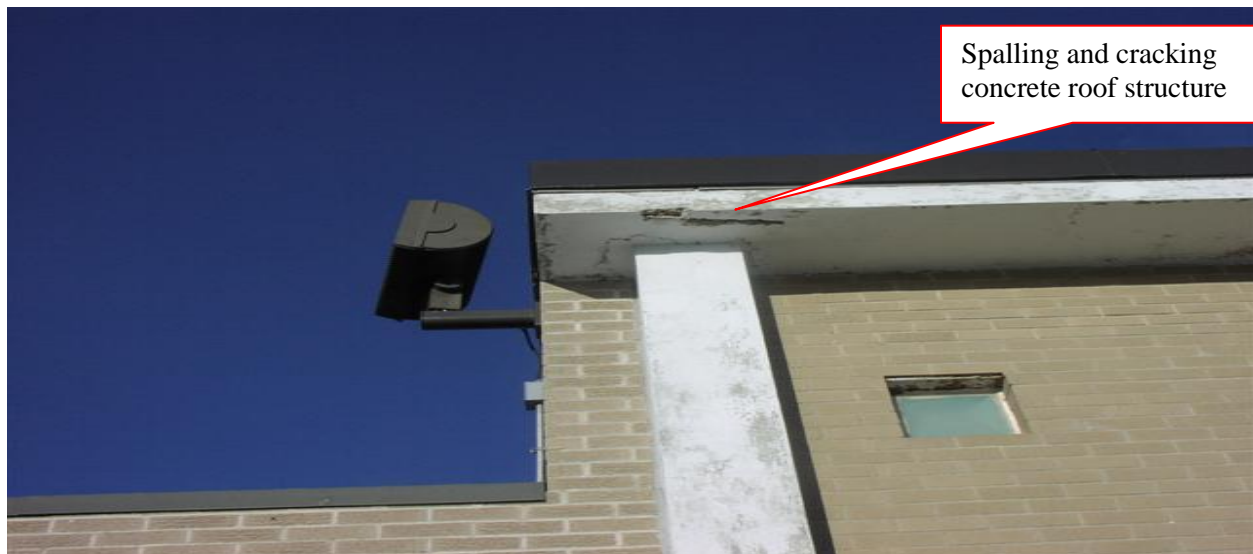
Close up of Spalling Condition

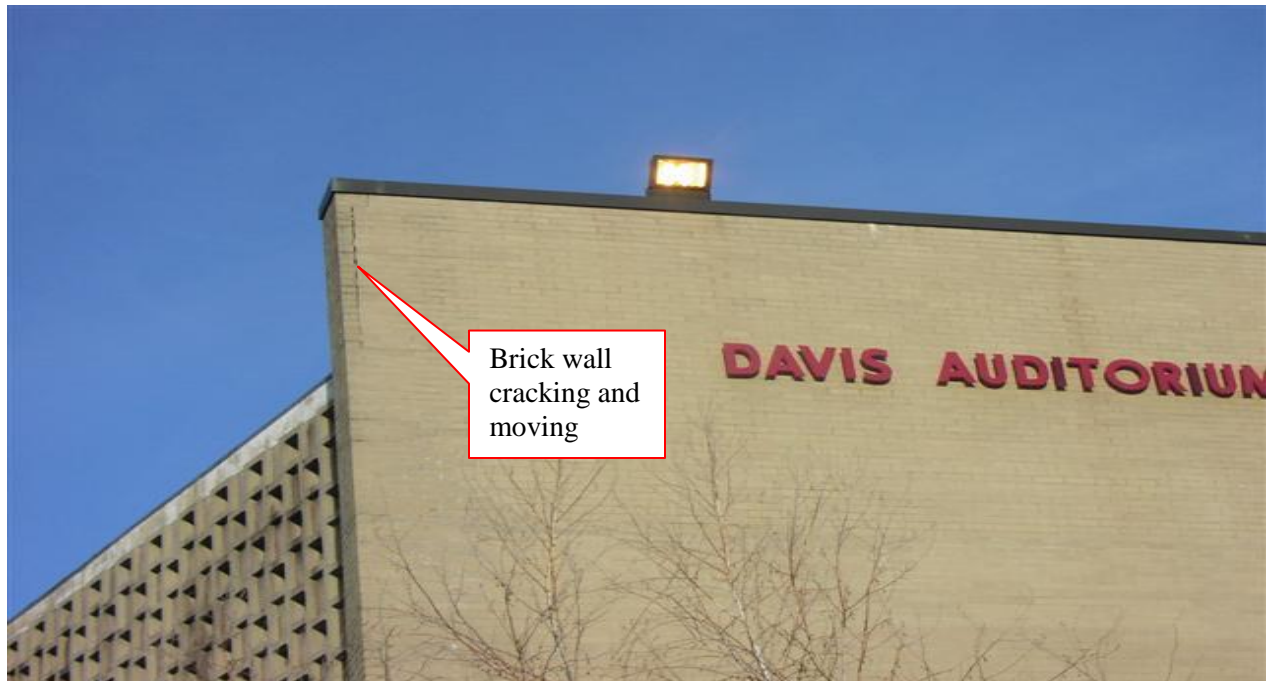
- The exterior brick wing walls at the Auditorium entrance are exhibiting movement and cracking. The cracking and movement is vertically between the outermost course of brick and the adjacent wall.

Condition of Exterior Masonry on South Wall of Auditorium

- The cracks that have developed in the exterior brick of the Auditorium walls must be further investigated to determine the cause of the movement and cracking. Recommended repairs will be based upon the findings.

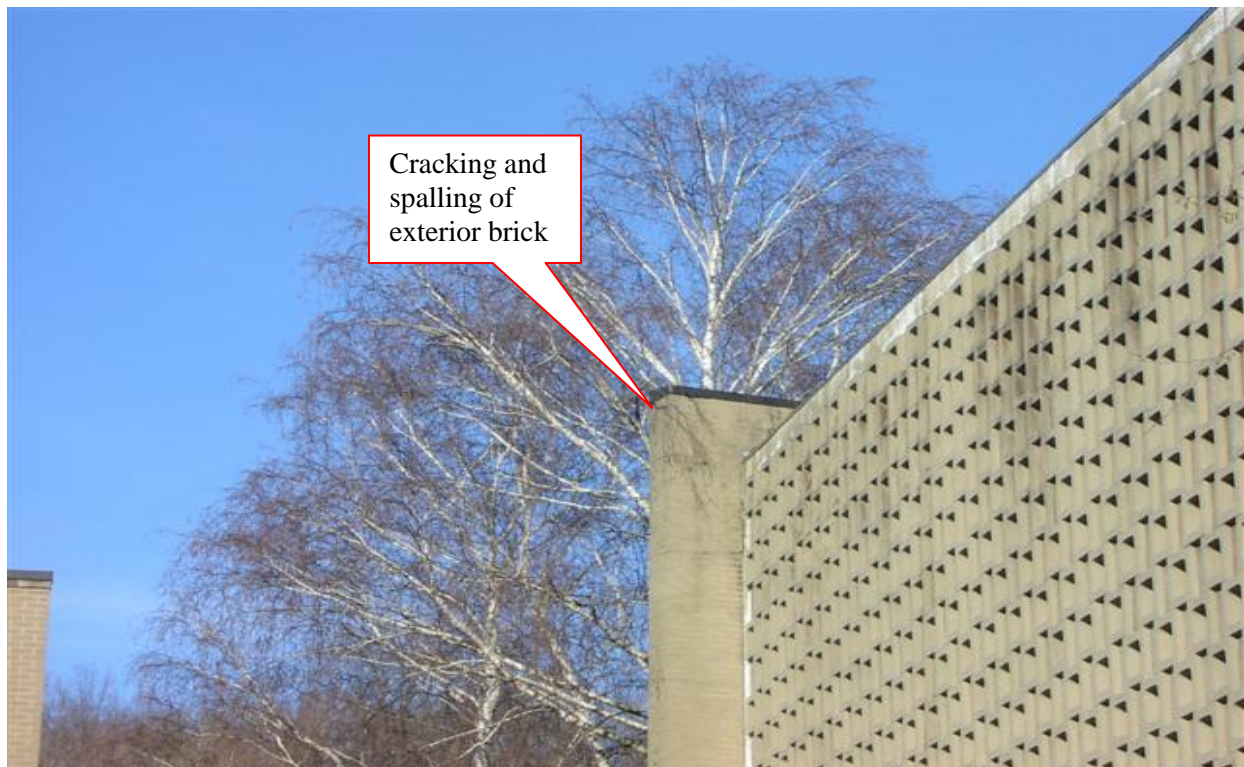
Condition of Exterior Masonry on South Face of North Wall of Auditorium

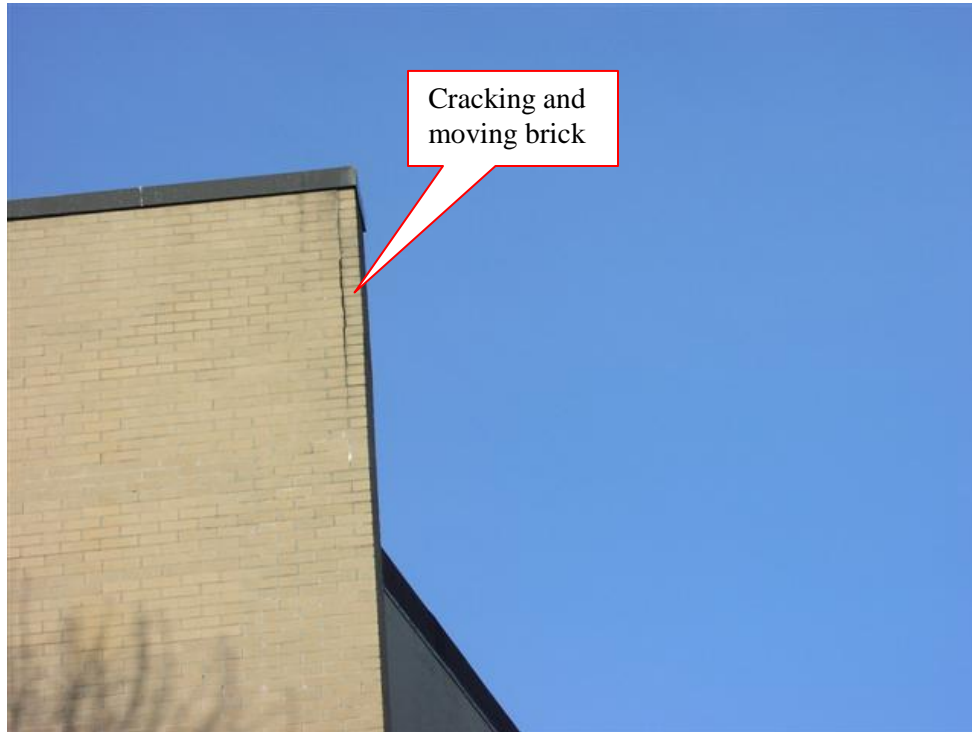
Condition of Exterior Masonry at Southeast corner of Auditorium

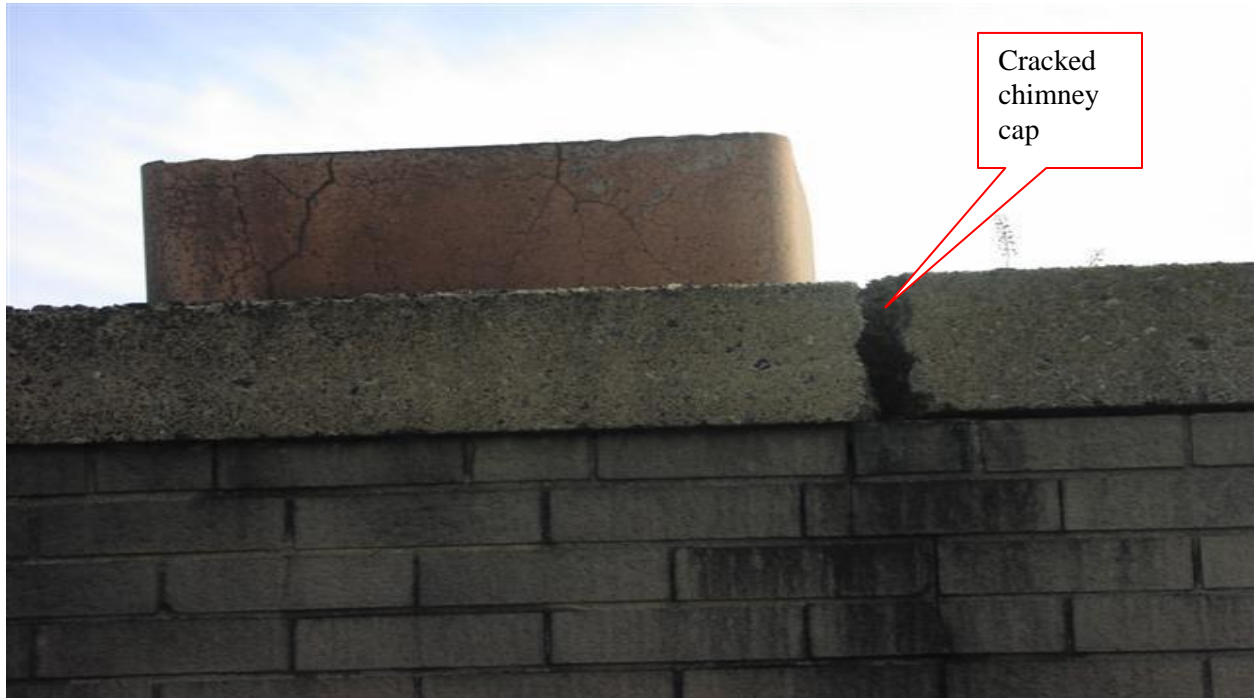
- The chimney projecting above the roof line is exhibiting considerable movement and cracking especially on the east face and the concrete cap. The bricks have shifted horizontally and vertically and the cap contains several large vertical cracks.

Close Up of Cracks and Movement in West Face of Chimney

- The masonry chimney must be demolished and rebuilt from the roof line. The masonry for the rebuilt portion must be anchored to the existing chimney below the roof.

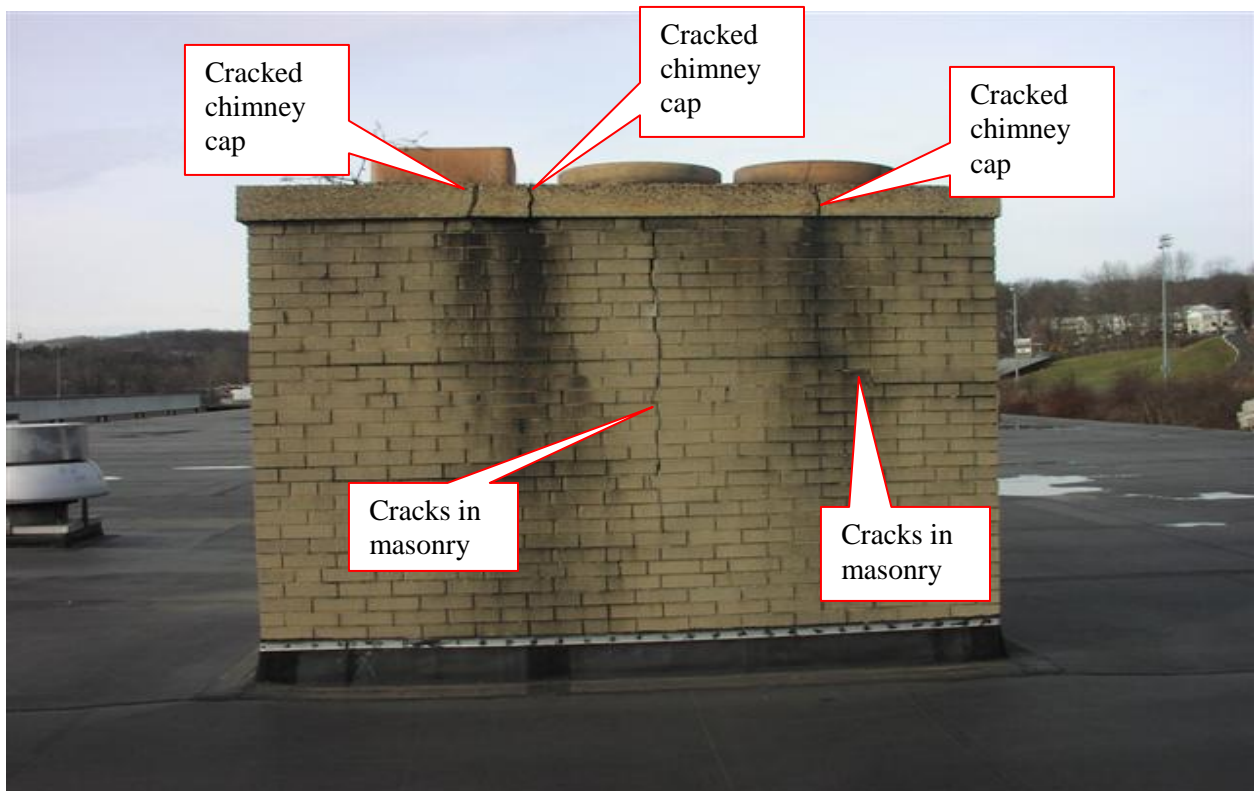
Condition of East Face of Chimney

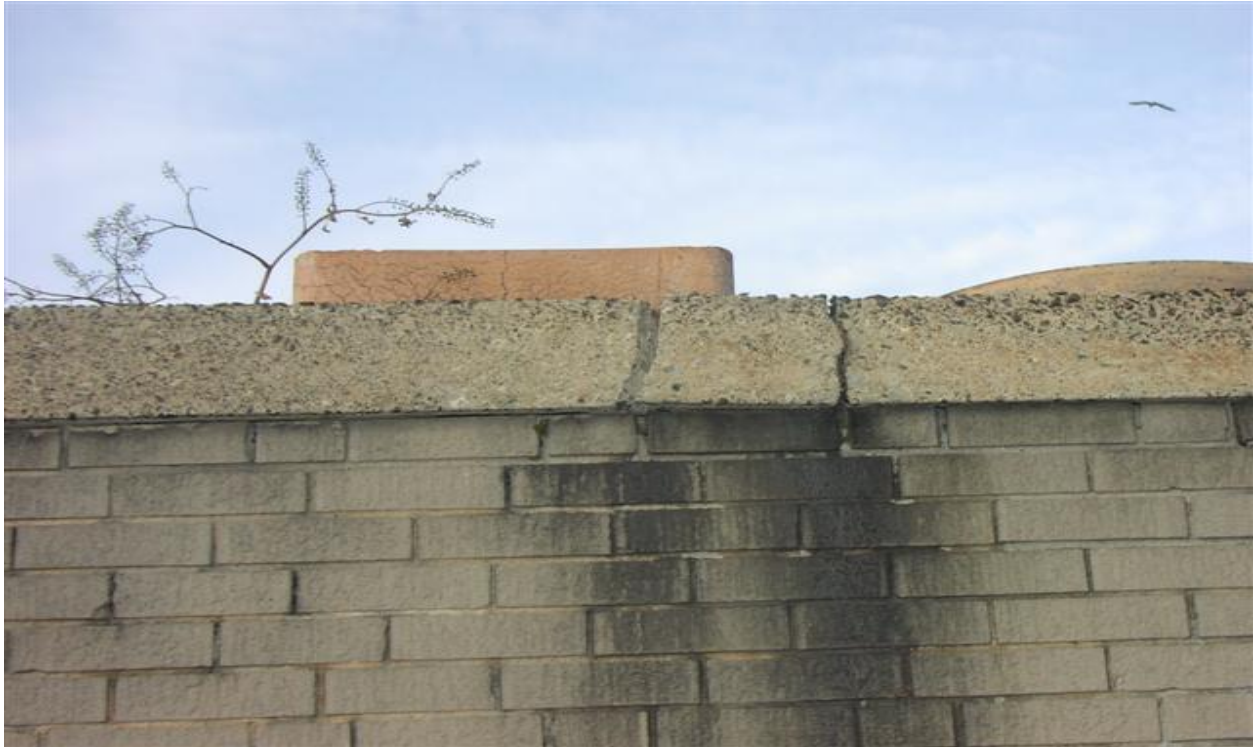
Close Up of Cracks and Movement in East Face of Chimney

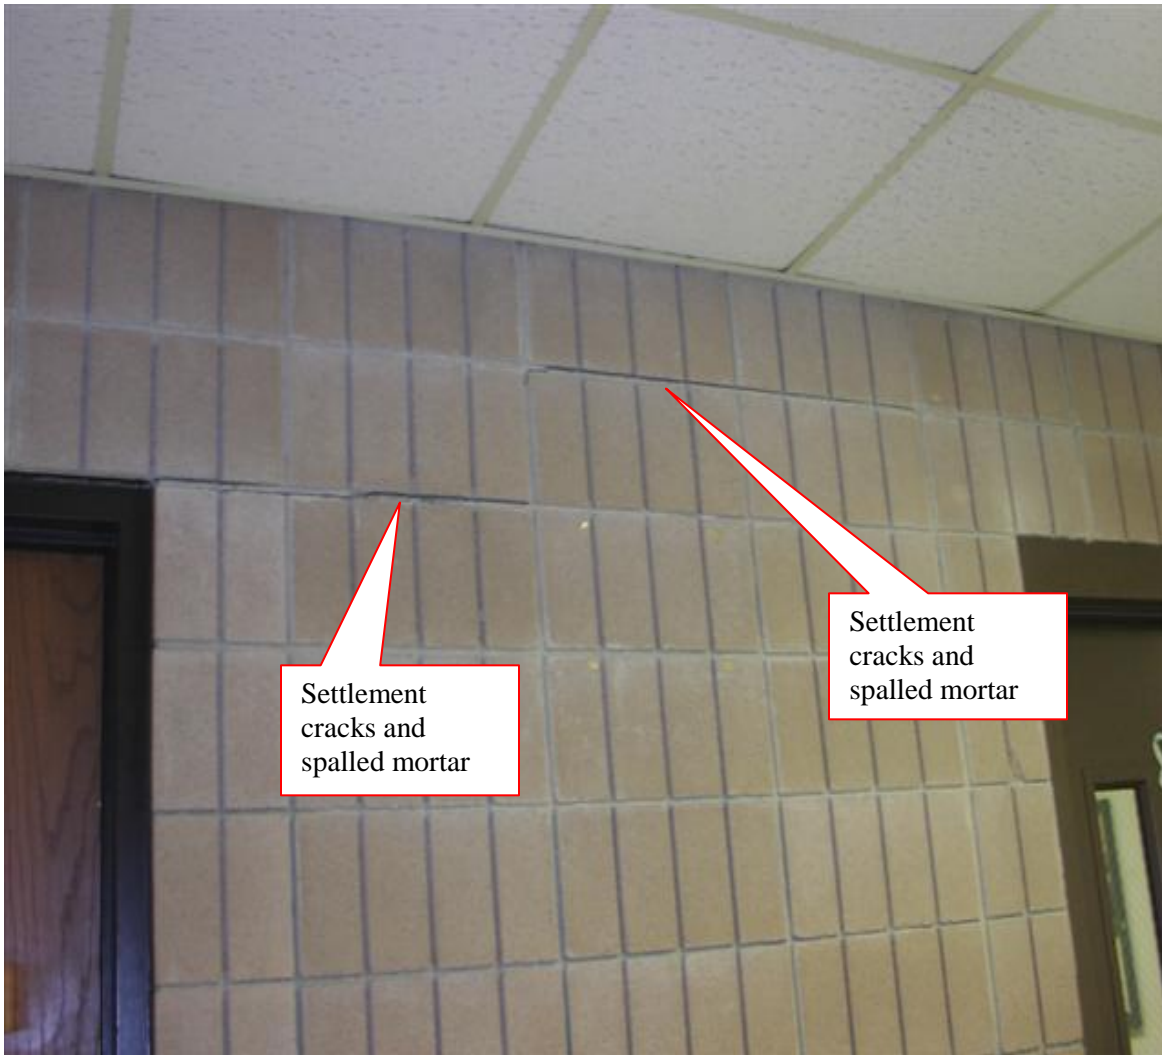
- Typically the additions appear to be structurally sound but some movement has been observed in the classroom wing and the connectors to the original building. Cracked interior block walls are visible in the south Corridor of the Goodyear House. The block wall bears on the slab-on-grade. The movement may be caused by settlement in the subgrade and slab-on-grade. The concrete block wall that forms the stairwell located on the east end of the Goodyear House contains numerous areas where diagonal cracks have developed. The cracks vary in width from hairline to 1/16". Cracks are also visible in the east and west walls of the Media Center on the Upper Level. These cracks are vertical and appear to occur where control joints were not constructed.

Goodyear House Main Level South Corridor

- The cracks and movement in the south Corridor and adjoining stairwell must be explored to determine the anchorage and reinforcing in the walls. The movement must be monitored with gauges to verify if the walls are continuing to move. Based on the information gathered from the monitors, recommendations to repair the condition will be developed.

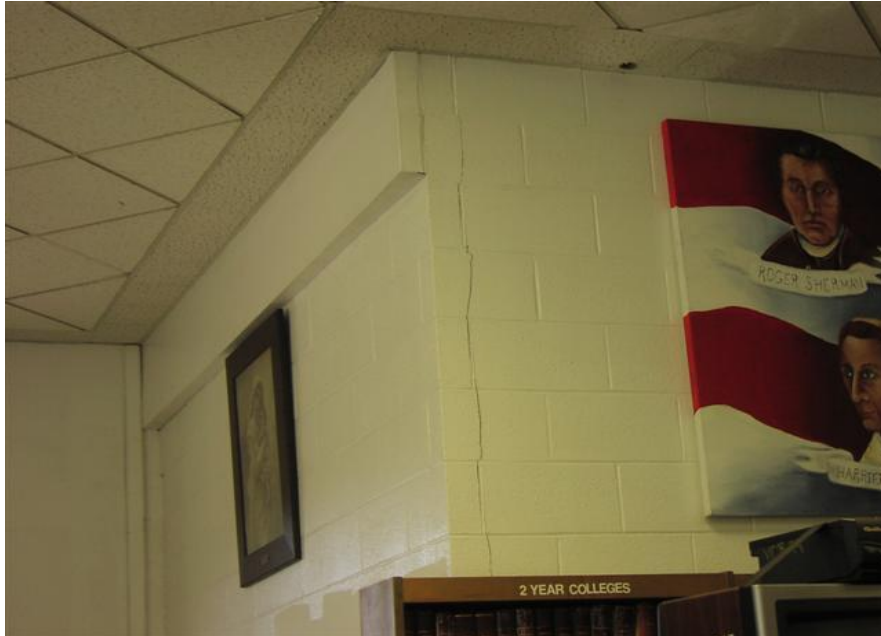
Crack in Media Center Wall

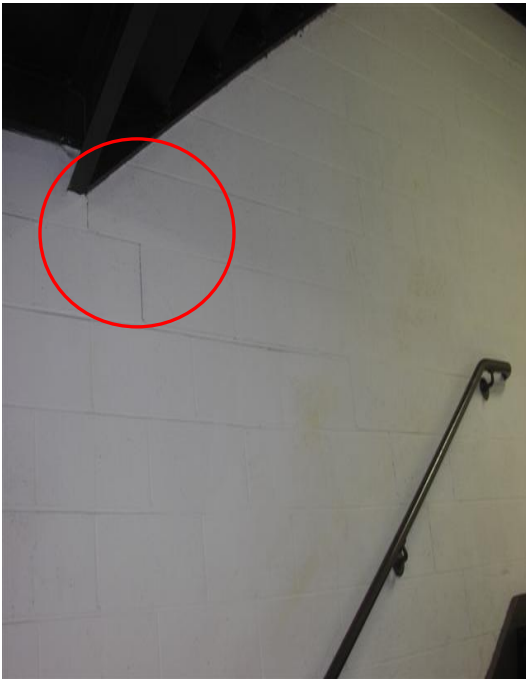
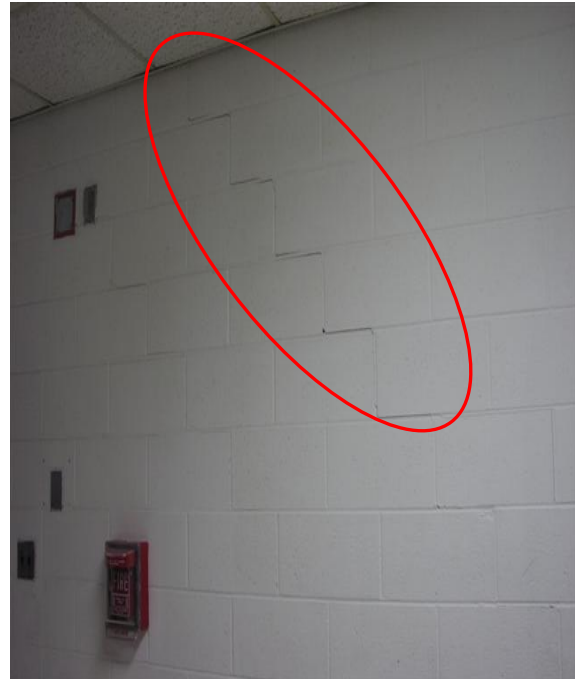
Cracks and Movement in the East Goodyear House Stairwell

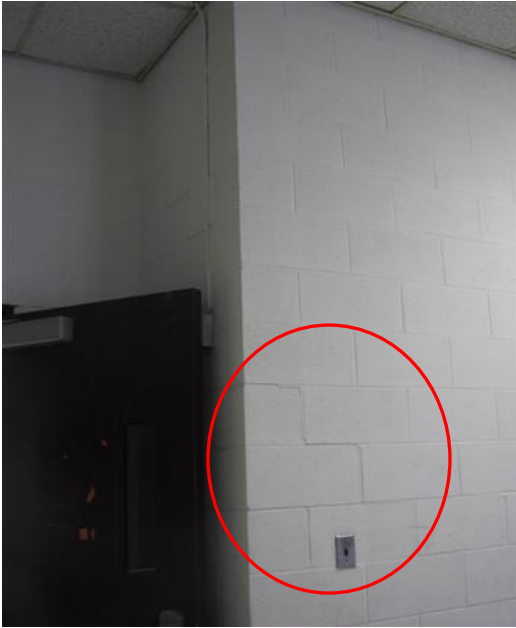
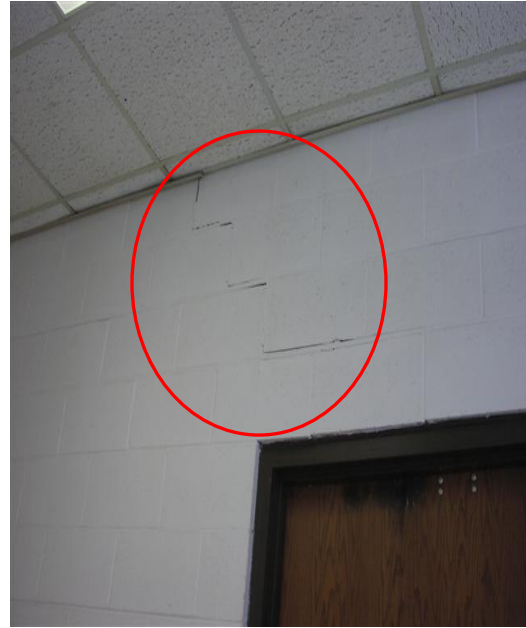
Cracks and Movement in the East Goodyear House Stairwell

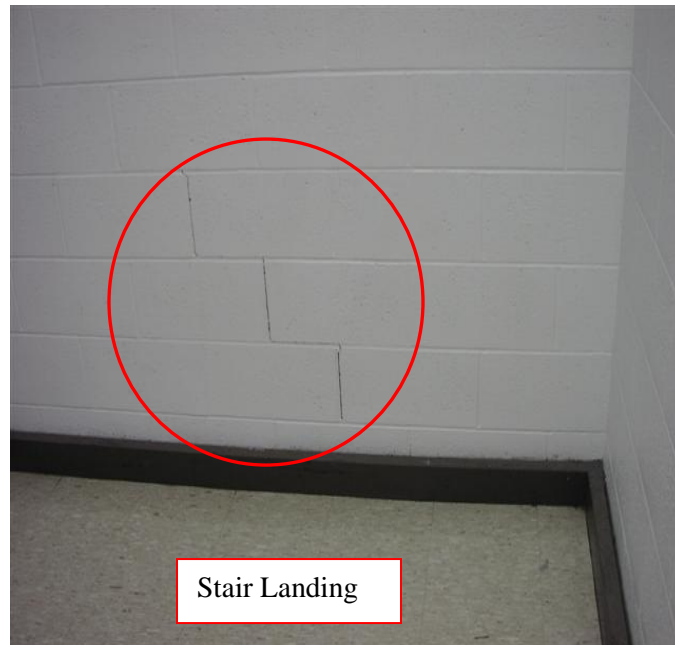
Cracks and Movement in the East Goodyear House Stairwell

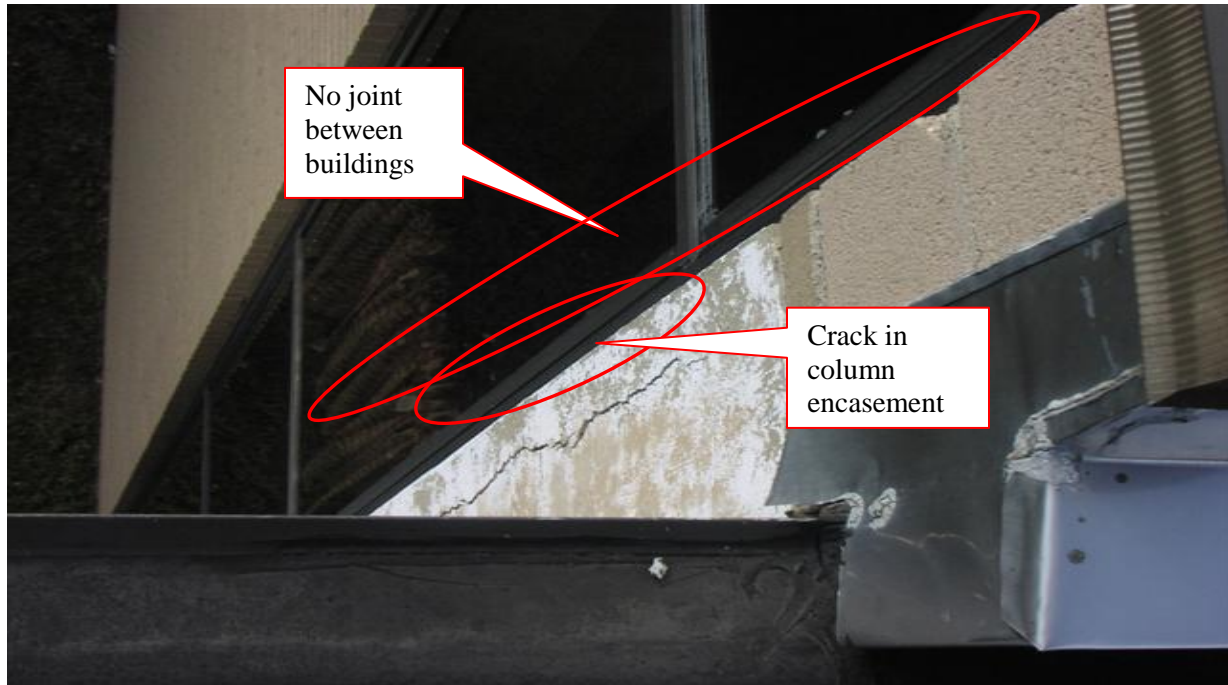
- At each of the 1974 connectors it appears that expansion joints were not provided where the exterior walls are abutting the original building. Due to the lack of expansion joints the differential movement between the buildings has caused cracking and spalling of mortar and masonry.

Lack of Expansion Joint between the Original Building and the 1974 Main Connector

- An expansion joint must be created between the original building and the 1974 Connectors on the exterior of the structures. Currently the joint is filled with mortar, brick or other building material. A 2" minimum joint must be permitted and opening formed shall be concealed with expansion joint covers to prevent water from entering the building.

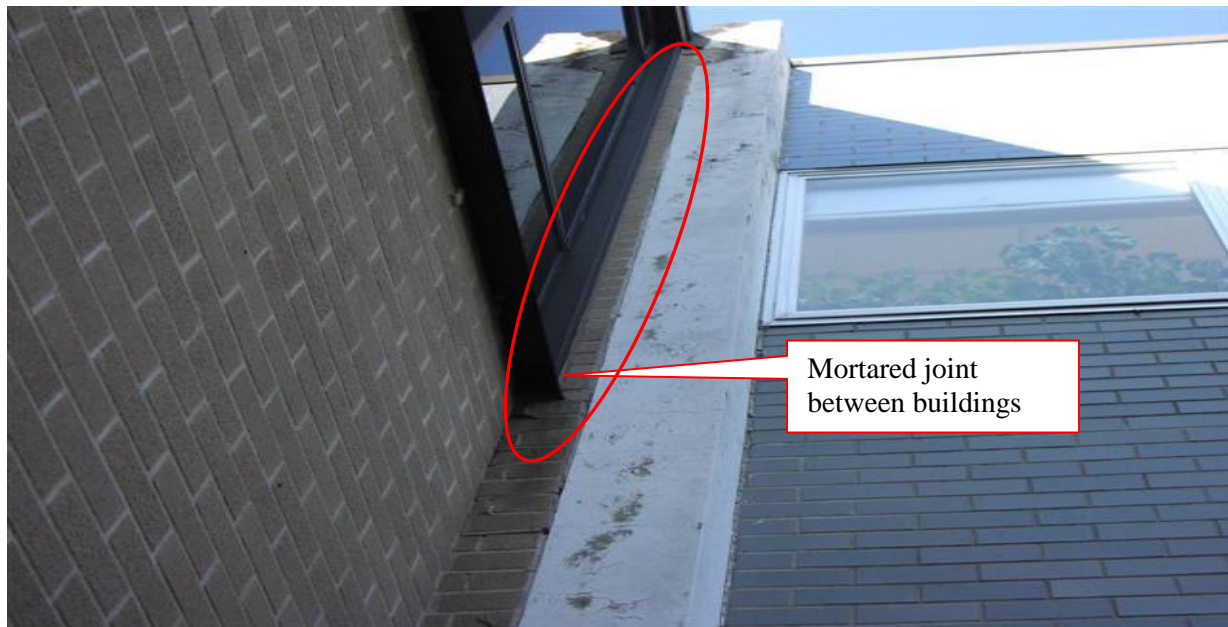
Mortared Expansion Joint between West Connector and Original Building

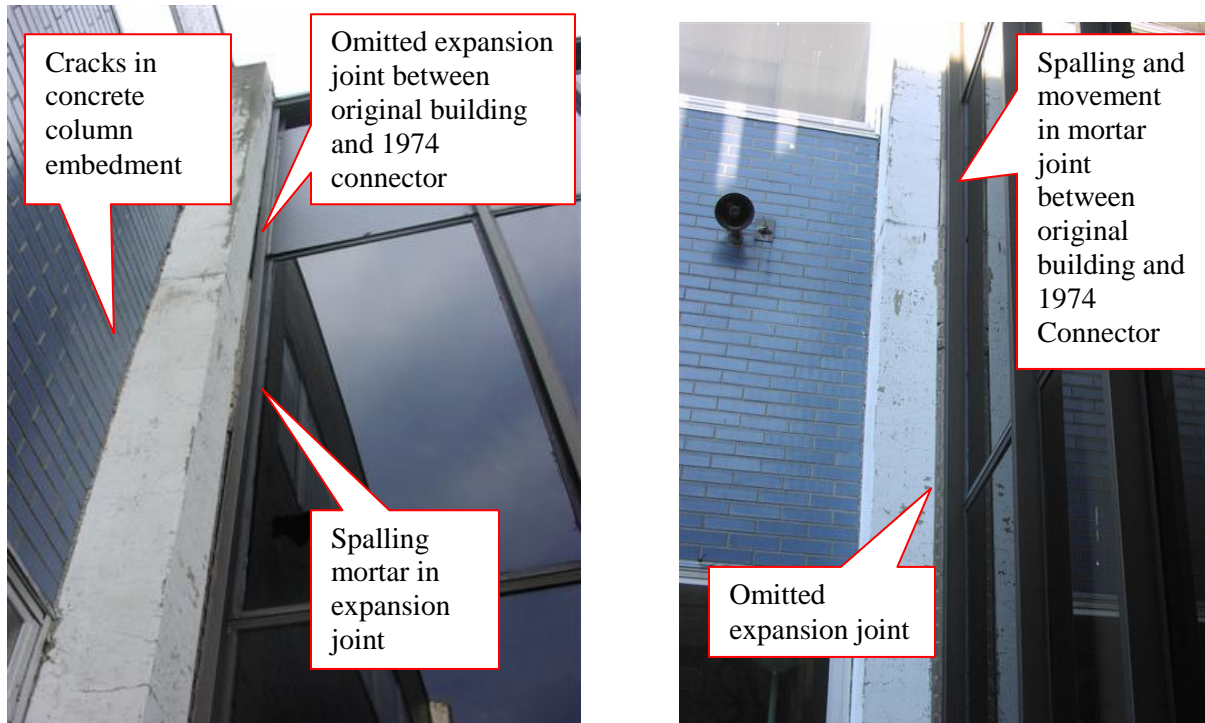
Views of the Intersecting Exterior Walls of the East Connector to the Original Building

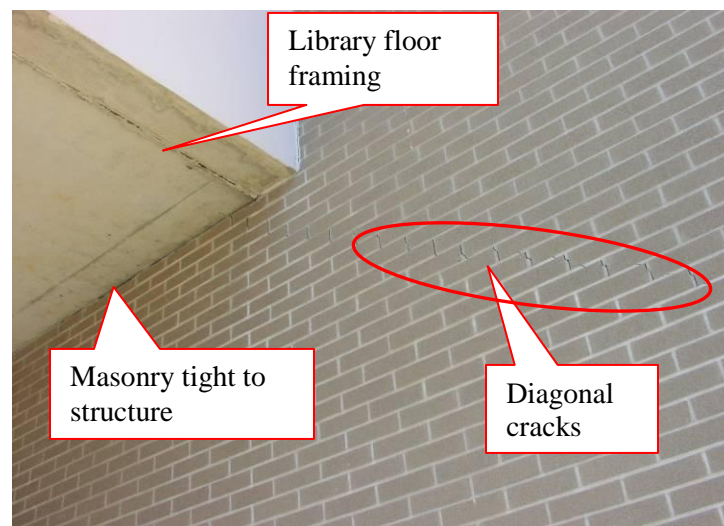
- Considerable cracking and movement have occurred between the exterior brick and Upper Level waffle slab in the Goodyear House at the Terrace. It appears that the brick was constructed tight to the underside of the concrete framing without a soft joint to allow for movement in dissimilar materials. The damage is more prevalent at the south entrance.

Exterior East Masonry Wall at Goodyear House at the Media Center Slab Structure

- Similarly on the exterior of the Goodyear House and the Castle House, gauges should be installed to determine if the movement is continuing to occur and the direction of the movement. Based on the information gathered from the monitors, recommendations to repair the condition will be developed.
