Structural Report

1959 Original Building

Existing Conditions Assessment

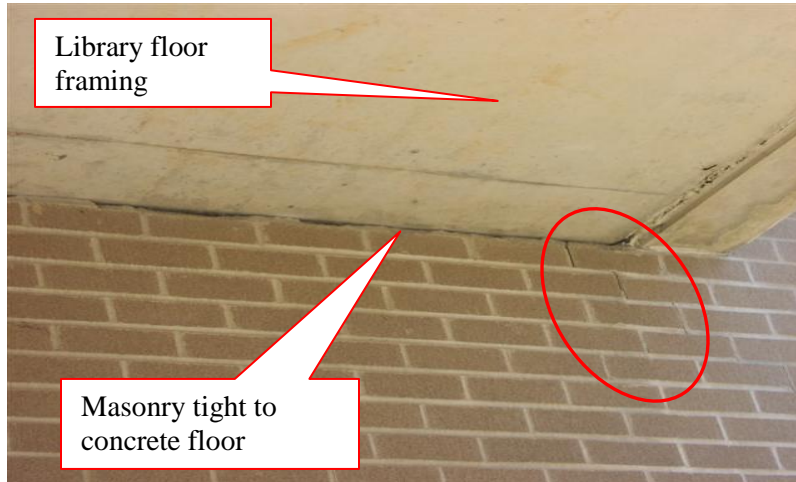
- Considerable cracking and movement have occurred between the exterior brick and Upper Level waffle slab in the Goodyear House at the Terrace. It appears that the brick was constructed tight to the underside of the concrete framing without a soft joint to allow for movement in dissimilar materials. The damage is more prevalent at the south entrance.

Close up of Exterior East wall of Goodyear House

- Similarly on the exterior of the Goodyear House and the Castle House, gauges should be installed to determine if the movement is continuing to occur and the direction of the movement. Based on the information gathered from the monitors, recommendations to repair the condition will be developed.

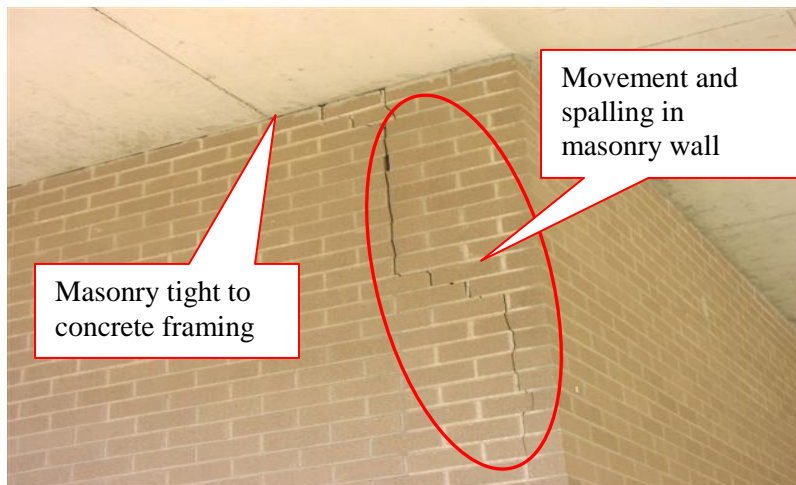
Southeast Entrance to the Goodyear House

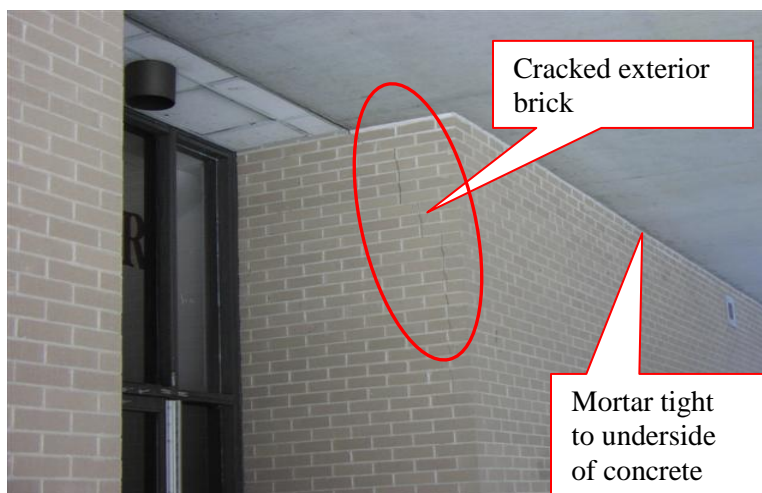
Northeast Entrance to the Goodyear House

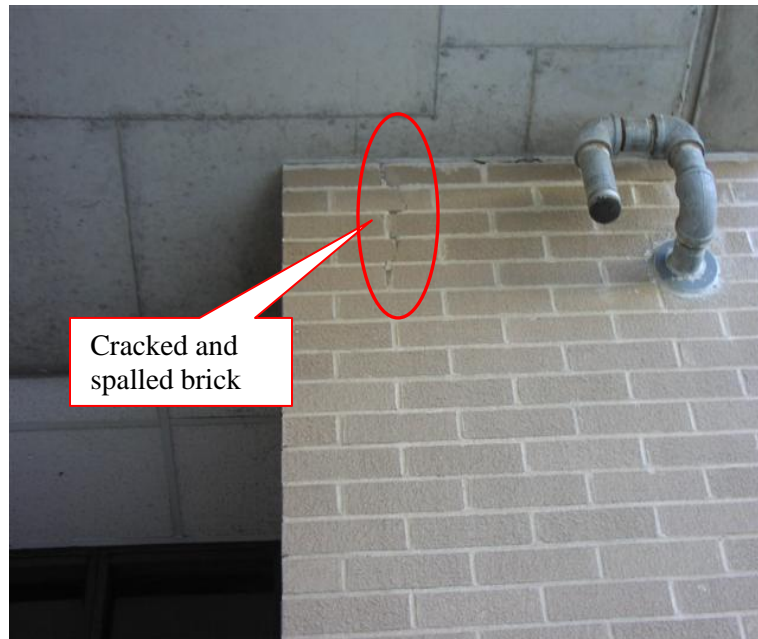
Southwest Entrance to Castle House
