**BUILDING REMEDIATION / DEMOLITION / REMOVALS AT**

**1 Orchard Terrace  
1 South Main Street  
58 Maple Street  
146 Walnut Street**

**NAUGATUCK, CONNECTICUT**

**Contract No. 14-18**

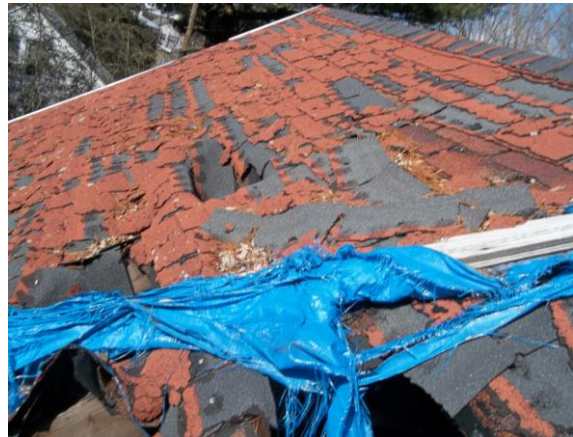
Photo #2:	Holes in roof
-----------	---------------

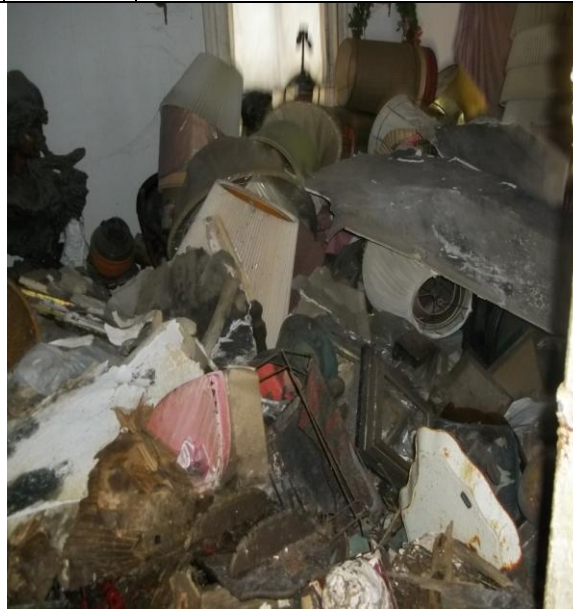
Photo #4:	Stored items with collapsed ceiling debris
-----------	--

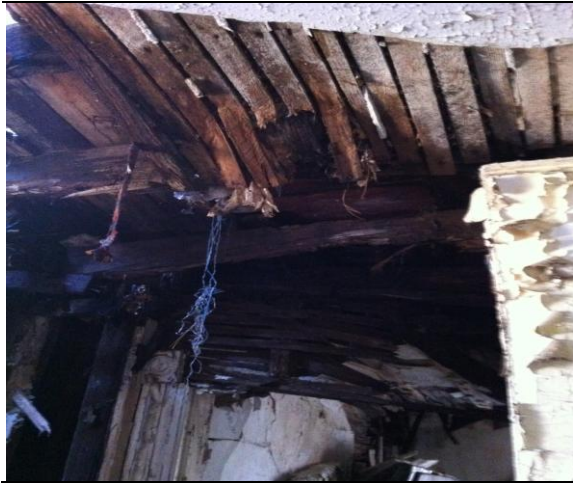
Photo #5:	Collapsed ceiling joists
-----------	--------------------------

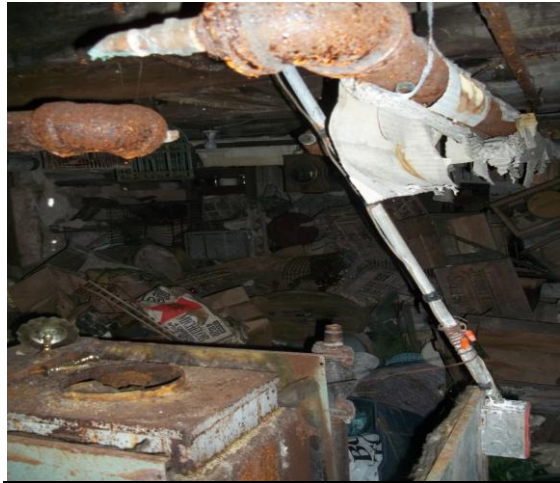
Photo #6	Damaged aircell insulation and stored materials in basement
----------	---

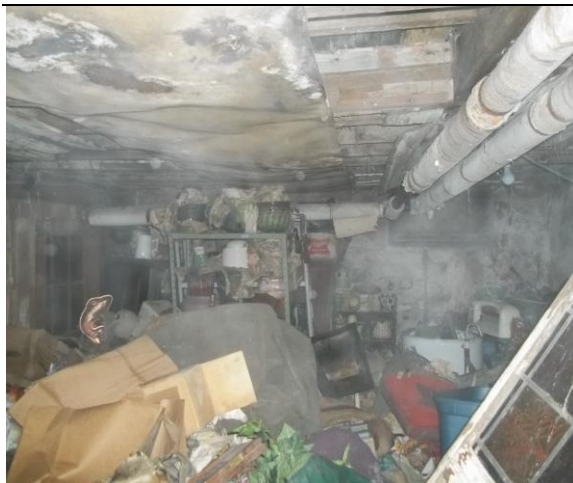
Photo #7:	Aircell insulation and stored materials in basement
-----------	---

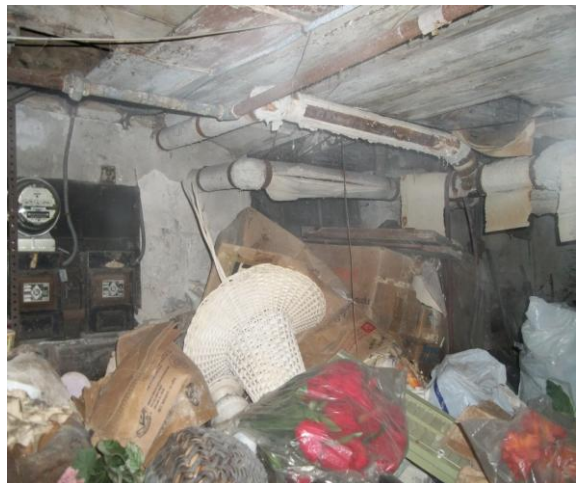
Photo #8	Damaged aircell insulation and stored materials in basement
----------	---
