TO: Jim Stewart, Director of Public Works, Borough of Naugatuck
FROM: Pamela Westgate, P.E., Kleinfelder
DATE: July 28, 2016

This Technical Memorandum describes the condition assessment and needs identified in evaluations of the Hop Brook, Horton Hill, Inwood, Maple & May, and the Platts Mill Pump Stations (PSs) in the Borough of Naugatuck, CT. This assessment of the five pump stations was done as part of developing a Facilities Plan for the Borough owned wastewater collection and treatment facilities in Naugatuck. The purpose of the condition assessment was to:

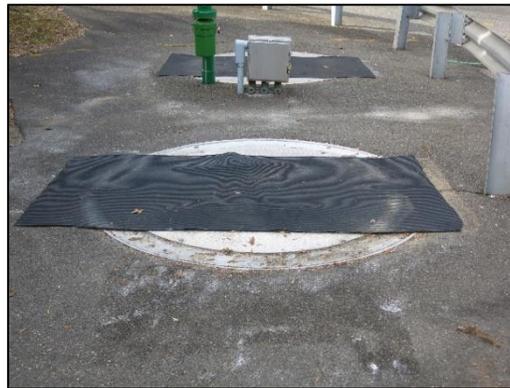
The piping, valves, and pump rails in the wet and drywells at all of the pump stations are in good condition with the exception of the Inwood PS, where there is deterioration from corrosion. Inwood PS also has had some odor issues, which have been somewhat abated with the addition of mats over the wetwell hatches (see). The corrosion and odor at the Inwood PS are indicative of hydrogen sulfide generation in the collection system. If found to be present, control of hydrogen sulfide in the collection system at or upstream of the Inwood PS, as necessary, would alleviate the corrosion as well as the odor issue.

Corrosion and odor at the Inwood Pump Station are indicative of hydrogen sulfide generation in the collection system. If found to be present, control of hydrogen sulfide in the collection system at or upstream of the Inwood Pump Station, as necessary, would alleviate the corrosion as well as the odor issue.

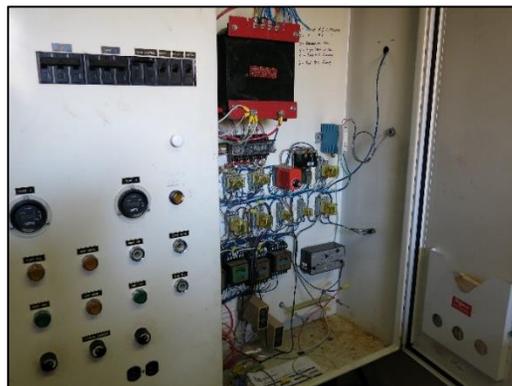
The controls are in good condition at the Hop Brook, Horton Hill, and Maple & May PSs. At the Inwood PS the control panel and wiring is in fair condition, while the control panel at the Platts Mill PS is obsolete and the wiring is in poor condition (see). The control panels and wiring will need to be replaced within the 20 year planning period.

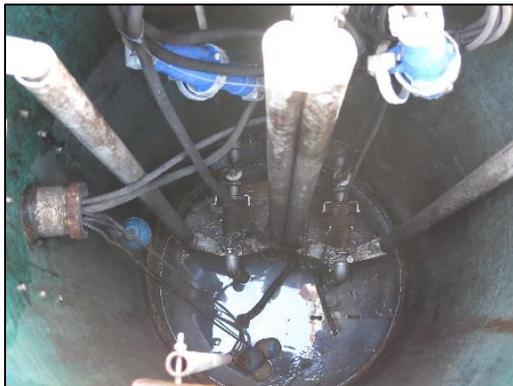
Figure 1. Hop Brook Wetwell

- This station has a wetwell with two submersible pumps installed on a rail system that discharges the sewage to a piping system located in a drywell adjacent to the wetwell.
- Piping and valves are stainless steel and appear to be in good condition.
- Both pumps were rebuilt in 2012 and are in good operating condition.

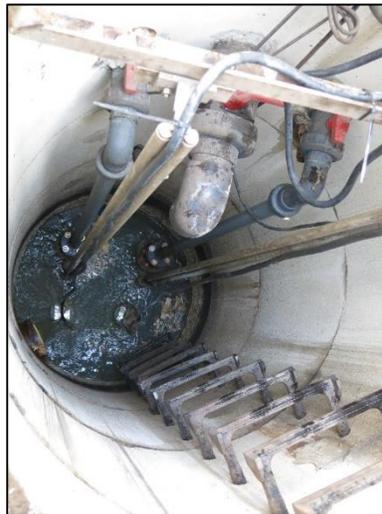
Figure 3. Horton Hill Wetwell

- The wet well is made from concrete ring sections with one of the upper rings slightly displaced, as presented in the following figure, and may benefit from realignment or sealing to prevent leakage.

- HH1 – Seal the interior of concrete rings, with particular focus on the top cover area to prevent leaks. A more costly alternative to sealing would be to realign the ring through excavation and replacement.
- HH2 – Remove rust and paint exterior gas piping, or replace the gas line with corrosion resistant piping.
- HH3 – Roof damage visible. Appears to be from a single impact event.
- HH4 – One of the pumps at this location was overhauled in 2014 and one pump is new, although they appear to be in good operating condition, they may require replacement in the next 20 to 25 years.

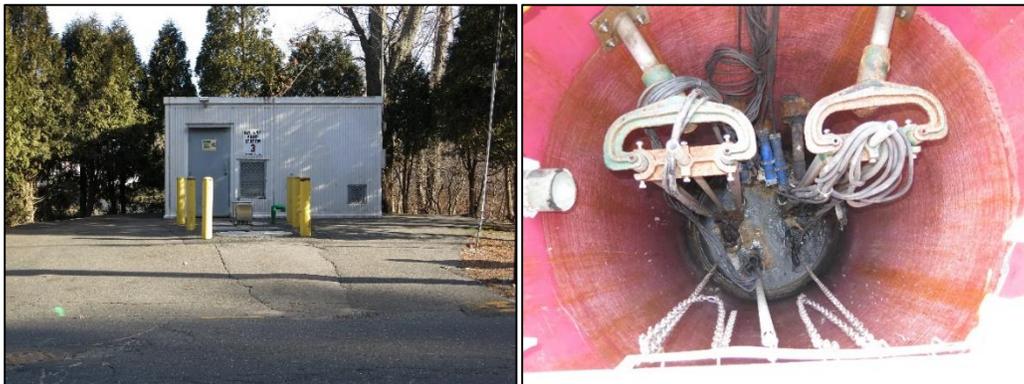
Figure 10. Maple & May Pump Station and Wetwell

- The exhaust fan may require maintenance or replacement on the interior of the building. It did not initially start when placed into the on position. This may be an electrical connection issue.
- The wetwell, rails and piping systems appear to be in good condition.
- Minor corrosion was noticed at this station, which may be due to corrosive gases from Inwood PS, which is down stream of this station.

- MM1 – Seal and/or coat exposed concrete, iron, and steel inside wetwell.
- MM2 – Troubleshoot exhaust fan operation connecting wires.
- MM3 – Exterior building is in good condition, slight damage visible on concrete.
- MM4 – The pumps at this location were either rebuilt or replaced in 2012. The pumps appear to be in good operating condition, they may require replacement in the next 20 to 25 years.

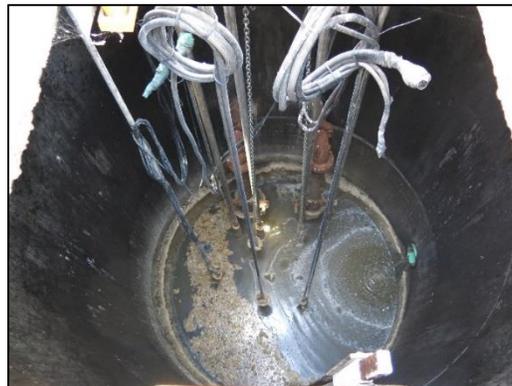
Figure 11. Platts Mill Wetwell

- The piping system, wetwell, and pumping system appears to be in good condition.
- The station control system is original to construction with outdated relay logic technology, and should be considered for replacement. It should be noted that the controls are still functioning, however, replacement parts may be difficult to obtain.

- PM1 – Upgrade control system.
- PM2 – Repair dry well concrete casing at entry hatch.
- PM3 – The pumps at this location were either rebuilt or replaced in 2014. The pumps appear to be in good operating condition, they may require replacement in the next 20 to 25 years.

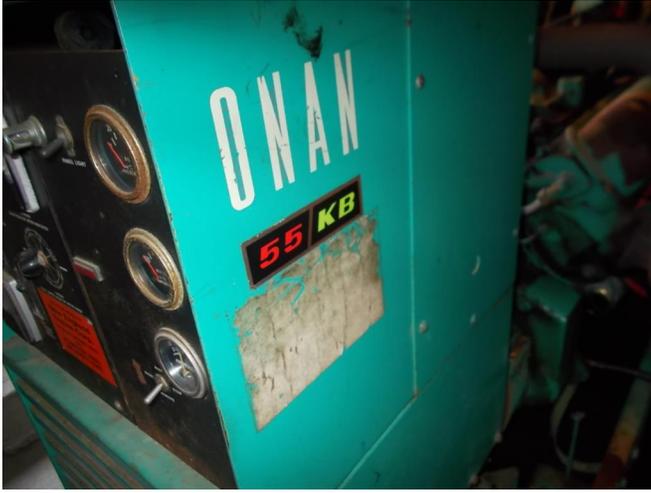
E-PS4-1 GENERATOR

- The generator for this station appear to be old (circa 1980's) and should be considered for upgrading. It should be noted that the generator is in operating condition and is able to maintain the full-load during the monthly test.
- Current efforts to minimize odors around the Inwood station have helped reduce customer complaints. However, there is evidence of corrosion deterioration on the steel, cast iron, and

- IW2 – Replace emergency generator.
- IW3 – Seal wetwell and drywell covers to prevent odor issues in surrounding neighborhood. A more costly alternative to increasing the seal on the existing covers would be to replace the covers. It should be noted that the hatch sizes seem to be custom and may require custom fabrication.
