**REQUEST FOR QUALIFICATIONS
ARCHITECTURAL/ENGINEERING DESIGN SERVICES
For the RENOVATION OF THE TUTTLE BUILDING**

EXISTING CONDITIONS REPORT

TUTTLE HOUSE NAUGATUCK, CONNECTICUT

**Re: Investigation of building envelope at the
Naugatuck Board of Education
Naugatuck, CT**

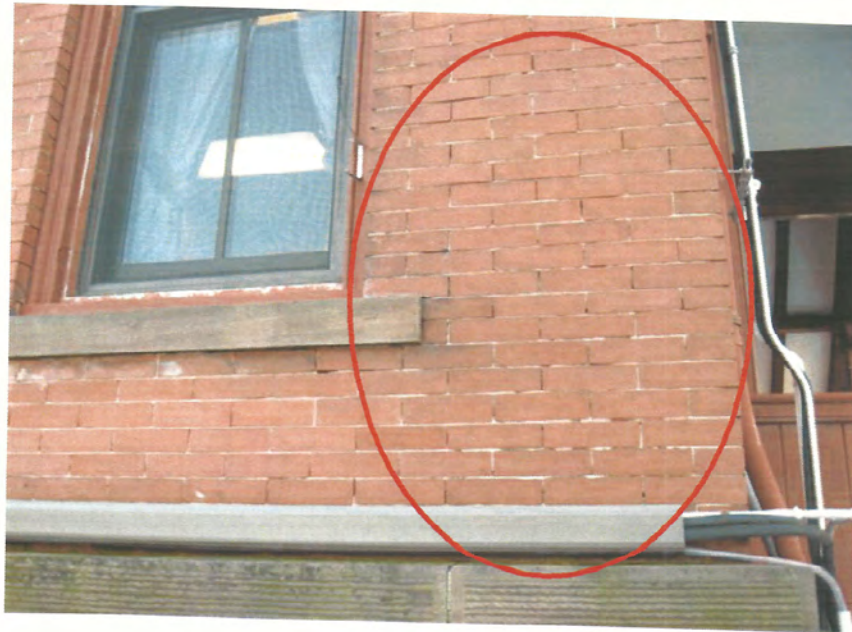
Vegetation growing on the exterior walls typically opens up the mortar joints allowing water to enter the facility, accelerating the deterioration to the masonry due to repeated freeze thaw cycles.

Voids in mortar joints
