**REQUEST FOR QUALIFICATIONS
ARCHITECTURAL/ENGINEERING DESIGN SERVICES
For the RENOVATION OF THE TUTTLE BUILDING**

EXISTING CONDITIONS REPORT

TUTTLE HOUSE NAUGATUCK, CONNECTICUT

**Re: Investigation of building envelope at the
Naugatuck Board of Education
Naugatuck, CT**

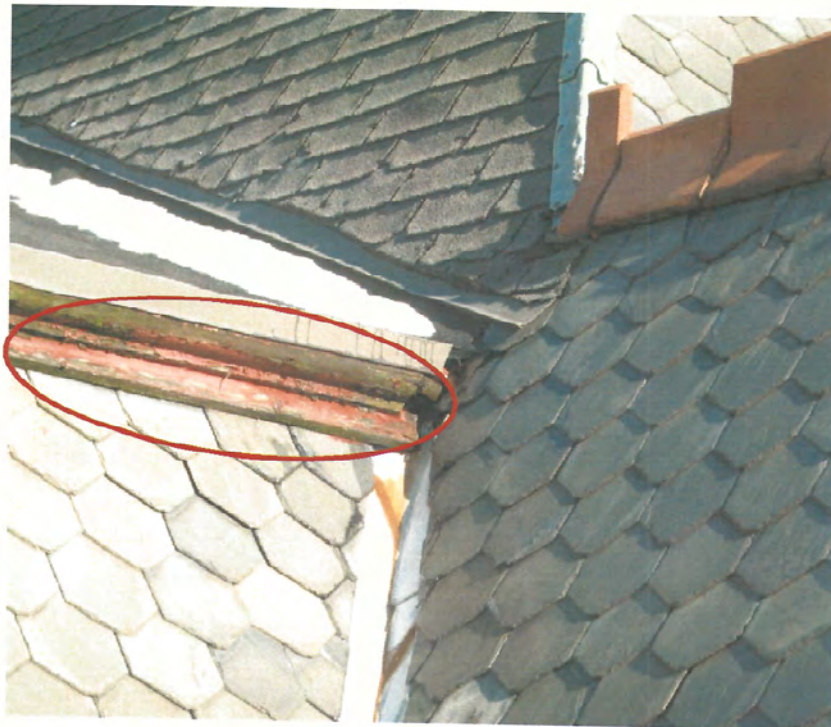
- Wood trim installed at several roof flashing details is rotted and in extremely poor condition.

Wood Trim

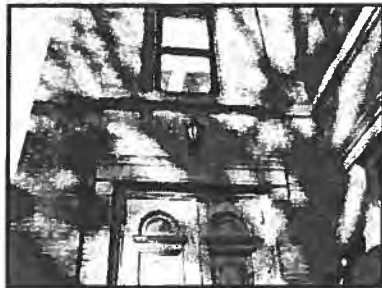
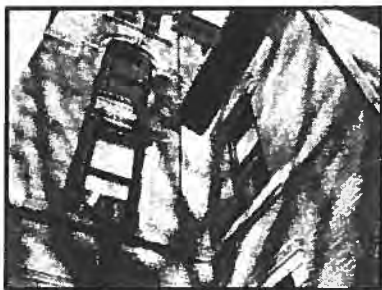
ALTERNATE: REPAIR AND REPOINT BRICK VENEER

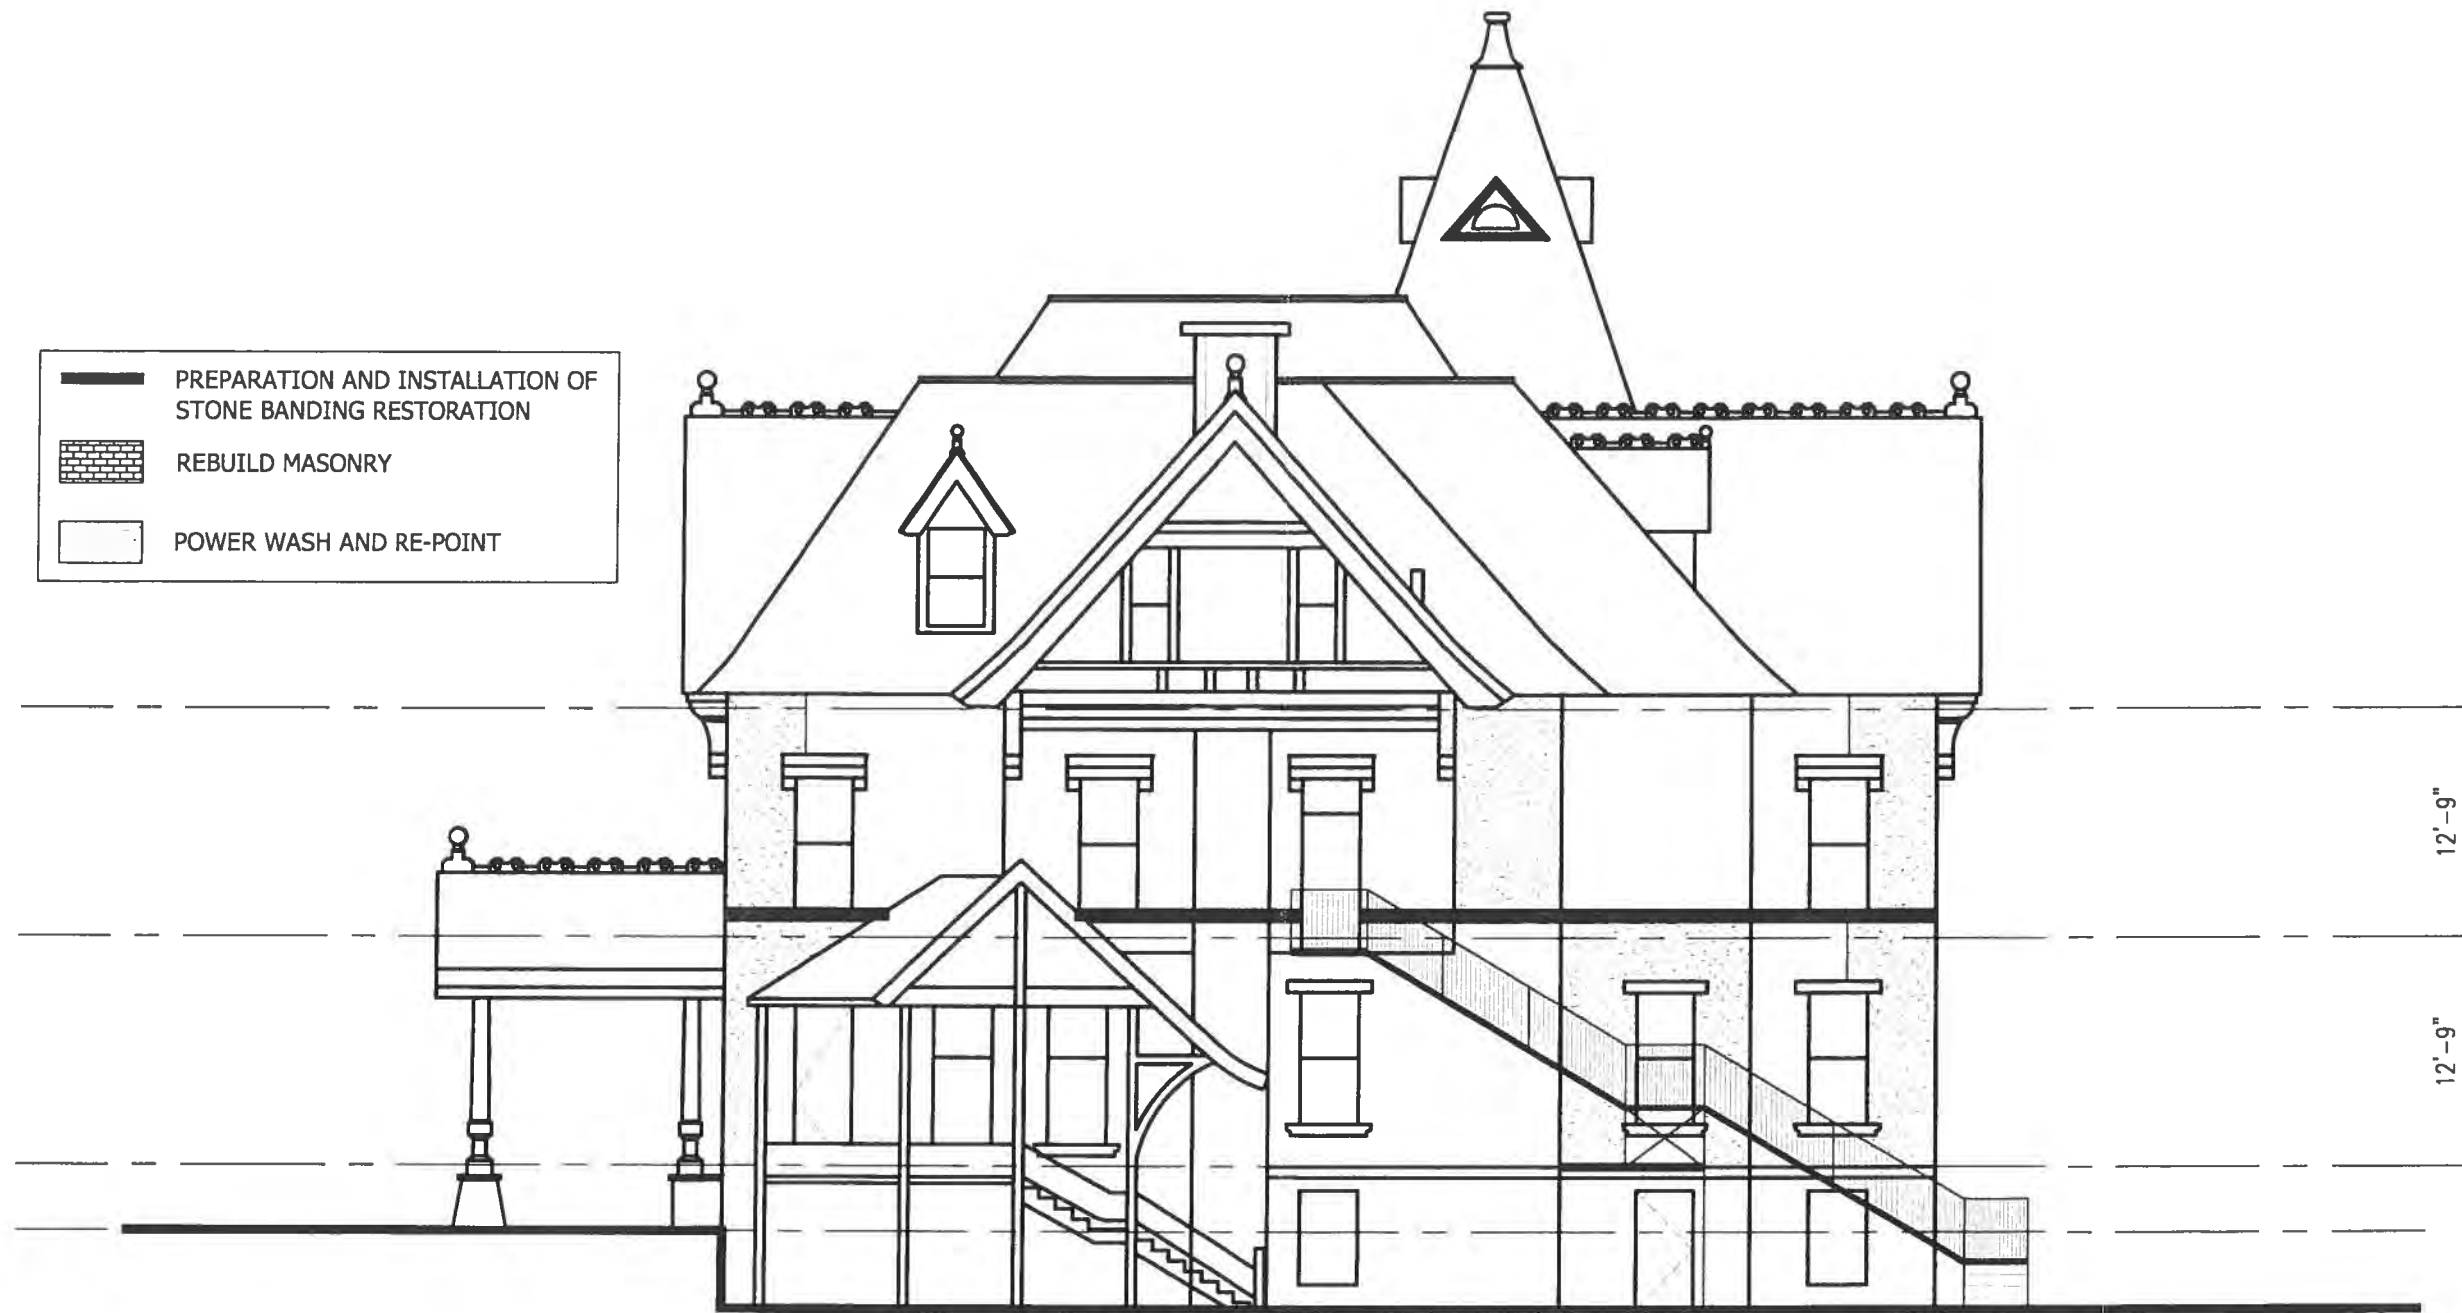
**EXISTING WEST ELEVATION
Tuttle House**

POWER WASH AND RE-POINT

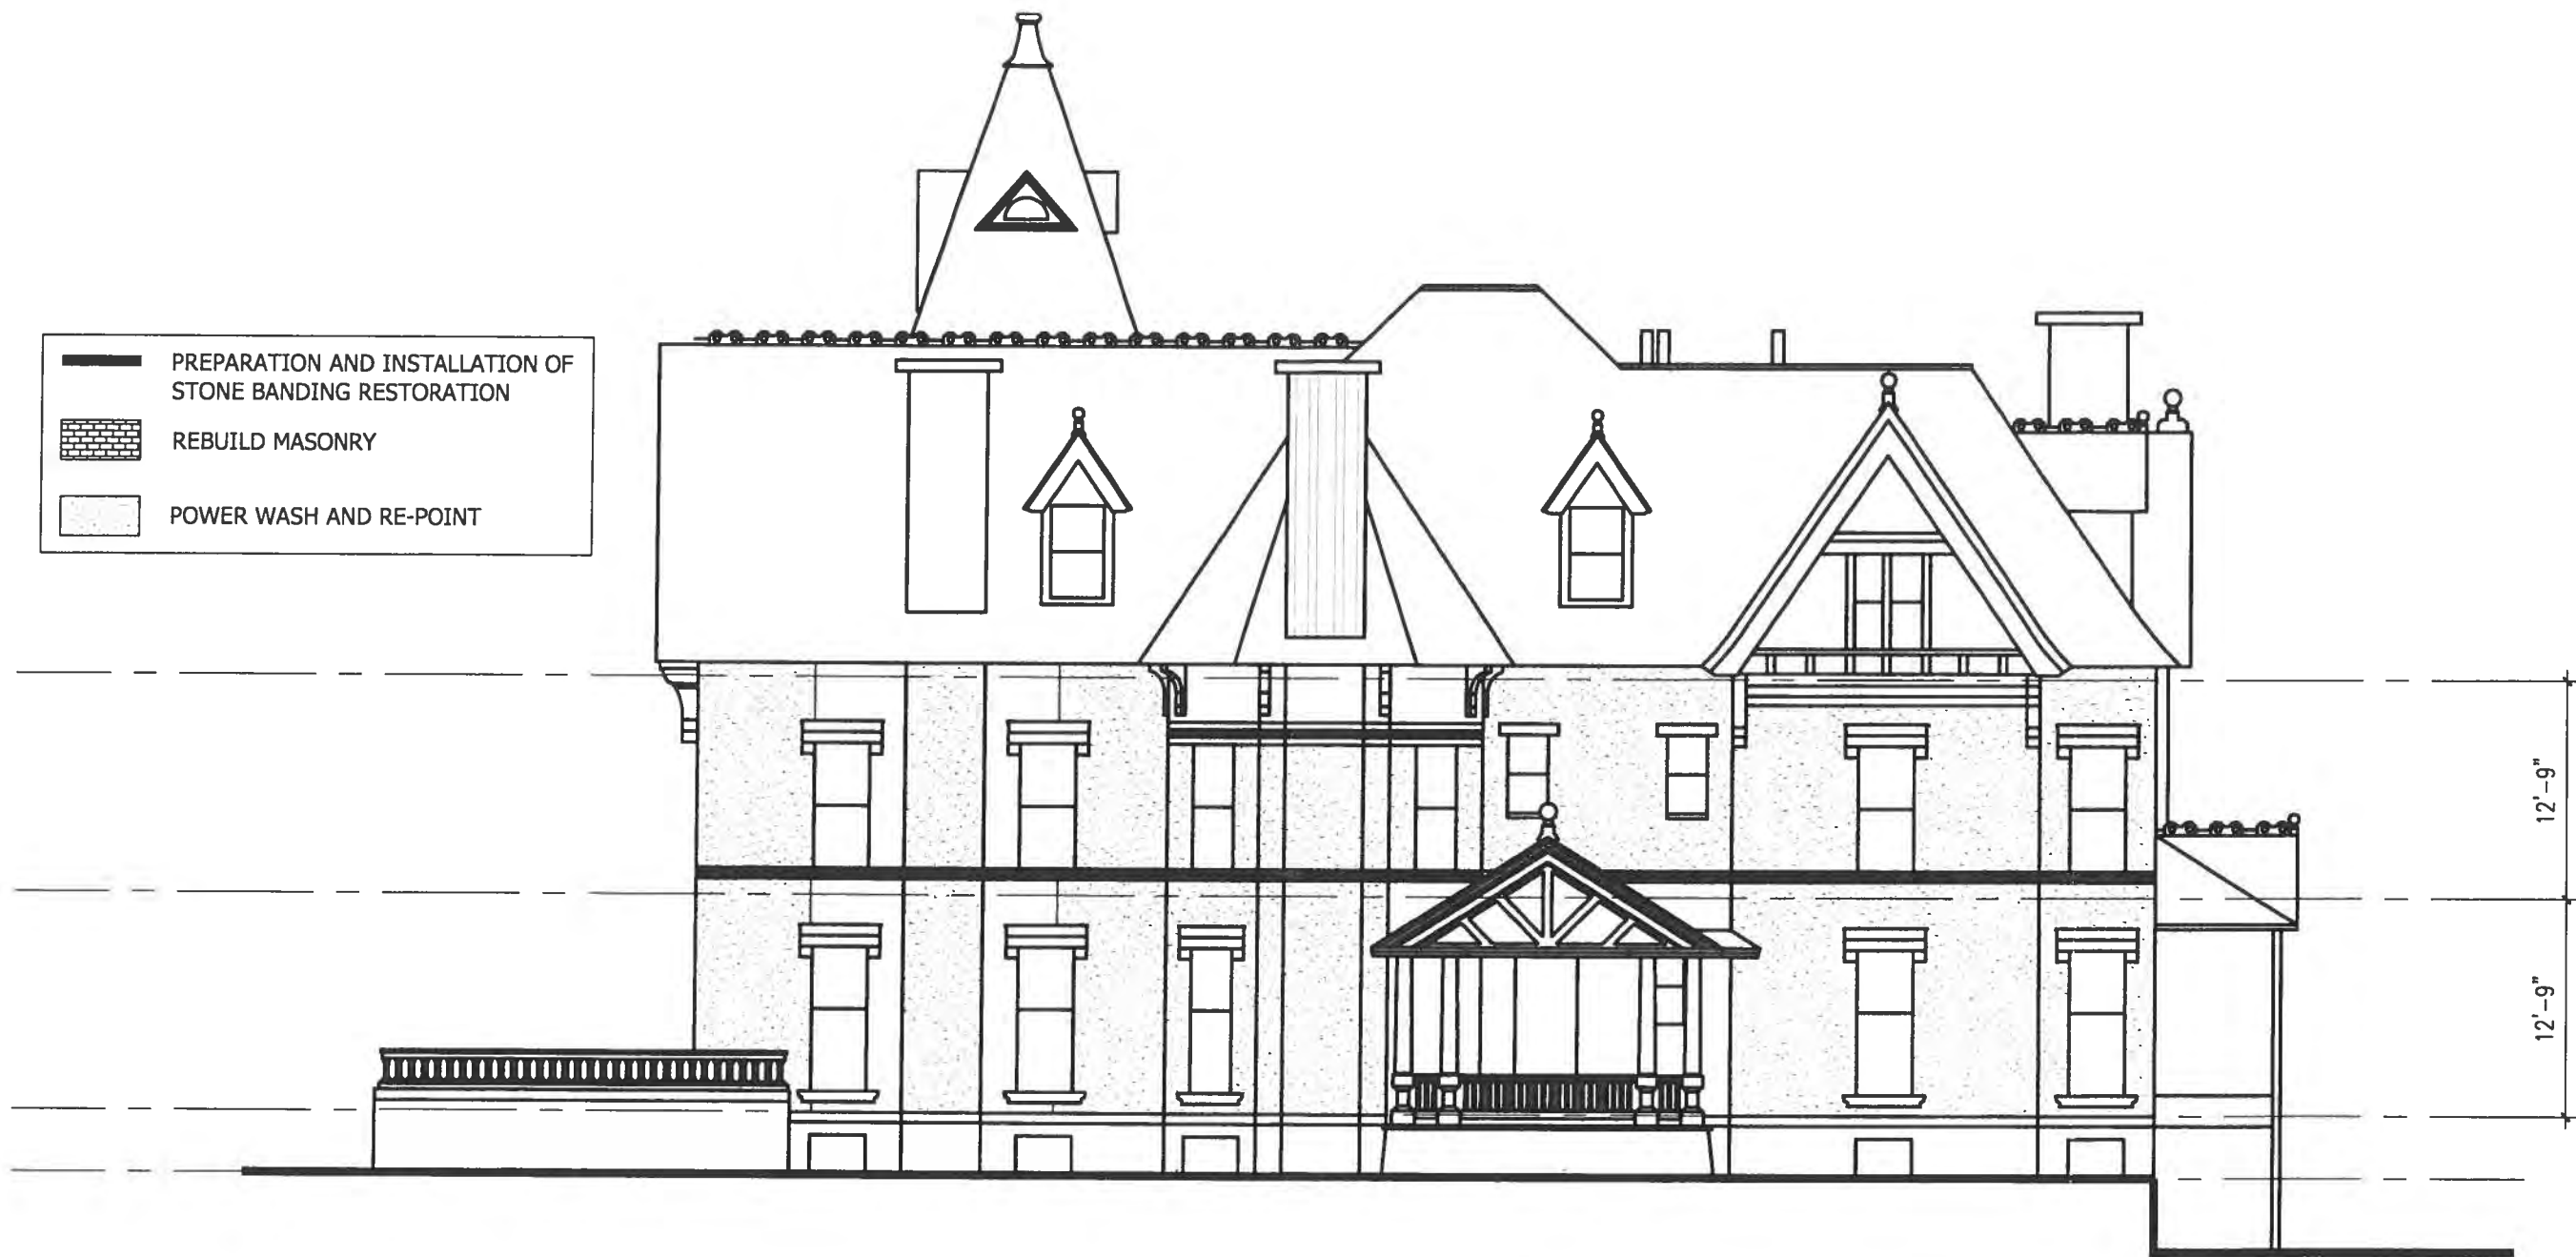
**EXISTING NORTH ELEVATION
Tuttle House**

POWER WASH AND RE-POINT
